# FCU flow body/drive body split

January 18, 2024  
5:28 PM

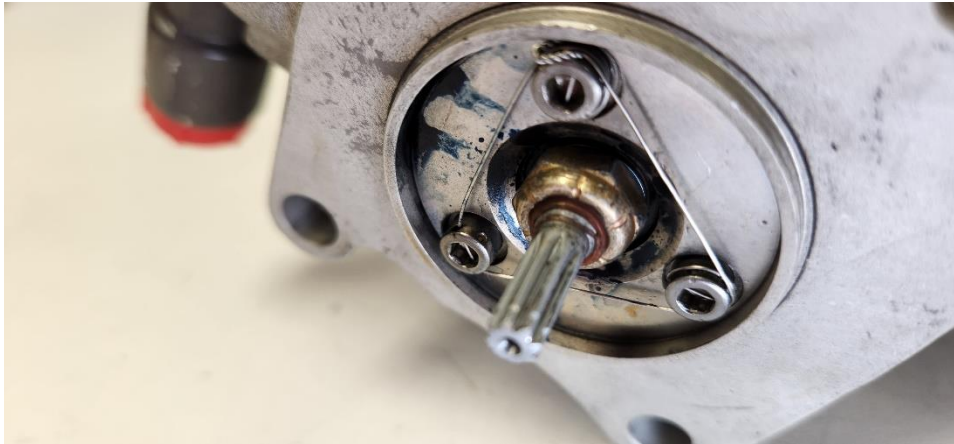
Blue dye found at FCU mating flange between fuel pump and FCU.

- All oil found was consistent with engine oil
- Oil most likely caused FCU bearing blue dye washout
- As FCU and Fuel pump was bench tested, FCU bearing was not found seized and performed normally during testing on December 13th, 2023.

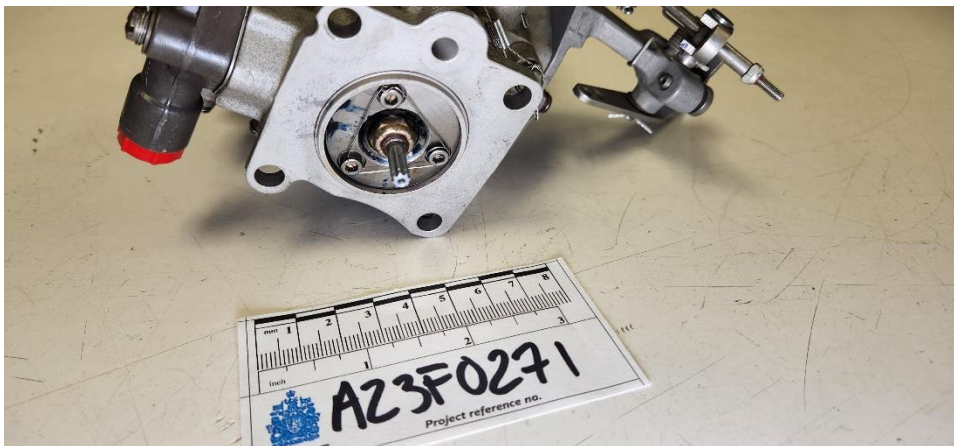
Blue dye found at mating flange between fuel pump and FCU.

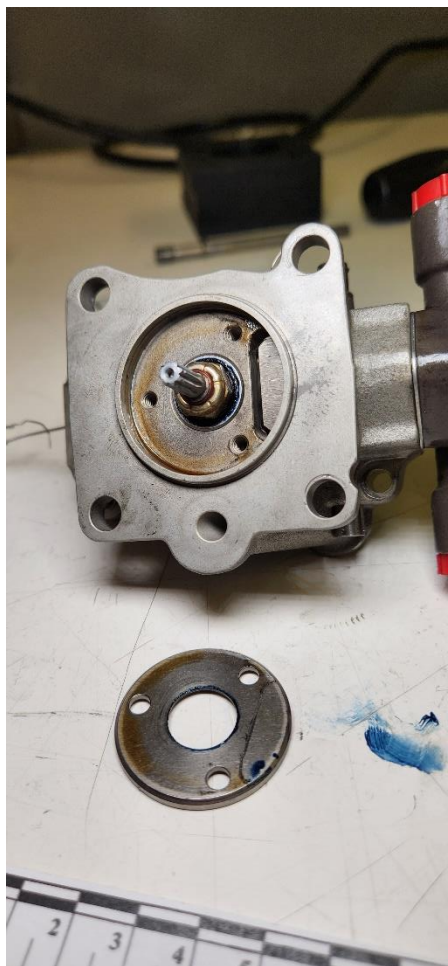
Oil consistent with engine oil found on adapter plate at FCU shaft.

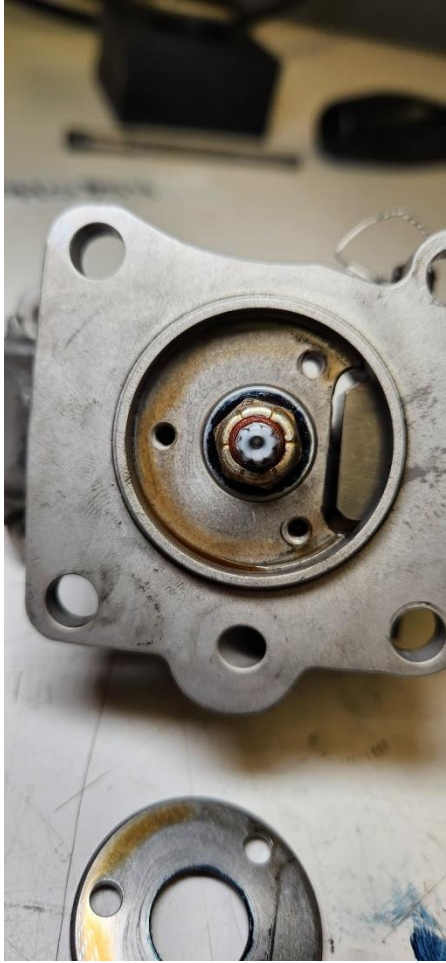
Oil consistent with engine oil found on adapter plate at FCU shaft.

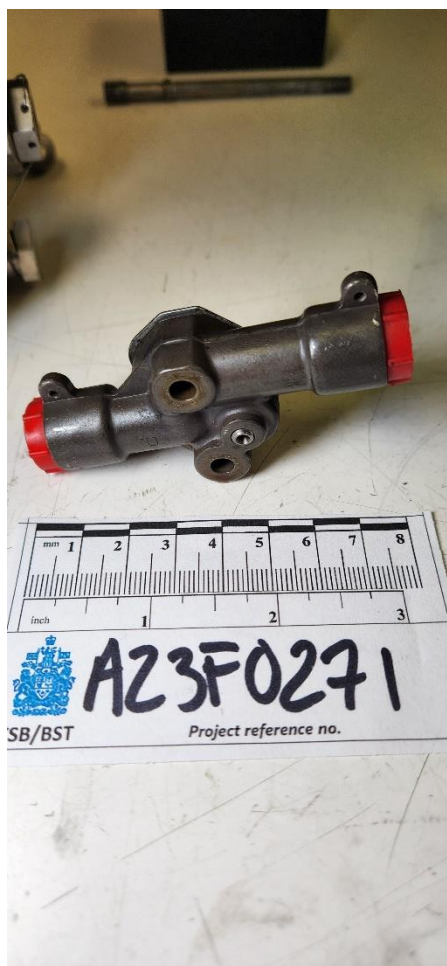
Oil found consistent with engine oil found at P3/Py mounting case and also on screws.

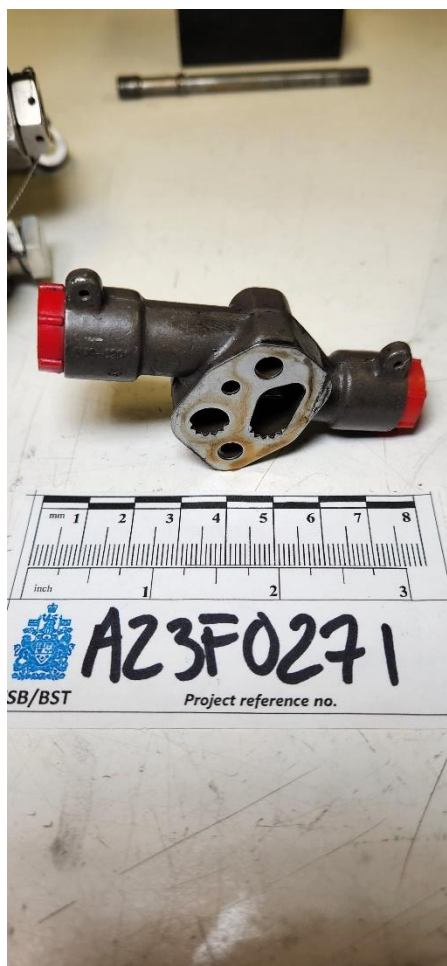
Oil found consistent with engine oil found at P3/Py mounting case and also on screws.

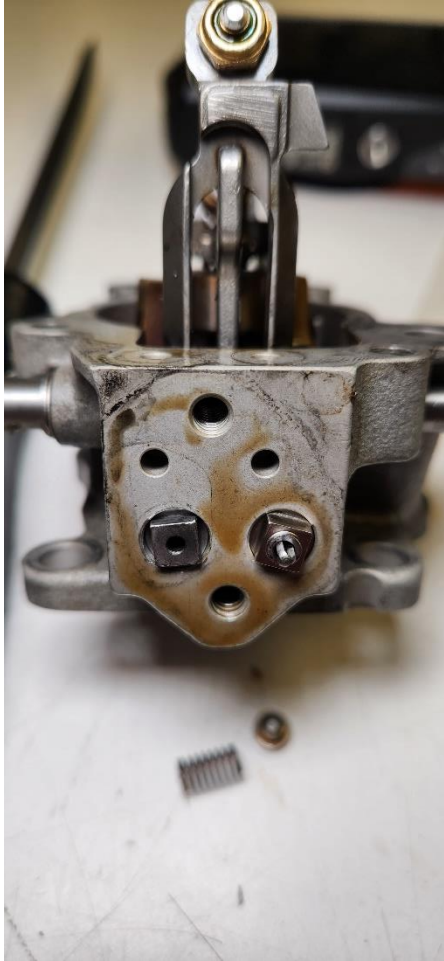
Mating P3/Py flange on governing case found with oil consistent with engine oil.

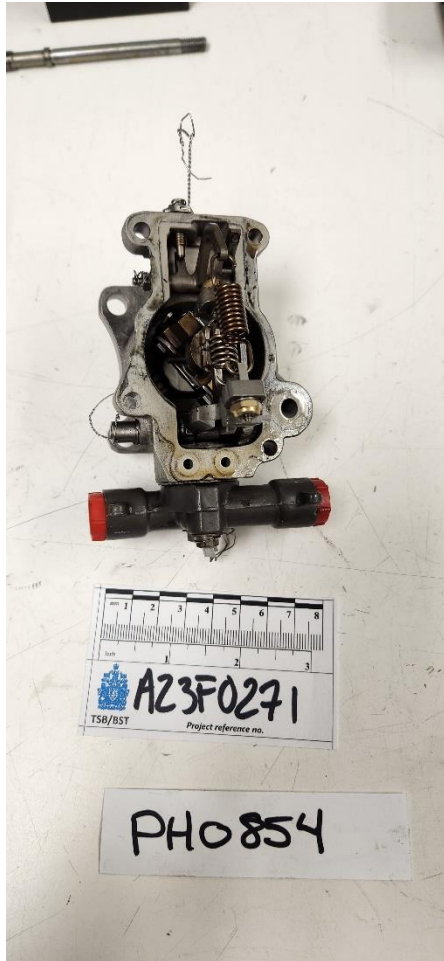
Oil found at mating flange of governing section.

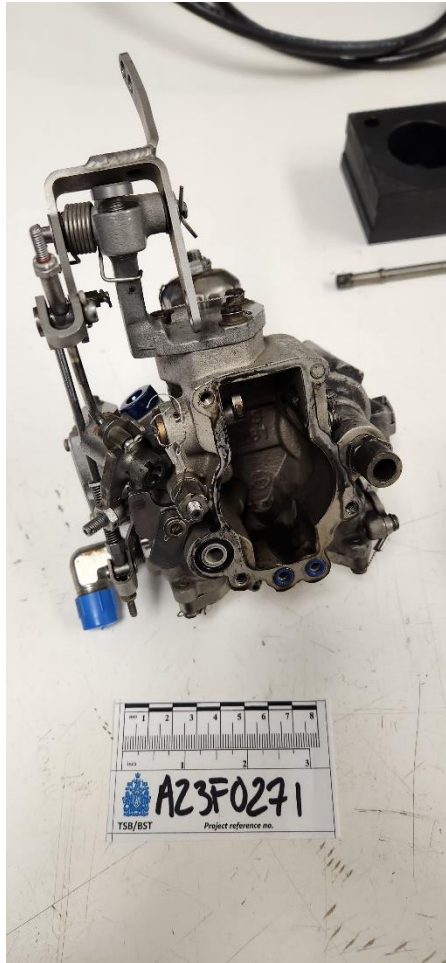
Oil found at mating flange of governing section. Note that no oil was found inside governing body.

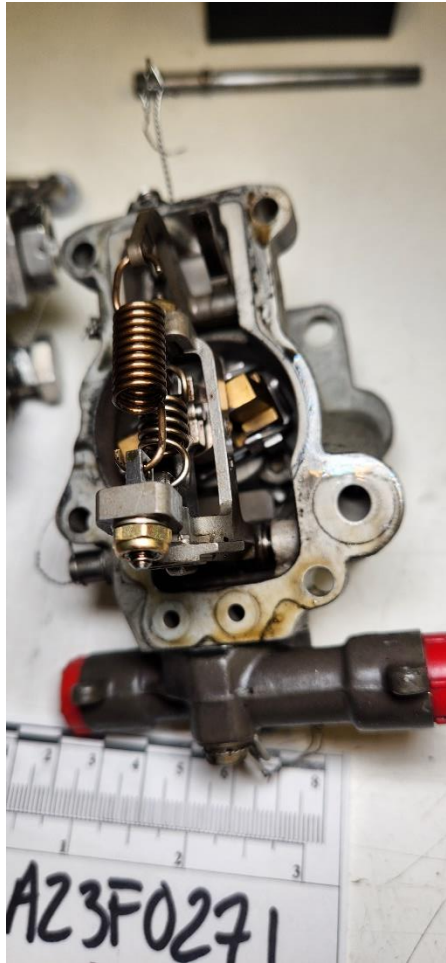
Oil found at mating flange of governing section.

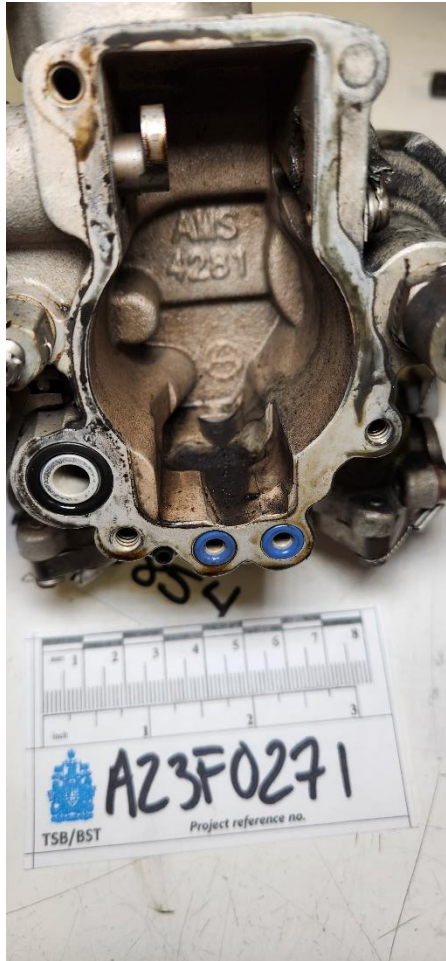
Deposit found in the governing body, but no oil was found inside the governing body.
