# National Transportation Safety Board

CEN24FA215

## **AUTOMATIC DEPENDENT SURVEILLANCE- BROADCAST (ADS-B) STUDY**

Aircraft Performance Study

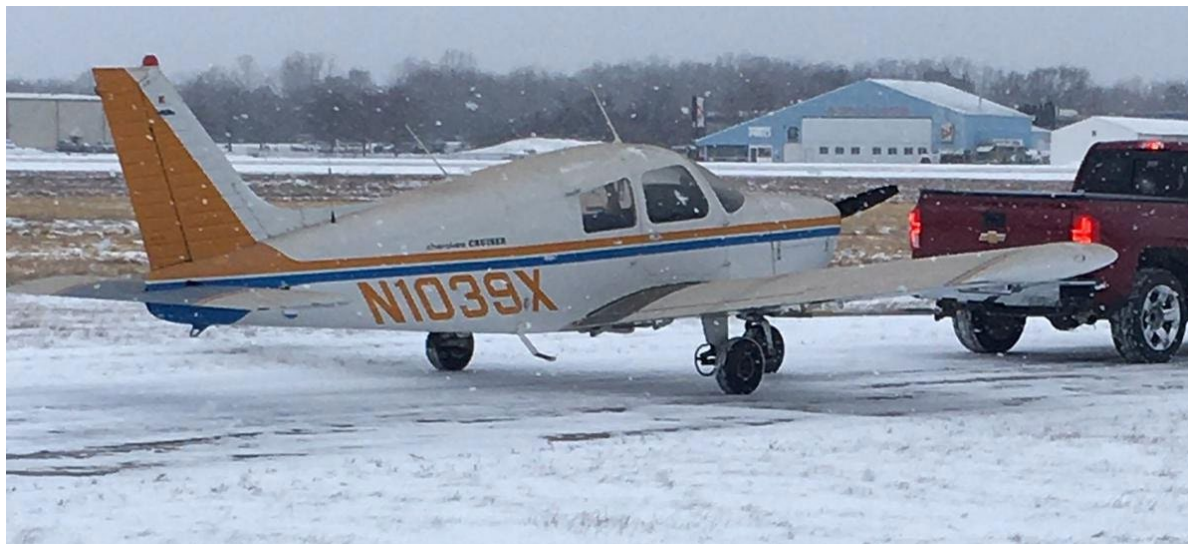
The airplane was a Piper PA-28, also known a Cherokee. It was a single-engine propeller airplane.

**Figure 1.** Piper PA-28-140, N1039X.

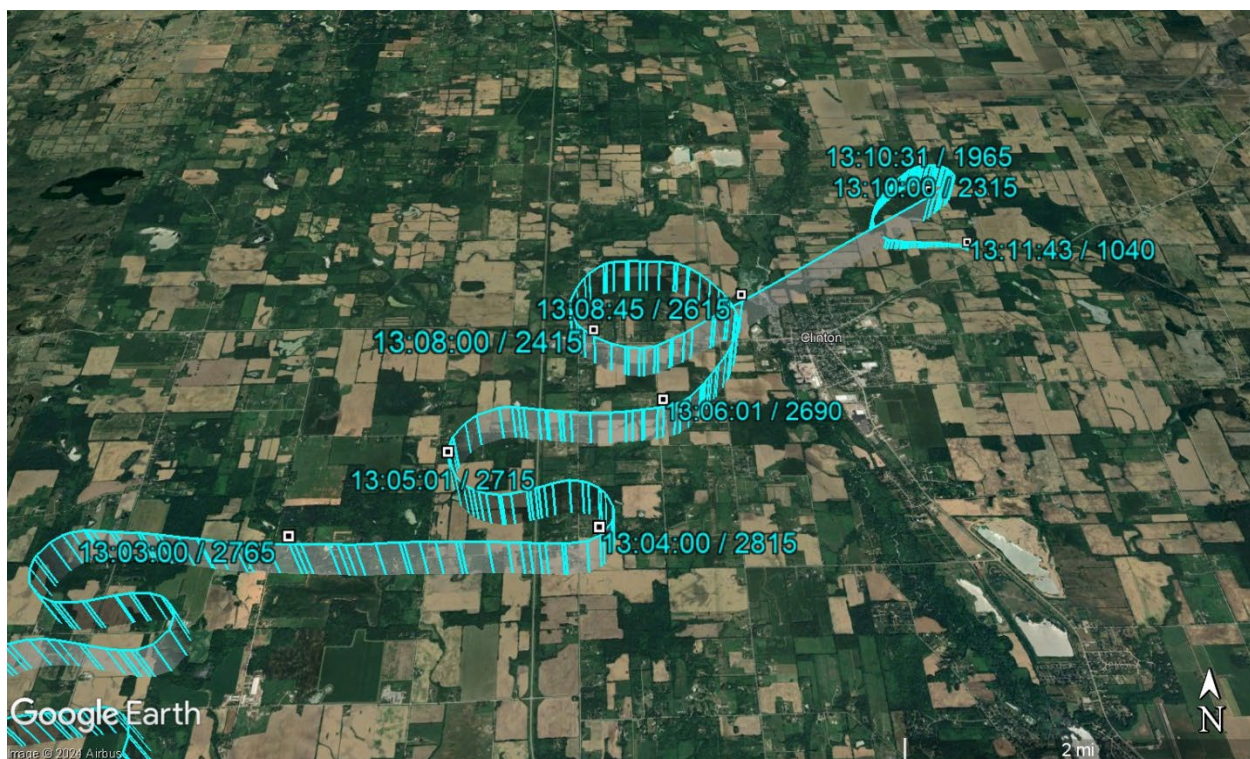
**Figure 2.** ADS-B end of flight path with selected times and altitudes indicated.

The airplane had performed various maneuvers at altitudes<sup>1</sup> between 2,600 ft and 2,900 ft mean sea level (MSL) (Figure 2 and Figure 3). Terrain elevation in the area was generally between 800 ft and 900 ft.

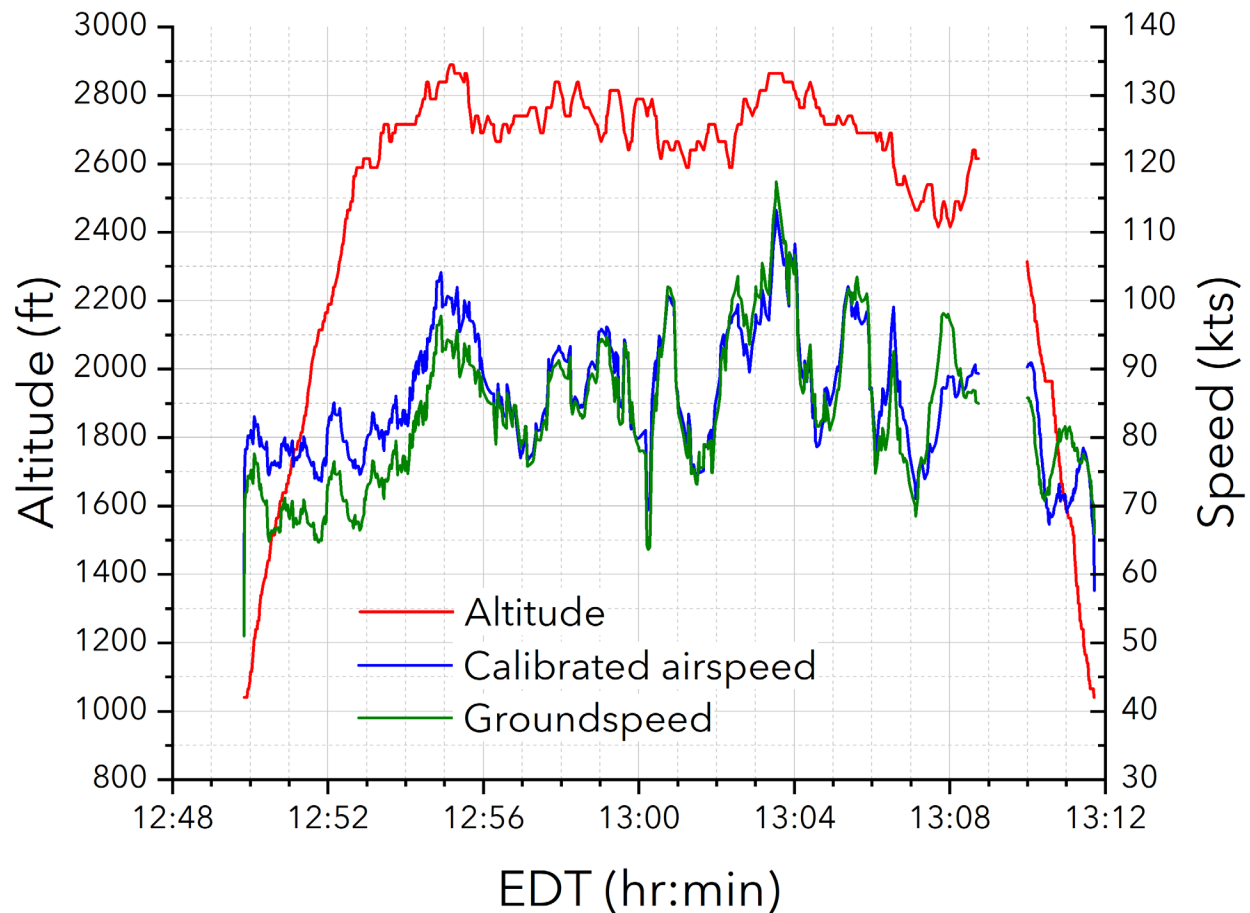
**Figure 3.** Altitude (MSL) with calculated calibrated airspeed and groundspeed versus time.

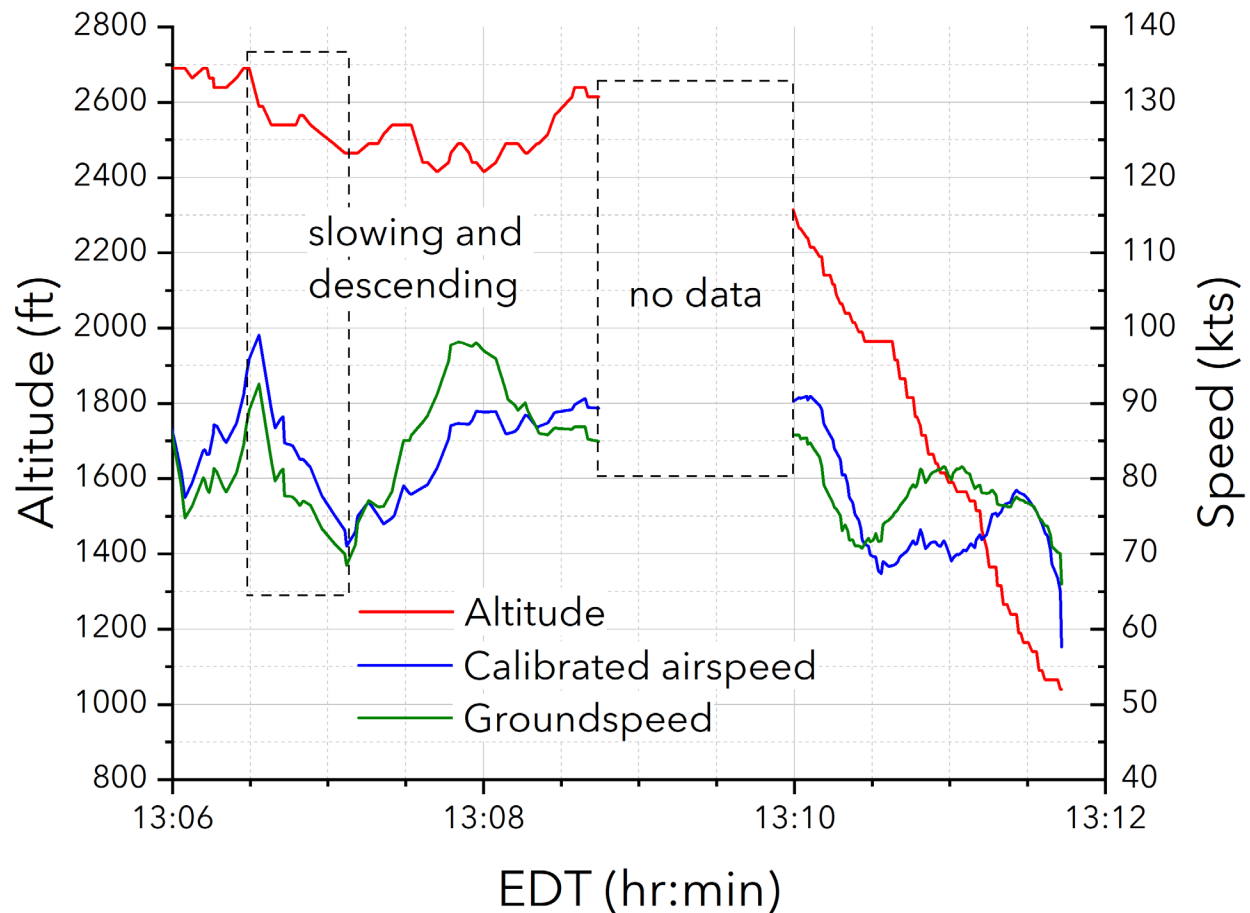
Figure 4 shows that from about 13:06:30 to 13:07:00 the airplane descended 200 ft while losing nearly 30 kts of airspeed. This loss of both altitude and airspeed was consistent with a reduction in power. Afterwards, the airplane regained much of the airspeed while maintaining altitude. At about 13:08 the pilot contacted air traffic control (ATC) at Ann Arbor and was told to proceed straight to runway 6. The pilot did not mention any difficulties.

**Figure 4.** Altitude (MSL) with calculated calibrated airspeed and groundspeed versus time.

After contacting ATC the airplane continued on a track direct to Ann Arbor airport. During this time the airplane generally maintained altitude while increasing speed. ADS-B data was lost from 13:08:45 to 13:10:00. When the ADS-B data returned, the airplane was on the same track at approximately the same speed (90 kts calibrated airspeed), but had descended 300 ft. The airplane descended for the remainder of the flight. Airspeed slowed from 90 kts to 70 kts.

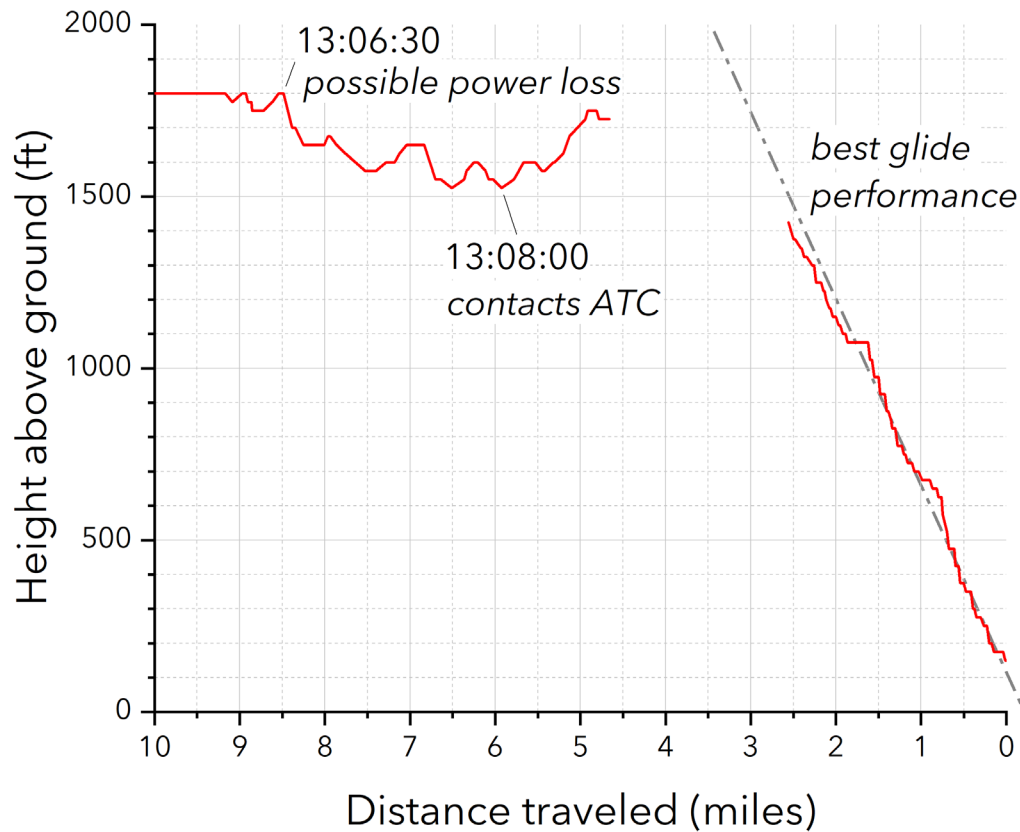
Figure 5 shows altitude as height above ground versus the distance the airplane traveled to the impact point. For the final 2.5 miles of flight, the airplane achieved the glide performance reported in the Pilot's Operating Handbook (POH) [1]. At 13:10, the Ann Arbor airport was 14 miles away, well beyond the airplane's glide distance. The airplane made a left turn (Figure 6) onto a track consistent with a local section of road. After 13:10:30 and 13:11:00 the airplane was able to arrest its deceleration and briefly gain airspeed while continuing to descend, possibly indicating the reduction in power was somewhat intermittent.

**Figure 5.** Height above ground versus distance traveled.

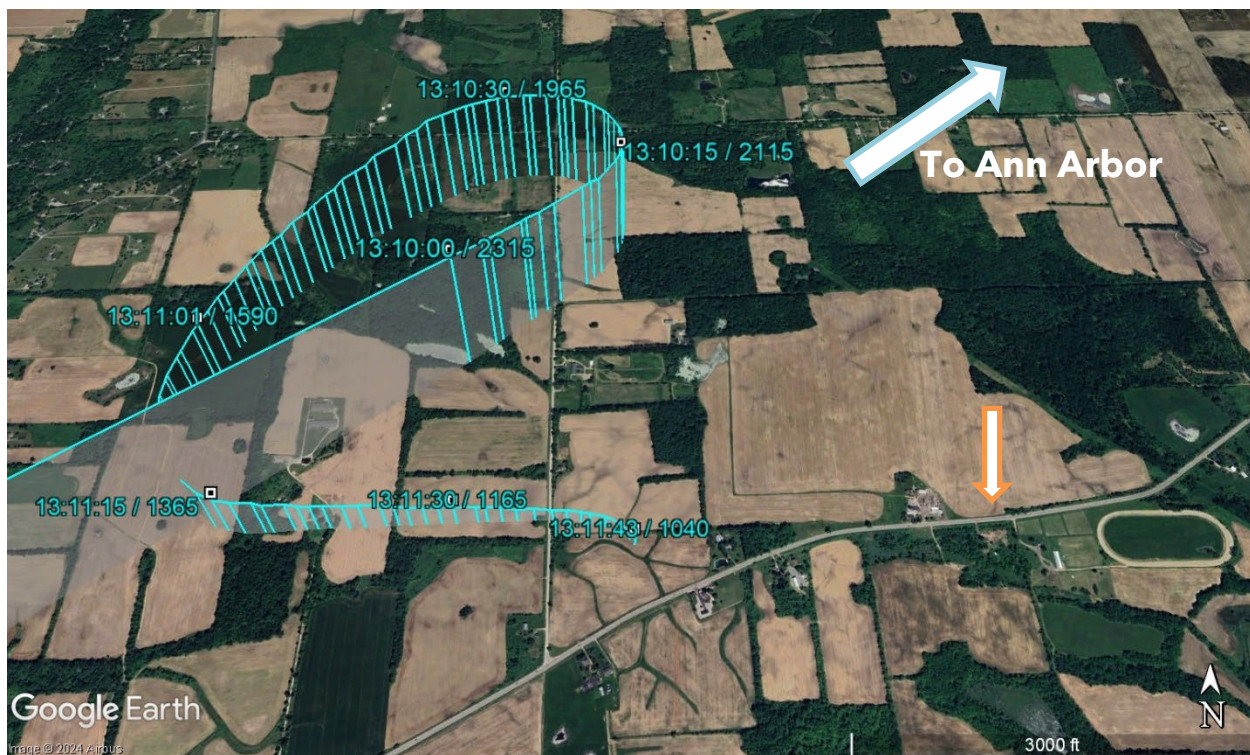
**Figure 6.** End of ADS-B data, selected times and altitudes annotated. The direction of Ann Arbor is noted by a blue and white arrow and a section of road is noted with a white and orange arrow.

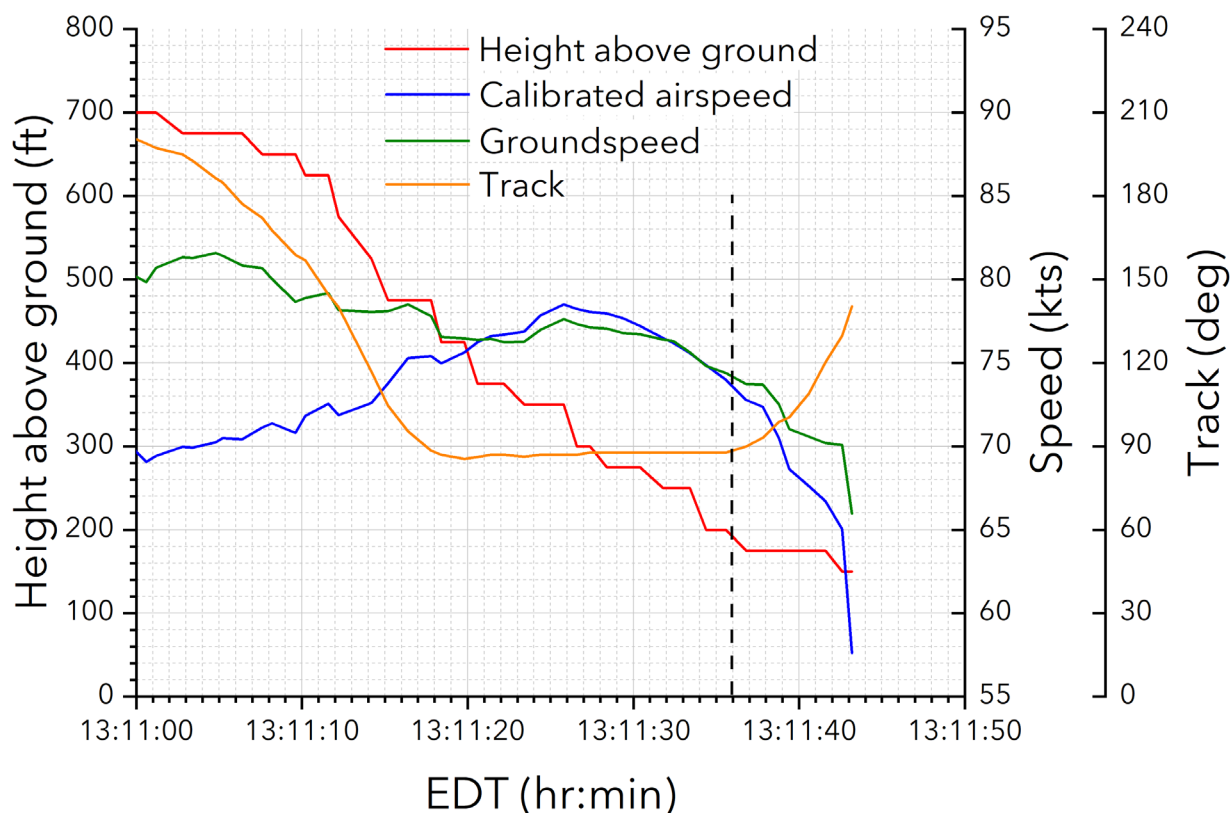
However, at 13:11:36 at an airspeed of 74 kts and 200 ft above the ground, the airplane began a right turn away from the road (Figure 7). The airplane's maximum weight, wings level, no flaps calibrated stall speed is 56 kts [1], indicating the turn was not caused by aerodynamic stall. The airplane maintained its altitude for several seconds while continuing to slow. The final ADS-B return was at an altitude of 1,040 ft msl (150 ft above ground level) and had a calculated calibrated airspeed of 57 kts and dropping.

**Figure 7.** End of ADS-B altitude, speeds, and track versus time. The dotted line marks the beginning of the final right turn at 13:11:36.

The airplane showed signs of a reduction in power before beginning to return to the Ann Arbor airport. After 13:10 the airplane's descent was consistent with the glide performance in the POH, and it made a left turn onto a track consistent with a local section of road. However, when at 200 ft AGL and at a speed well above stall, the airplane made a final right turn. Data ended seven seconds later 150 ft above the local terrain.
