# National Transportation Safety Board

CEN24FA260

## **GLOBAL POSITIONING SYSTEM DEVICES**

Specialist's Factual Report

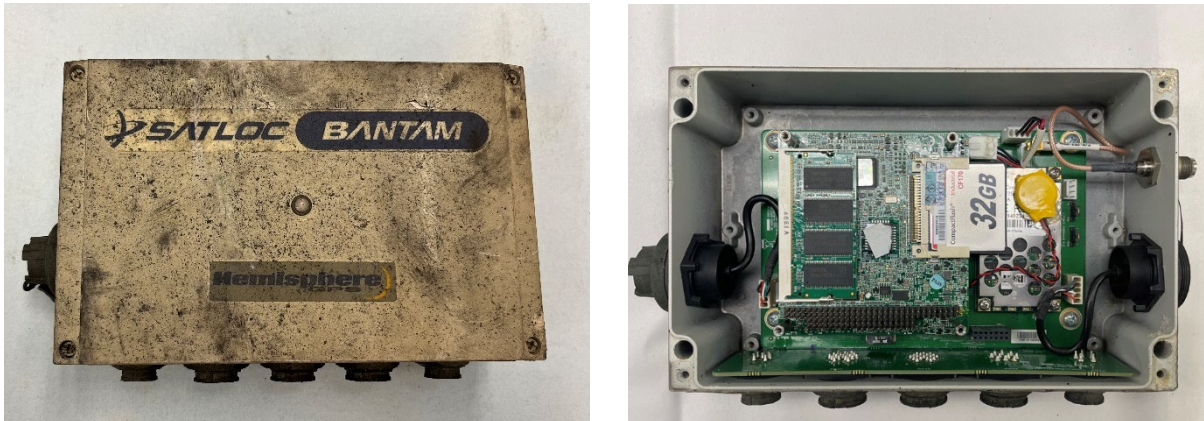
The Satloc M3 Bantam device arrived undamaged, and the internally mounted CF card was removed. The CF card is shown as installed in Figure 1. Data were then extracted from the CF card and converted to engineering units using the manufacturer's software.

**Figure 1.** Satloc M3 Bantam device (left) and internal CF card (right).

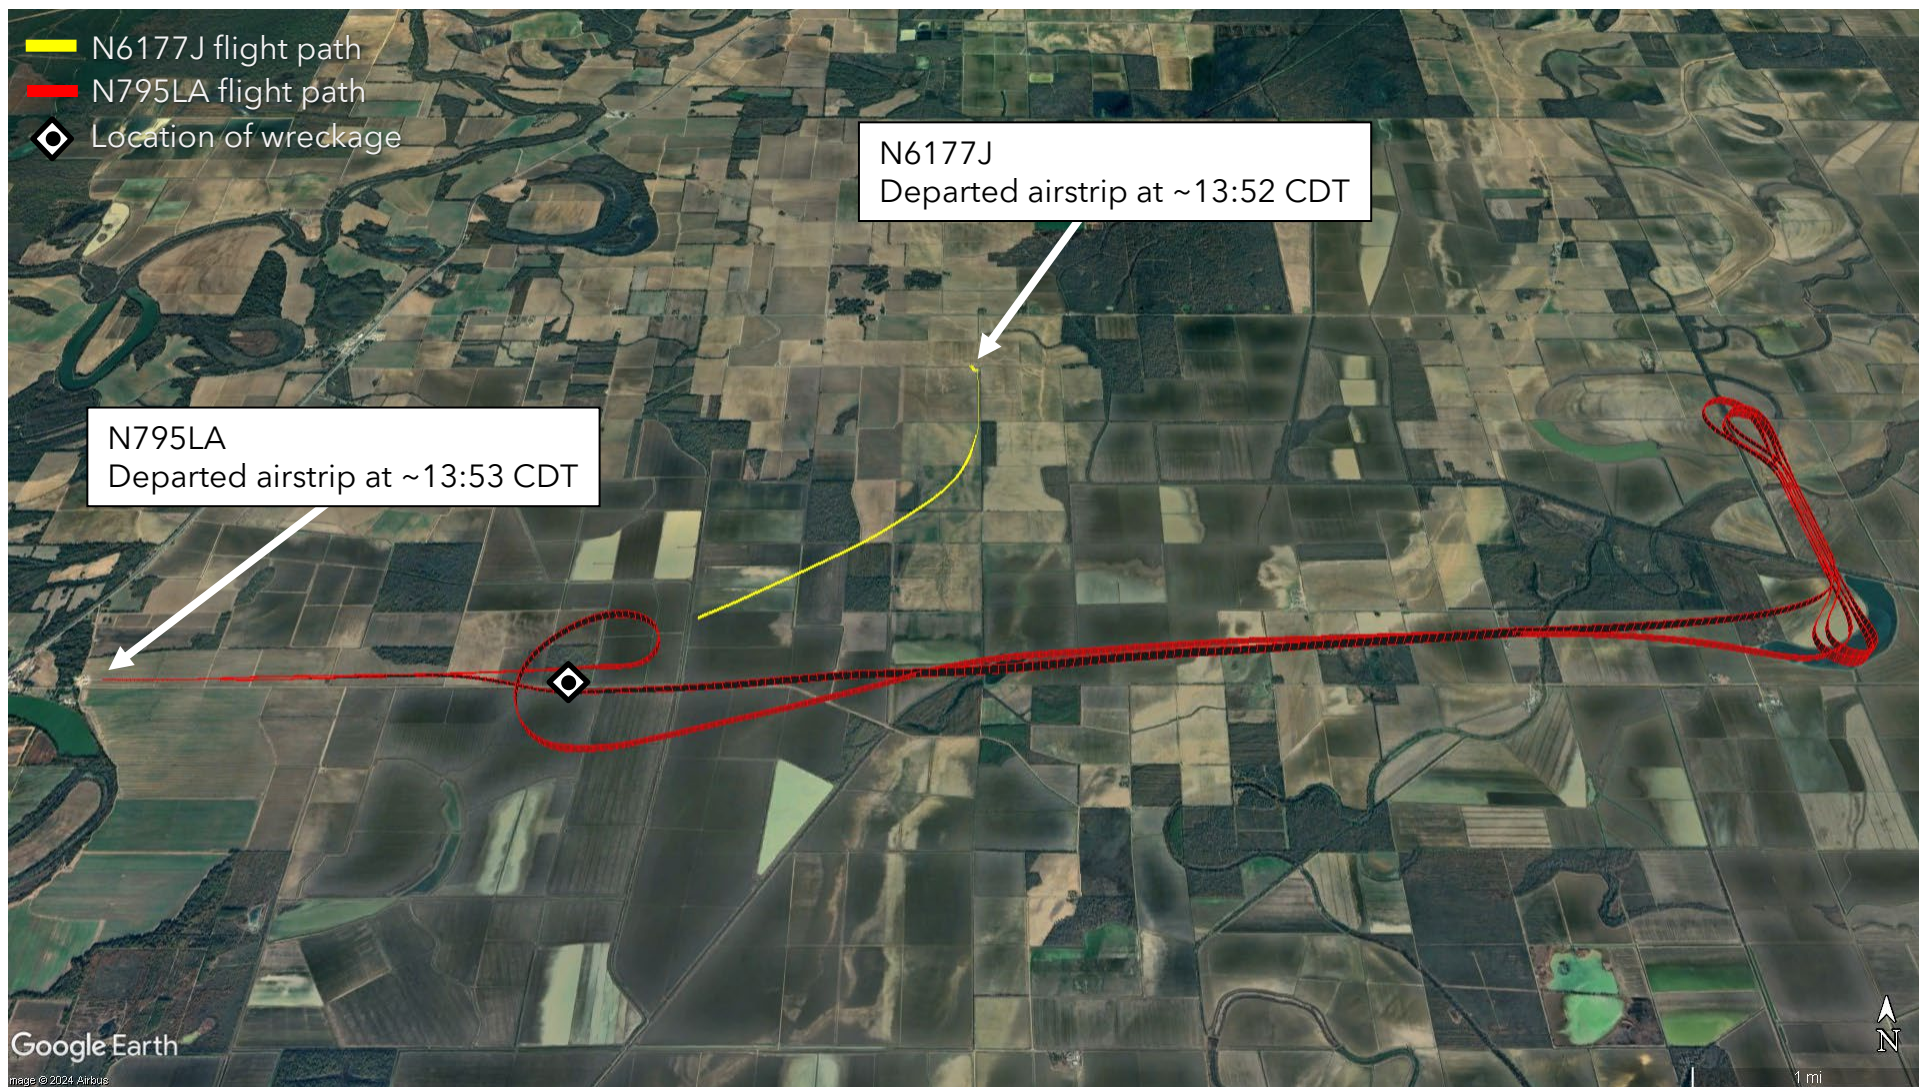
Figures 2 and 3 are graphical overlays generated using Google Earth showing the two airplanes' flight paths at the time of the accident. The yellow line is the flight path of Airplane 1, registration N6177J, and the red line is the flight path of Airplane 2, registration N795LA. The approximate location of the wreckage of Airplane 1 is also shown for reference. Note that the weather and lighting conditions in Google Earth are not necessarily the weather and lighting conditions present at the time of the recording.

**Figure 2.** Google Earth overlay of the flight path of Airplane 1 (N6177J) and Airplane 2 (N795LA).

The data show that Airplane 1 departed from an airstrip northeast of the accident site at about 13:52 CDT and started to travel toward the southwest. Airplane

2 departed from an airstrip west of the accident site at about 13:53 CDT and started to travel toward the east. Airplane 1's data ended at 13:53:32 CDT in the vicinity of the wreckage location. The device manufacturer indicated that if the device abruptly loses power during an accident, up to 30 seconds of data stored in a volatile buffer may be missing from the data stored on the internal CF card. Following the accident, Airplane 2 continued to an application area to the east before returning to land on the airstrip it originated from at about 14:06 CDT.

The corresponding tabular data used to generate figures 2 to 4 for Airplane 1 and Airplane 2 are provided in comma-separated value (CSV) format as attachment 1 and attachment 2 to this report, respectively.

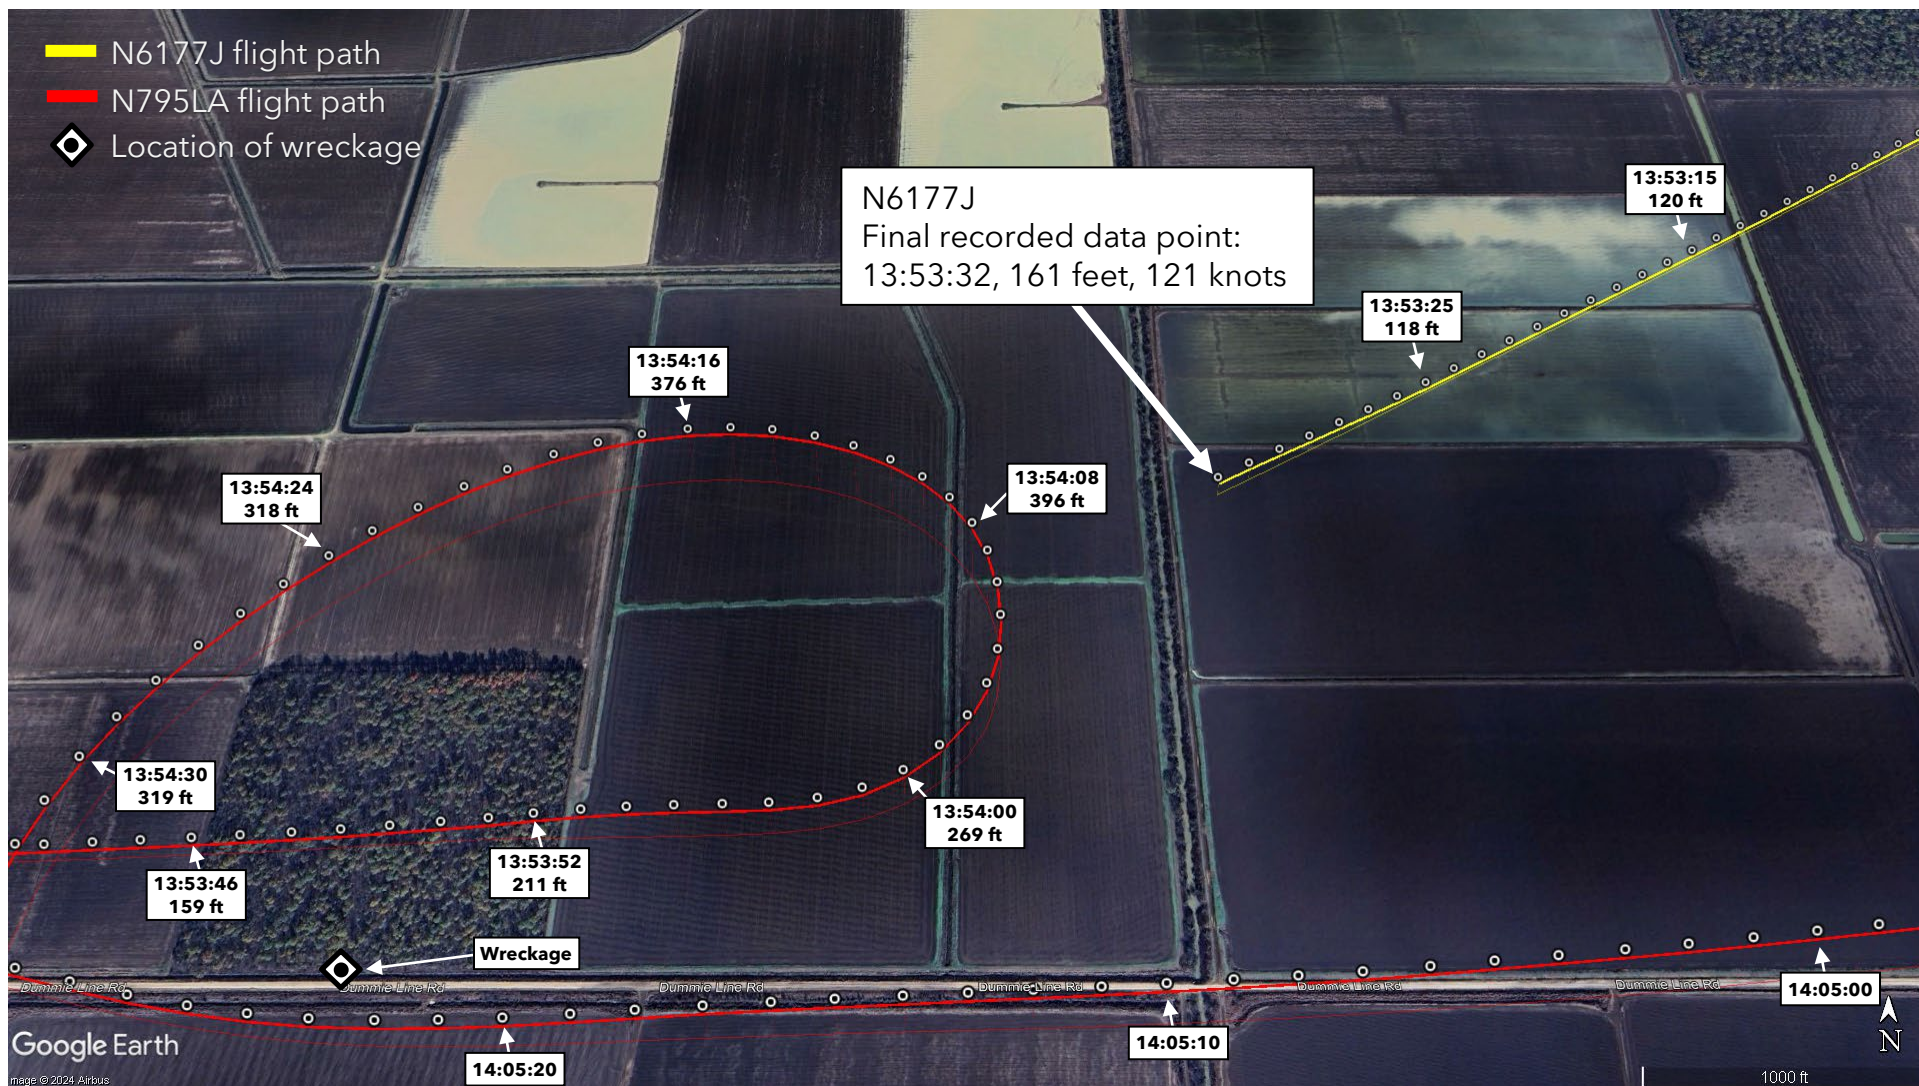
**Figure 3.** Google Earth overlay of the flight path of Airplane 1 (N6177J) and Airplane 2 (N795LA) - zoom to the accident site.
