# Carburetor Icing Probability Graph – CEN24LA096

Airplane: Lockwood AirCam, N1230R

Accident Date: 1/20/2024

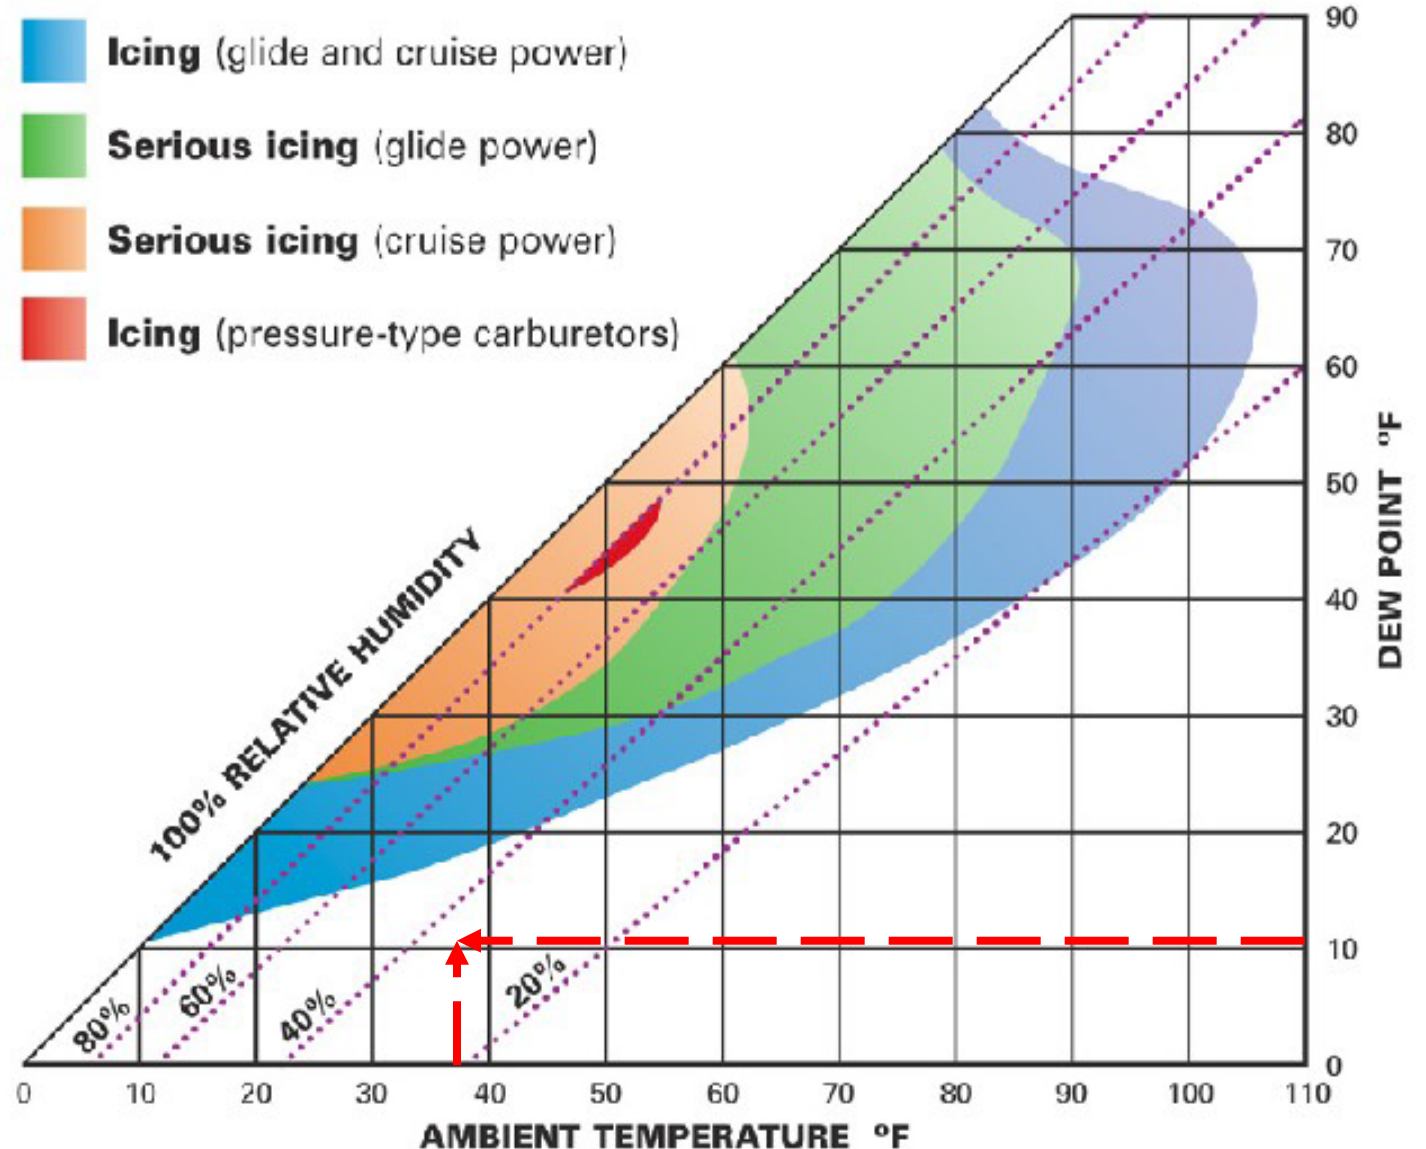
Temperature, 3° C = 37.4° F

Dew Point, -12° C = 10.4° F

Source: Federal Aviation Administration

Special Airworthiness Information Bulletin CE-09-35

Carburetor Icing Prevention
