# National Transportation Safety Board

CEN24LA119

## **MULTIPLE ELECTRONIC DEVICES**

Specialist's Factual Report

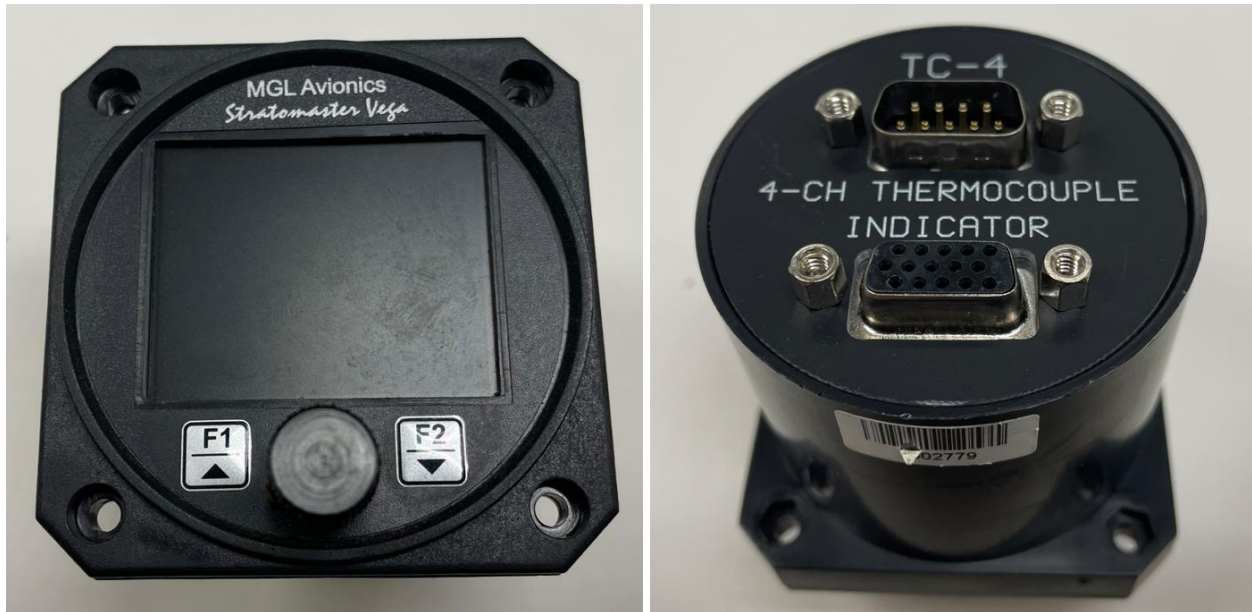
**Figure 1.** Front and back view of the MGL Stratomaster Vega TC-4 as received.

Figures 1 to 3 show the condition of the three MGL singles as received by the Vehicle Recorder Division. The devices were in good condition and powered on normally, however, it was confirmed by the manufacturer that in the absence of the MGL logger, those devices do not record data. Thus, no data pertinent to the investigation were recovered from the devices. The IIC (investigator-in-charge)

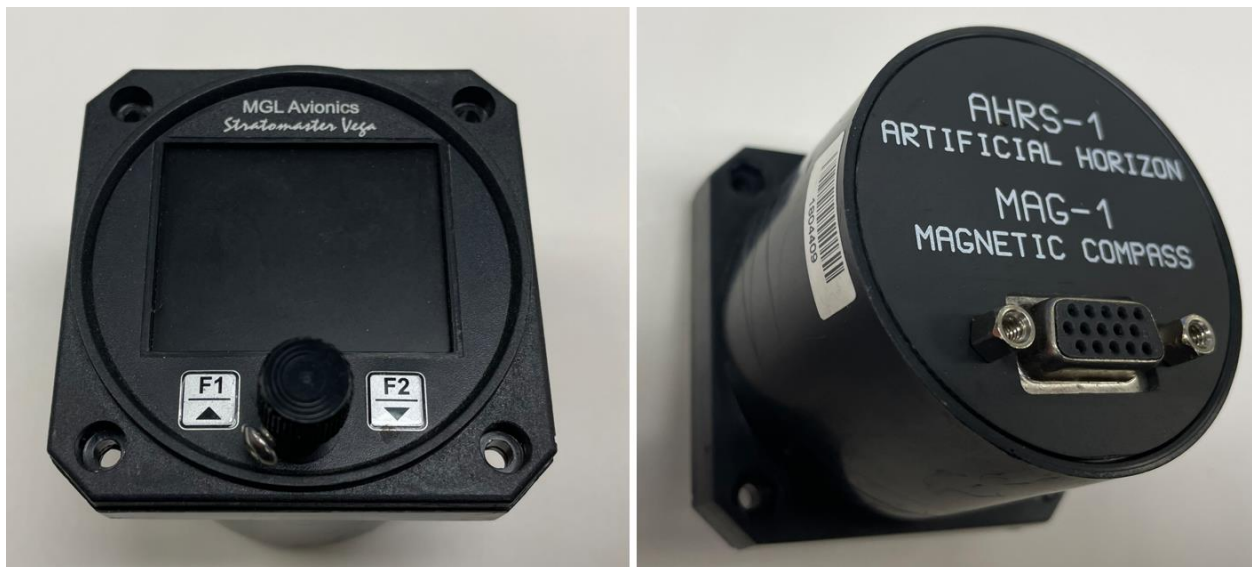
**Figure 2.** Front and back view of the MGL Stratomaster Vega AHRS-1/MAG-1 as received.

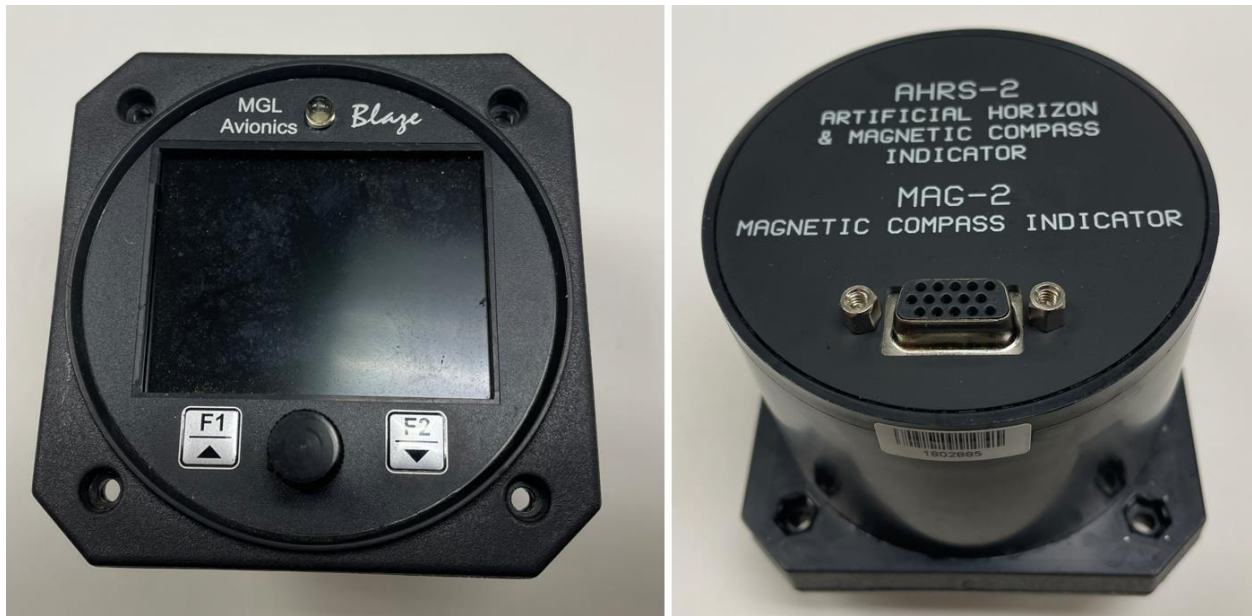
**Figure 3.** Front and back view of the MGL Blaze AHRS-2/MAG-2 as received.
