# National Transportation Safety Board

CEN24LA144

## **METEOROLOGY**

Specialist's Factual Report

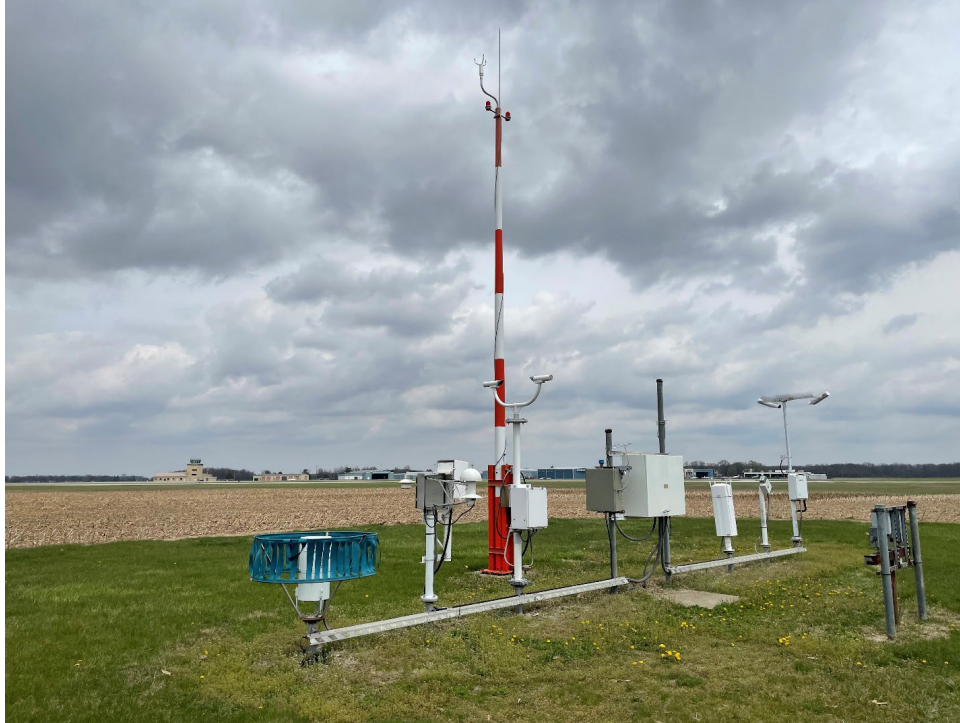
The KMIE ASOS was located on the south side of the airport about 1,000 ft southeast of the touchdown point of runway 3, and 1,000 ft south-southwest of runway 32, surrounded by a corn field. The ASOS was located about 3,500 ft east of the accident site. Figure 5 is an image of the ASOS looking north, with the wind sensor at the standard height of 10 meters (32.8 ft). The ASOS's Operator Interface Device (OID) terminal is in the control tower cab. The KMIE tower also had a separate wind indicator<sup>6</sup> for instantaneous wind readouts mounted on the tower at 60 ft agl. Both the wind gauge for instantaneous wind direction and speed and the ASOS OID are shown in figure 6.

**Figure 5 - KMIE ASOS system located on the south side of the airport.**

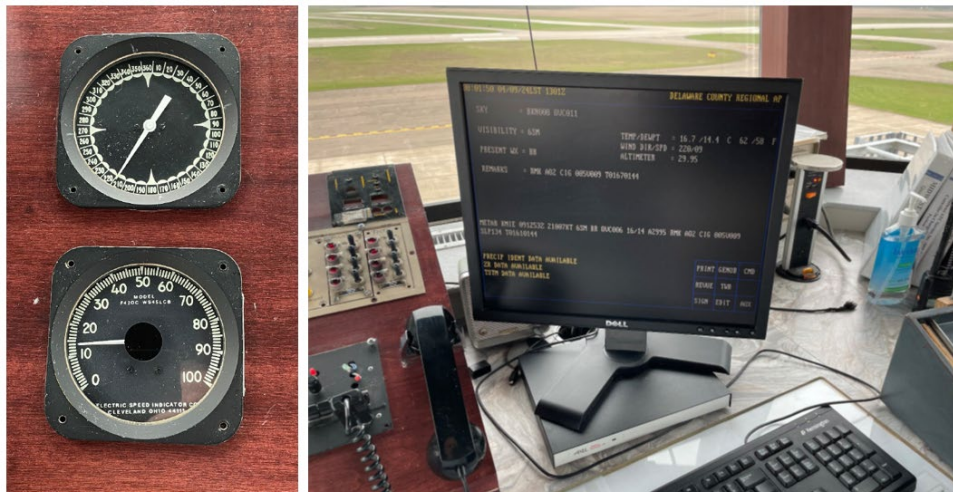
**Figure 6 - Photo of tower wind gauge (left) and the ASOS OID display (right) in the KMIE tower.**
