# National Transportation Safety Board

CEN24LA144

## **RECORDED FLIGHT DATA**

Location: Muncie, Indiana  
Date: April 1, 2024  
Time: 1027 eastern daylight time (EDT)  
1427 coordinated universal time (UTC)  
Airplane: Piper PA-28-236, private operator, N8438B

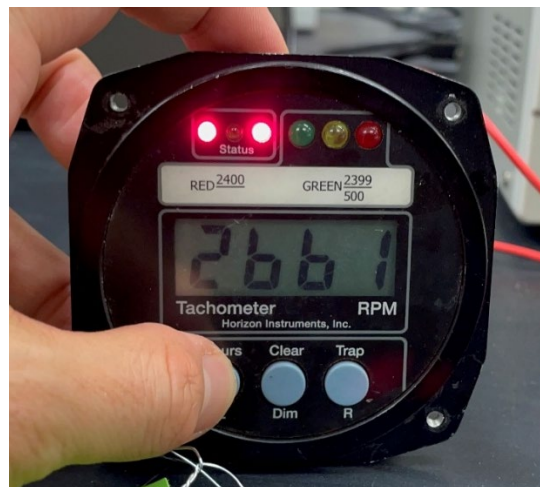
**Figure 1.** Tach Time shown on the Horizon Instruments P-1000.

No data were recovered from the remaining Garmin devices or the JPI EDM-700. The Horizon Instruments P-1000 is a digital tachometer that solely retains "Tach Time", which was 2661, as shown in Figure 1.

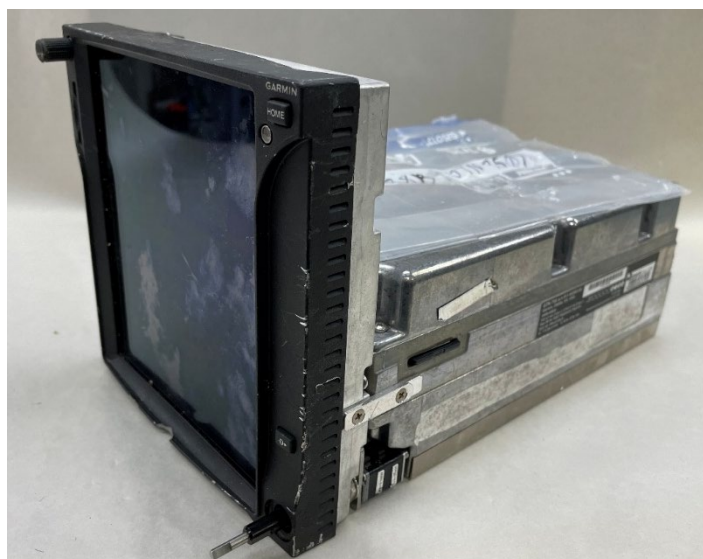
**Figure 2.** Garmin GTN 750 as received.

The device as received by the Vehicle Recorder Laboratory is shown in figure 1. Data were extracted normally from the internal SD card.
