**From:** [REDACTED]  
**To:** [REDACTED]  
**Subject:** Re: CEN24LA318 (N4004K, Ayres S2R-600) - Spray Boom Pressure Gauge Question  
**Date:** Tuesday, September 24, 2024 10:55:15  
**Attachments:** [image003.png](#)  
[Outlook-05nitnke.png](#)

I am working CEN24LA318 (N4004K, Ayres S2R-600). Here is the NTSB preliminary report:

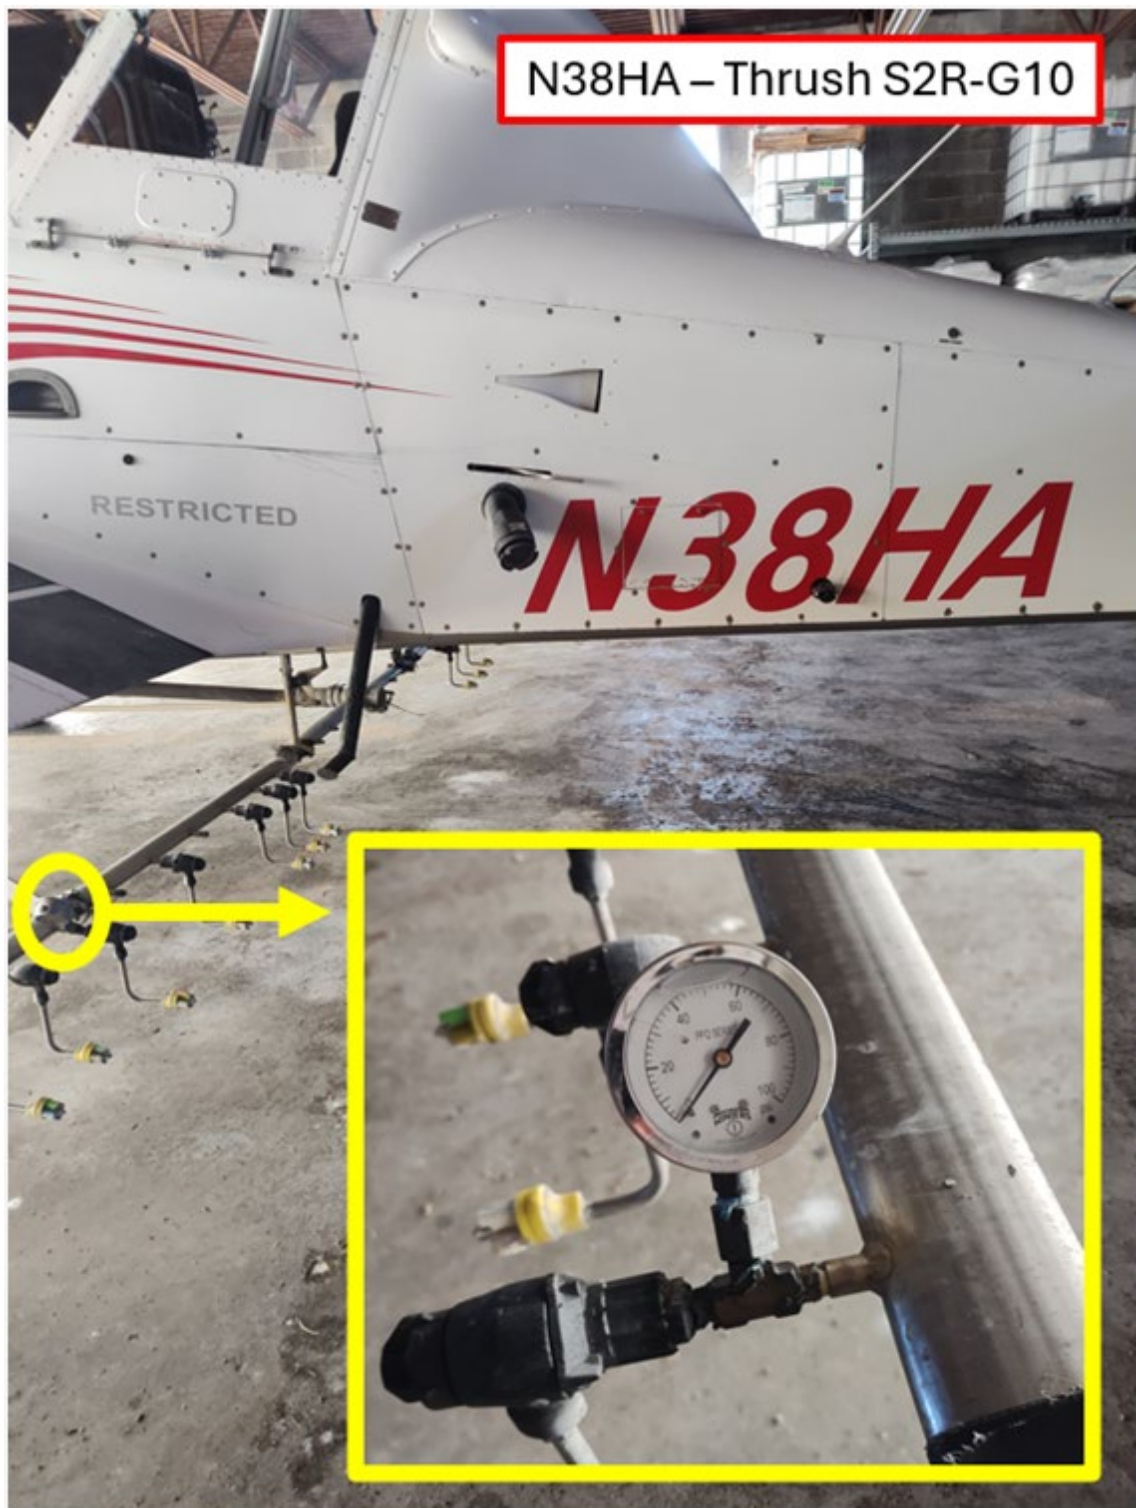
Here is an exemplar photo from one of the operator's airplanes, showing the same setup:

The operator has five Thrush Aircraft S2R series airplanes. All the operator's airplanes have a spray boom pressure gauge that is mounted on the left side spray boom and that is the only

source of reading spray boom pressure on their airplanes.

On the accident airplane, the spray boom pressure gauge broke off during the accident
