**Download and Analysis of Two N1  
Digital Electronic Engine Controls  
from  
Telluride, CO  
Hawker 900XP Accident Aircraft  
Registration N526FC  
Summary**

Swamp Bird LLC, Hawker 900XP, N526FC

Telluride, CO, July 20, 2024

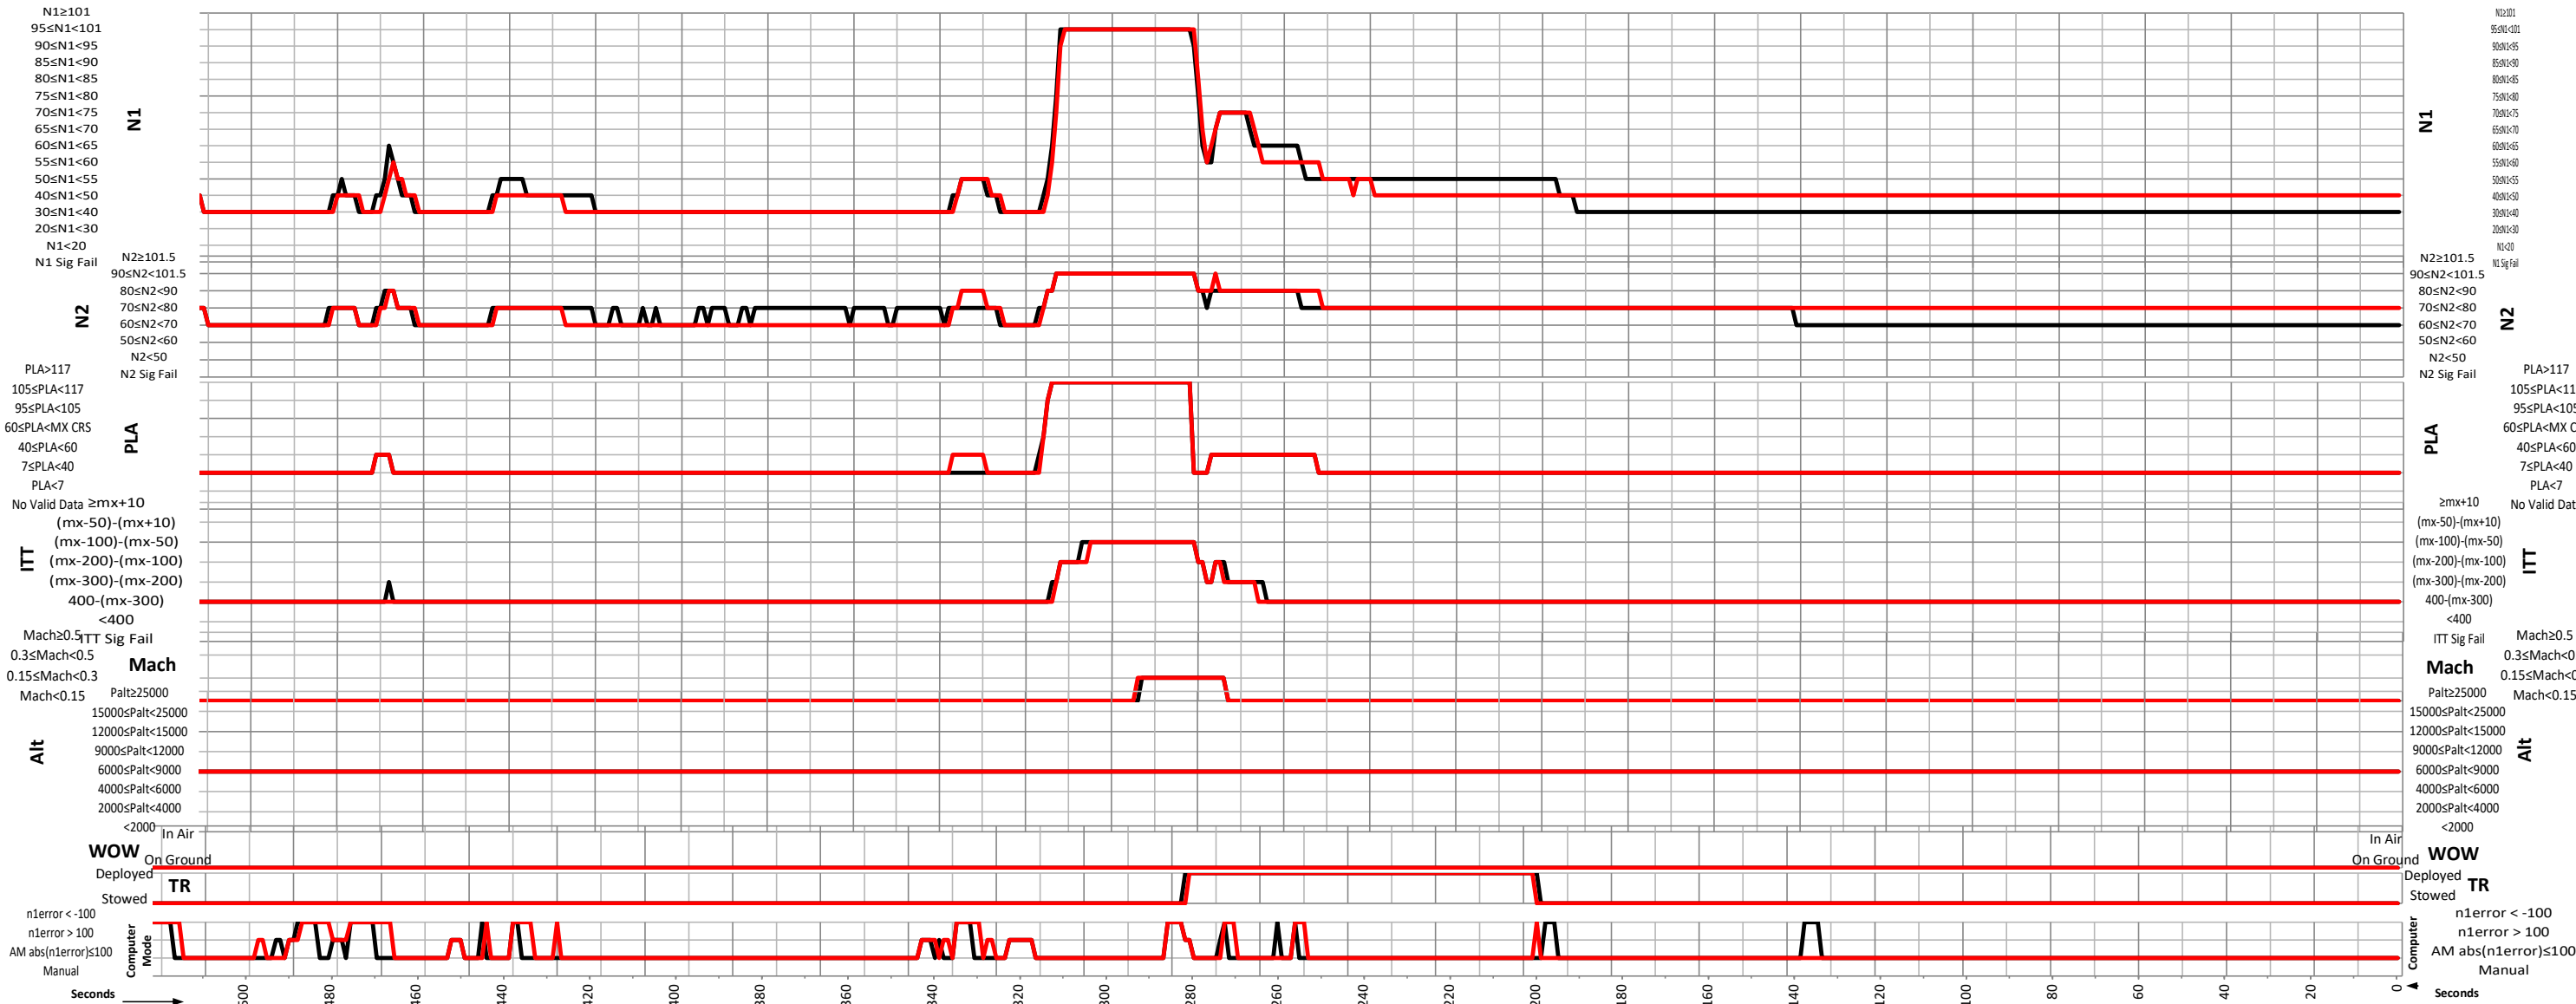
## **Appendix A: 512 Second Data Chart**

1-512 Seconds of Data

☒ P122137 Eng 1: Left Engine S/N

☒ P122135 Eng 2: Right Engine S/N

- The accident flight appears to start between the 318 second mark (the last change in PLA before takeoff power was applied) and 544 second mark (the last Air/Ground transition). Due to how the N1 DEEC records data, the exact startup time for the accident flight cannot be determined.
- Throughout the accident flight, the engine appears to be operating and correctly responding to Power Lever (PLA) movements.
- At time stamp 317 seconds, the increasing PLA movement begins. The N1, N2, and ITT data all show a corresponding response to the PLA movement.

- At time stamp 281 seconds (36 seconds after increased PLA), the decreasing PLA movement begins. Again, N1, N2, and ITT data all show a corresponding response to the PLA movement.
- At time stamp 277 seconds, the thrust reversers were deployed and increasing PLA movement begins.
- At time stamp 252 seconds, decreasing PLA movement begins.
- At time stamp 196 seconds, the thrust reversers are stowed.
- The engine continued to run after impact and was still running when power was removed from the N1 DEEC.

- Throughout the accident flight, the engine appears to be operating and correctly responding to Power Lever (PLA) movements.
- At time stamp 316 seconds, the increasing PLA movement begins. The N1, N2, and ITT data all show a corresponding response to the PLA movement.

- At time stamp 281 seconds (35 seconds after increased PLA), the decreasing PLA movement begins. Again, N1, N2, and ITT data all show a corresponding response to the PLA movement.

- At time stamp 276 seconds, the thrust reversers were deployed and increasing PLA movement begins.
- At time stamp 253 seconds, decreasing PLA movement begins.

- At time stamp 197 seconds, the thrust reversers are stowed.
- The engine continued to run after impact and was still running when power was removed from the N1 DEEC.

The download of the incident recorder data and fault history data from both N1 DEECs was completed successfully. Analysis of the data indicated that both engines were rotating, operating, and responding to power lever inputs throughout the takeoff roll and accident sequence. Approximately 250 seconds after PLA was decreased for the last time, power was removed from the N1 DEECs, but it appears both engines continued to run beyond that point in time.
