# National Transportation Safety Board

CEN24MA111

## AIRWORTHINESS

Group Chair's Factual Report

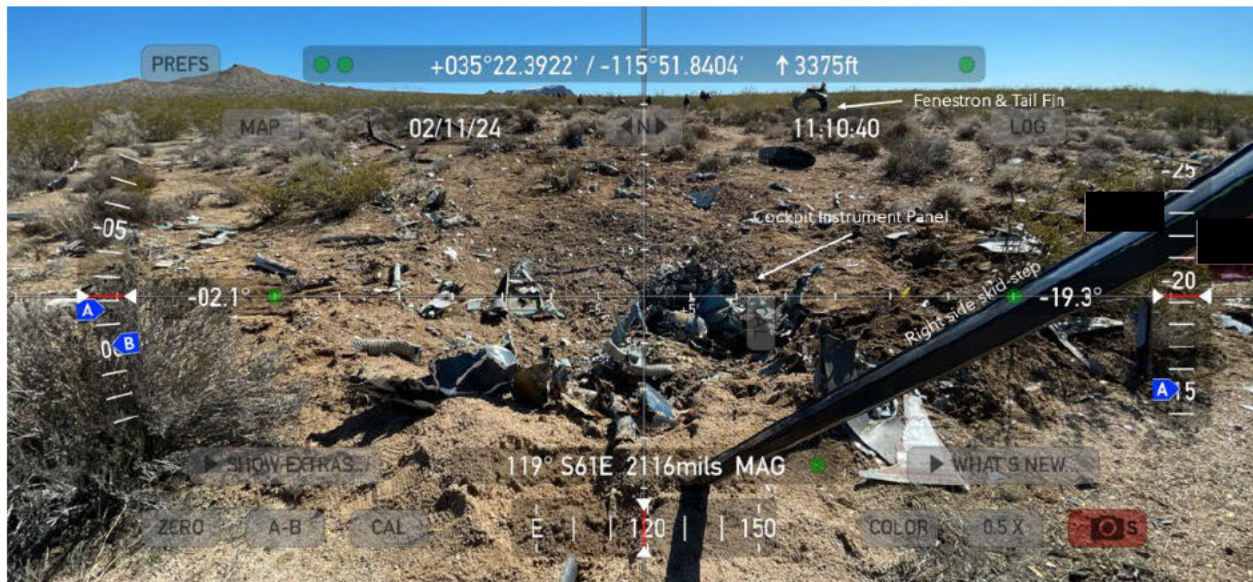
cabin floor fragments, and right-side skid fragments. Immediately to the right of the impact crater there was a ground divot consistent in size and shape of the rotor head, with 2 rotor blade impact marks radiating from the divot.

**Figure 1.** Accident scene wreckage debris viewed from the initial point of ground impact.

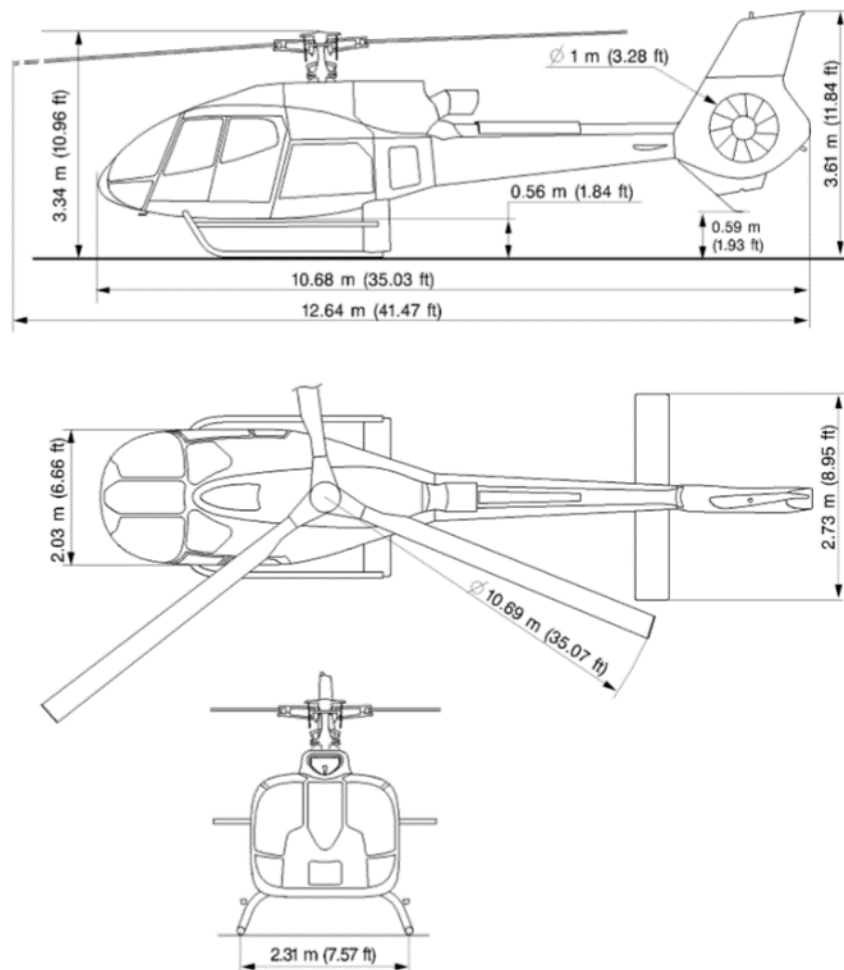
The Airbus Helicopters EC 130B4 has a three-bladed main rotor system that provides helicopter lift and thrust (Figure 2). A 10-bladed fenestron tail rotor system provides anti-torque and directional control. The helicopter flight controls are hydraulically assisted by a dual hydraulic system. The helicopter was equipped with a skid-type landing gear and a Safran Helicopter Engines Arriel 2B1 turboshaft engine. The EC 130B4 helicopter is type certificated under Federal Aviation Administration (FAA) Type Certificate Data Sheet (TCDS) No. H9EU as a normal category (14 CFR Part 27) helicopter.

**Figure 2.** EC 130B4 principal dimensions (Source: Airbus Helicopters).

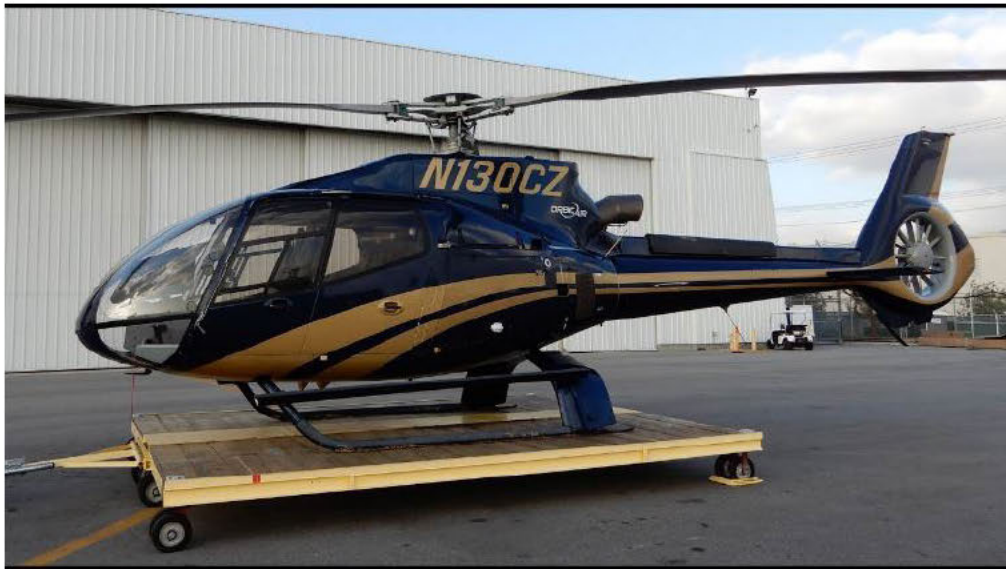
The accident helicopter, an Airbus Helicopters EC 130B4, serial number (SN) 4060, was manufactured in 2006 by Airbus Helicopters (previously Eurocopter) (Figure 3). FAA registration records document show that the helicopter's Indonesian registration, PK-CFZ, was cancelled on August 24, 2016. The helicopter was sold by Strata Aviation LTD to Integrity Aircraft Title Holdings, LLC, on September 2, 2016, and registered as N130CZ on September 15, 2016. The helicopter was sold by Integrity Aircraft Title Holdings, LLC, to Orbic Air, LLC on March 16, 2022.

**Figure 3.** Undated photo of the accident helicopter (source: internet).

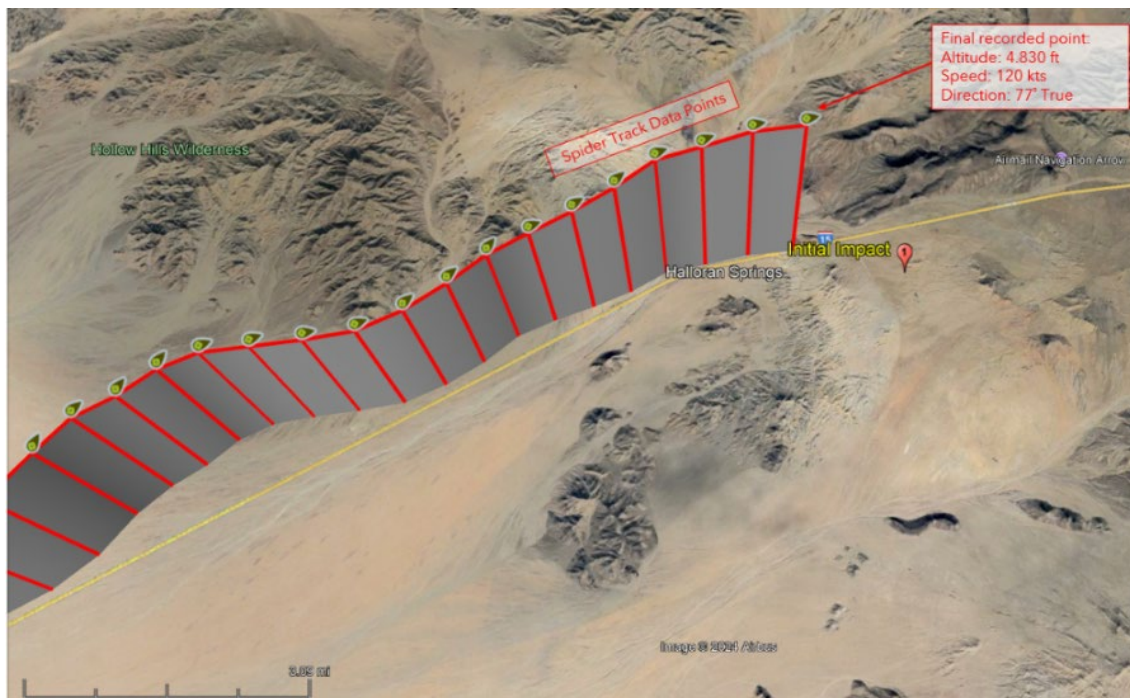
The wreckage was located a half mile south of Interstate 15 (I-15), 70 miles southwest of Las Vegas, Nevada, in mountainous desert terrain. The accident site was about 1.4 miles from the last recorded Spider Tracks<sup>7</sup> data point (Figure 4). Table 2 lists the latitude and longitude of the major airframe components.

**Figure 4.** Accident geographic location relative to the final Spider Tracks data point.

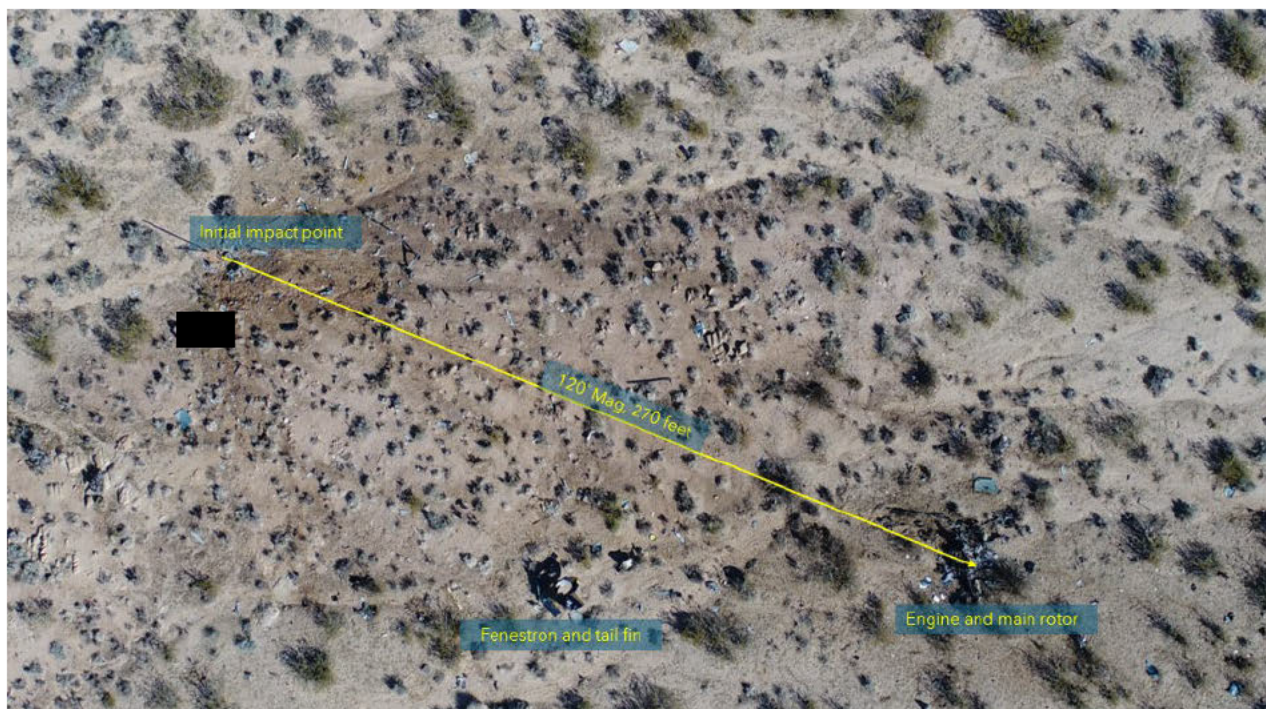
Figure 5. Overhead view of the accident site and wreckage distribution.

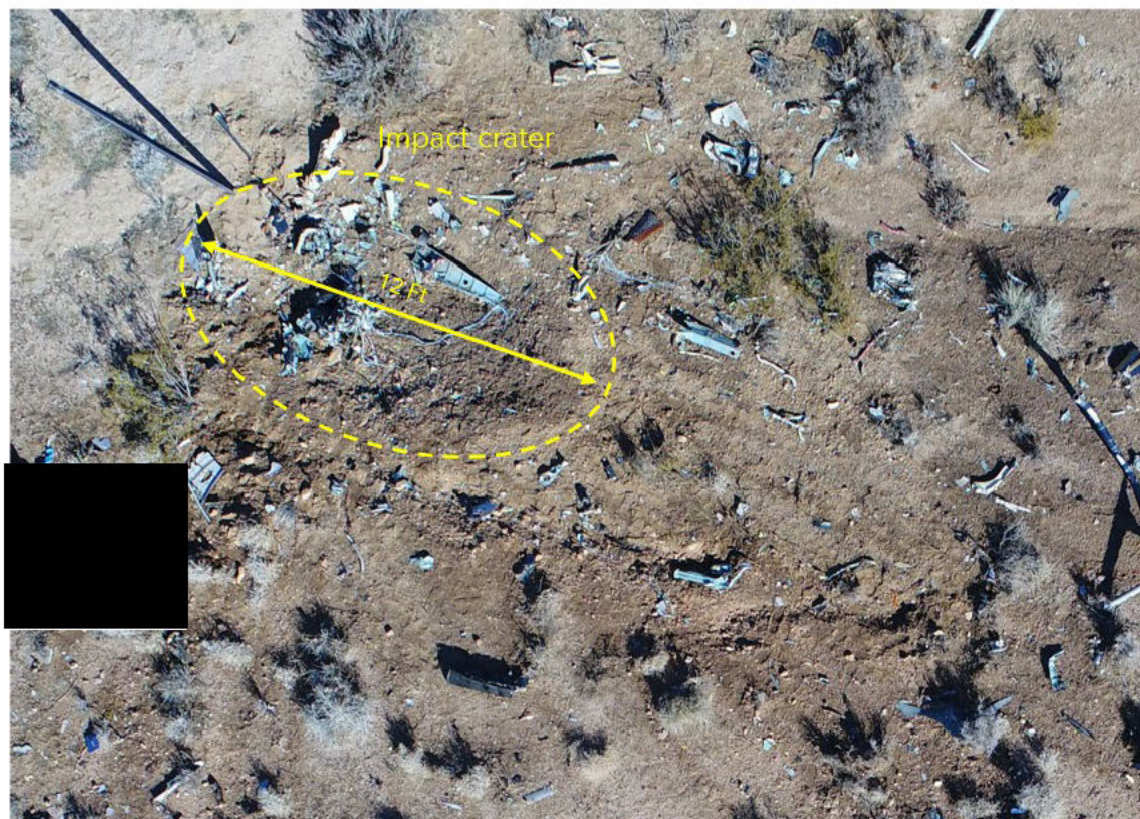
The initial point of ground impact was an area of disturbed earth with fuselage and cockpit debris imbedded into it. The initial impact point featured the helicopter’s right-side step, which is normally mounted to the landing skid cross tubes, stuck into the ground at a 45° angle (Figures 6 and 7).

Figure 6. Overhead view of the initial impact area.

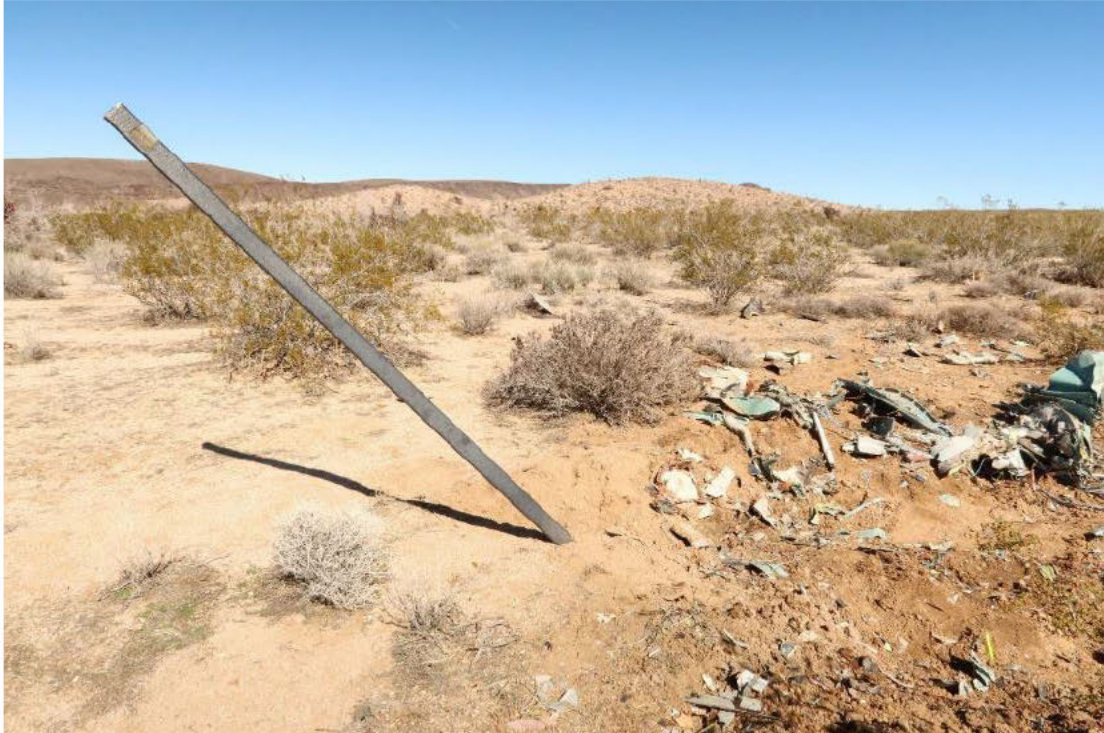
**Figure 7.** Right side skid step imbedded into the ground at the initial impact area.

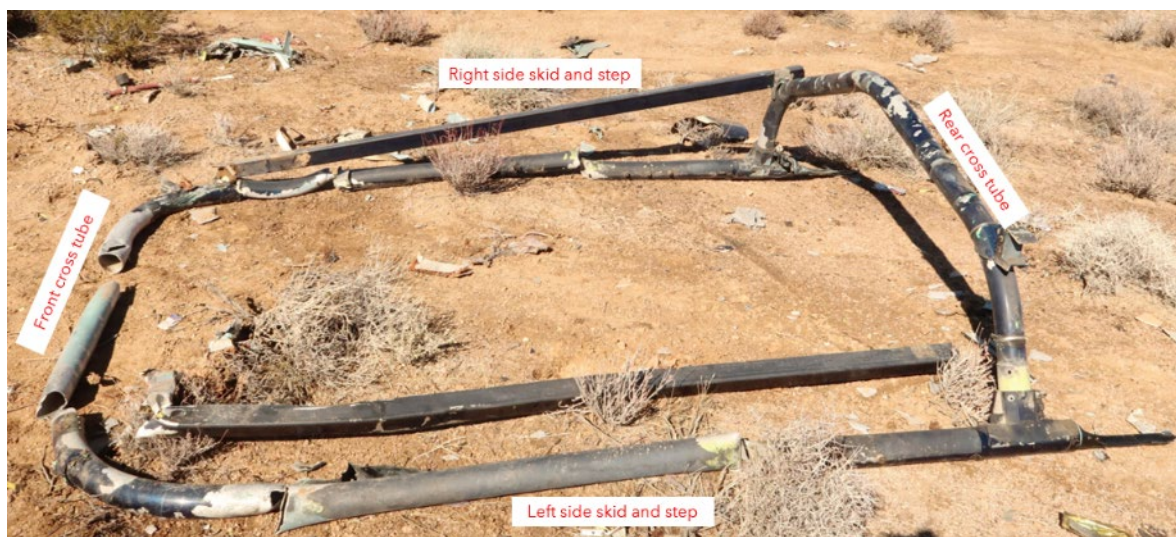
The skid type landing gear was fractured into 7 main pieces (Figure 8). Two sections of the forward right side of the right landing gear were imbedded into the terrain at the initial impact point.

**Figure 8.** Landing skids.

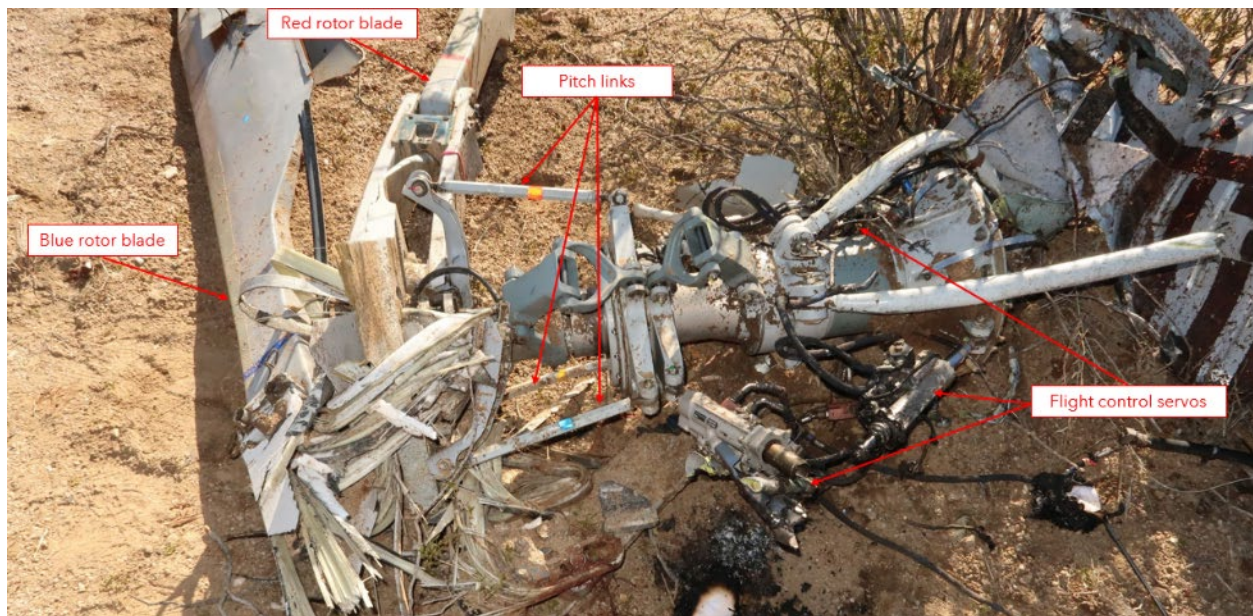
The upper transmission section (epicyclic), mast, and rotor head remained as a unit (Figure 9). The main rotor transmission case (magnesium) was fragmented or consumed by the post-crash fire. The main drive/bull gear was located 15 yards south of the rotor head. Both stationery and drive scissors remained attached. The transmission drive quill had separated from the transmission case. The drive shaft connecting flange was attached but the drive shaft had fractured at the base in bending overload.

**Figure 9.** Upper transmission section, upper flight controls, main rotor head.

The main rotor head was attached to the transmission mast. All three main rotor blade sleeves were present with the red and blue-colored blades attached at the sleeves to the hub/Starflex area. The red-colored blade had leading edge damage, the blade tip was broomstrawed, the blade spar was fractured in 2 locations, and blade trailing edge body was separated from the spar. The blue-colored blade had leading edge damage, the spar was fractured at one location, and there was blade trailing edge body separation from the spar. The yellow-colored blade root was attached to the Starflex sleeve. A 12-foot burned section of the yellow blade was located next to the engine (approximately 20 yards away) and had leading edge damage, the spar was fractured at three locations, and there was blade trailing edge body separation from the spar. All three main rotor blades exhibited powered impact signatures, and all three blade tips were accounted for.

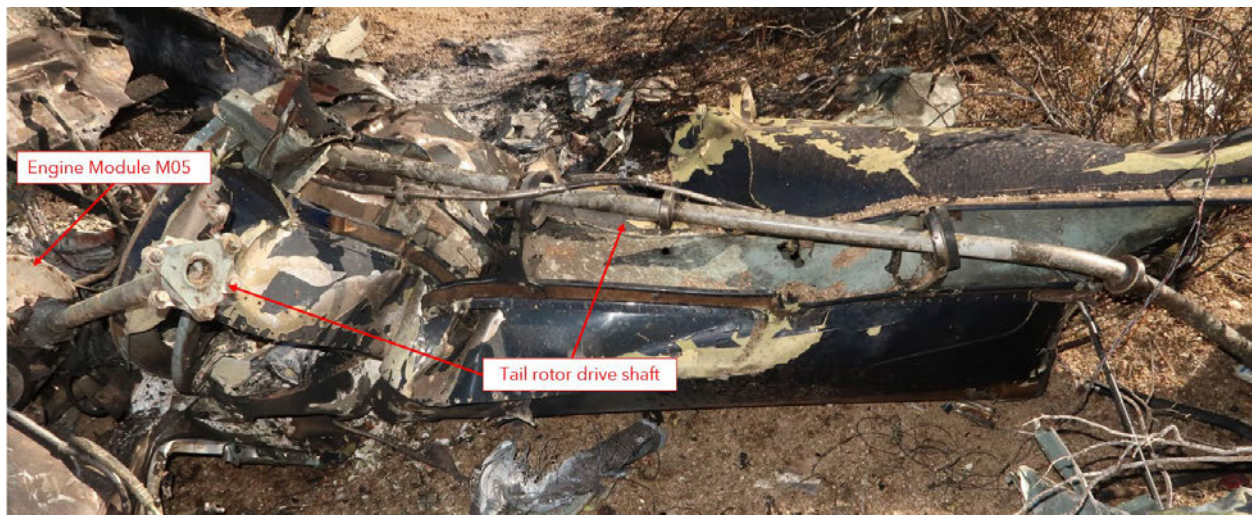
The tail rotor drive shaft (short shaft) was connected to the engine module 5 and the opposite end had pulled off the splined coupling exhibiting damaged flex coupling elements (Figure 10). The forward section of the aluminum tail rotor drive shaft remained with the damage forward section of the tail boom. A tail rotor drive shaft hanger bearing was located at the helicopter’s impact crater. A two-foot section of the fenestron drive shaft was located near the fenestron gearbox. An 8-inch section of the fenestron driveshaft was connected to the fenestron gearbox. The gearbox had separated and was next to the tail fin (Figure 11). The fenestron stators had all separated from the tail fin. All the fenestron blades remained in their hubs and blade tips had chordwise scratches. All ten fenestron blades were bent lengthwise inboard.

**Figure 10.** Tail boom inboard section with tail rotor drive shaft attached.

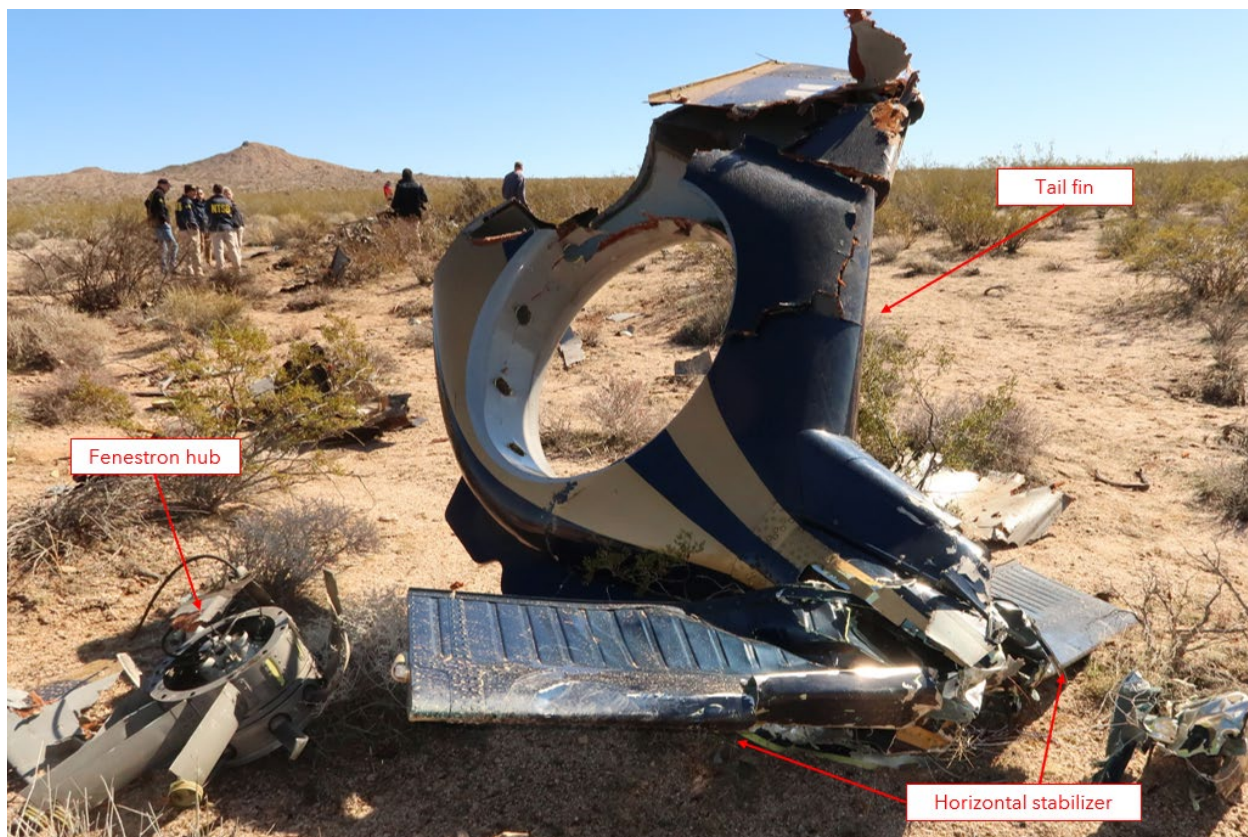
**Figure 11.** Outboard section of tail boom, horizontal stabilizer, tail fin, and fenestron.

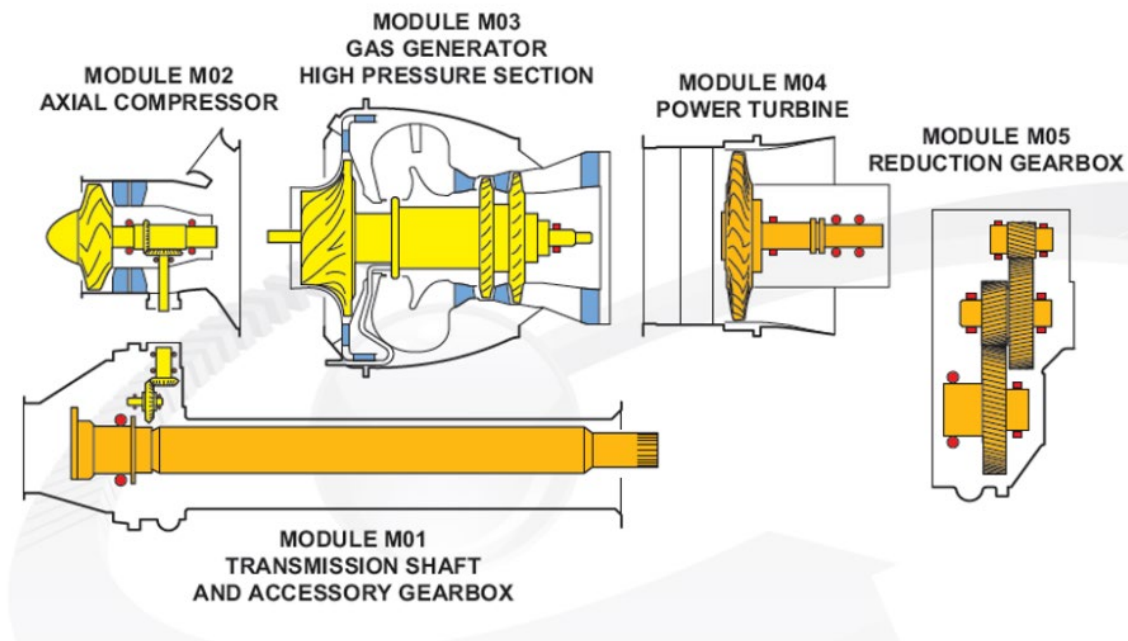
The Arriel 2B1 turboshaft engine features a single-stage axial flow compressor and a single-stage centrifugal flow compressor, an annular combustor, a single-stage gas generator turbine rotor that drives the compressor, and a free turbine power turbine rotor. A reduction gearbox is driven via a splined coupling (also known as a "muff coupling") connected to the free turbine power turbine rotor. The reduction gearbox provides final drive to the power transmission shaft. An accessory gearbox is driven from a gear coaxial to the shaft between the axial and centrifugal flow compressors.

**Figure 12.** Arriel 2B1 engine assembly modules (Source: Safran Helicopter Engines)

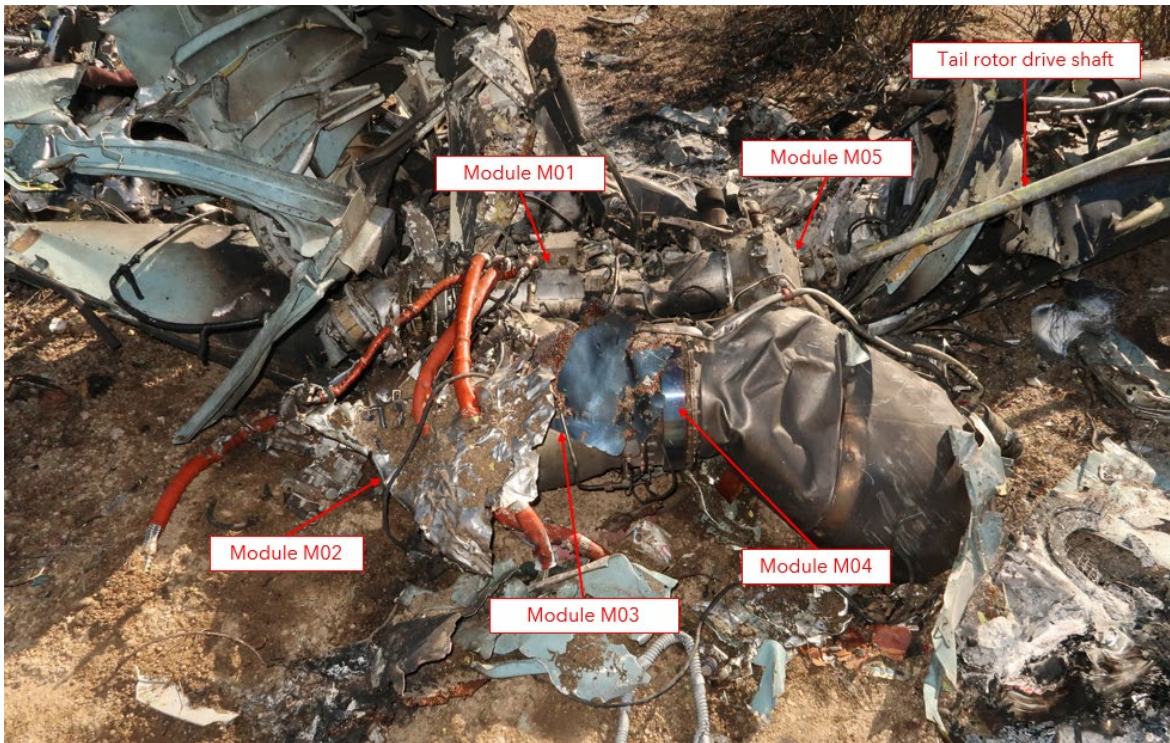
The engine had separated from the airframe mounts, was fire damaged, and the exhaust pipe was deformed (Figure 13). The axial compressor blades were damaged on both the leading and trailing edges (Figure 14). The turbine case was deformed but was not breeched. The turbine case and power turbine containment shield were intact with no evidence of free turbine power turbine blade shedding.

**Figure 13.** Engine wreckage with engine modules labeled.

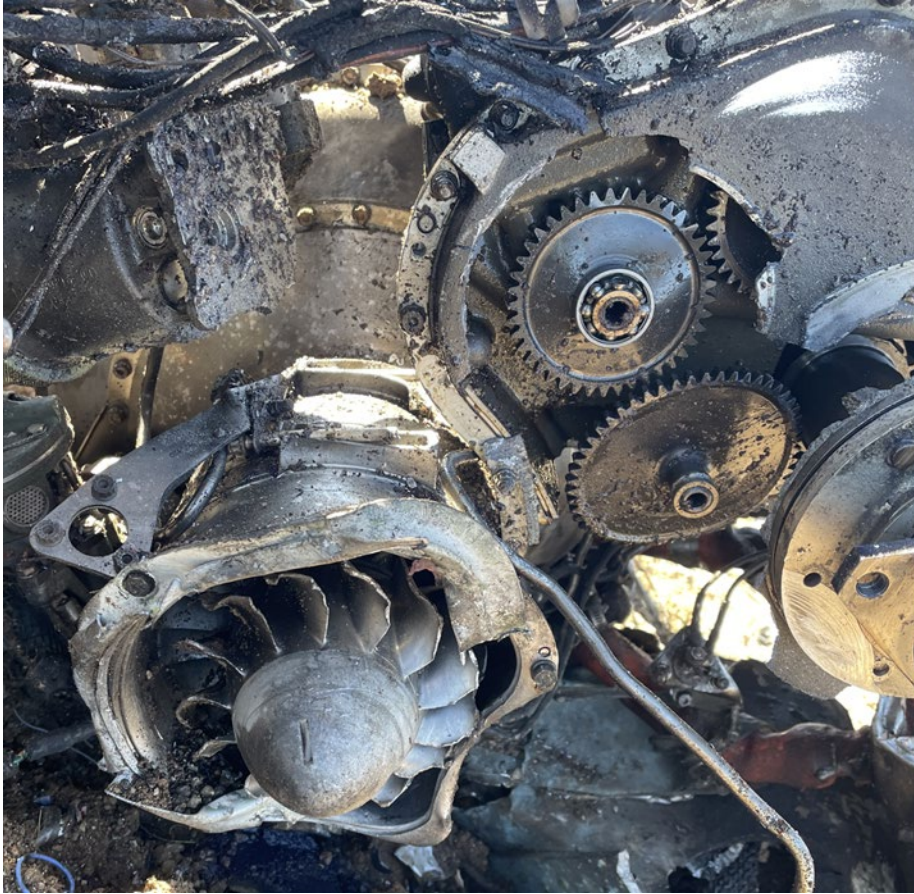
**Figure 14.** Engine axial compressor (module M02) exhibiting leading edge gouging and blade bending opposite the direction of rotation (Source: Safran Helicopter Engines)
