# National Transportation Safety Board

CEN25FA281

## **ELECTRONIC DEVICE**

Specialist's Factual Report

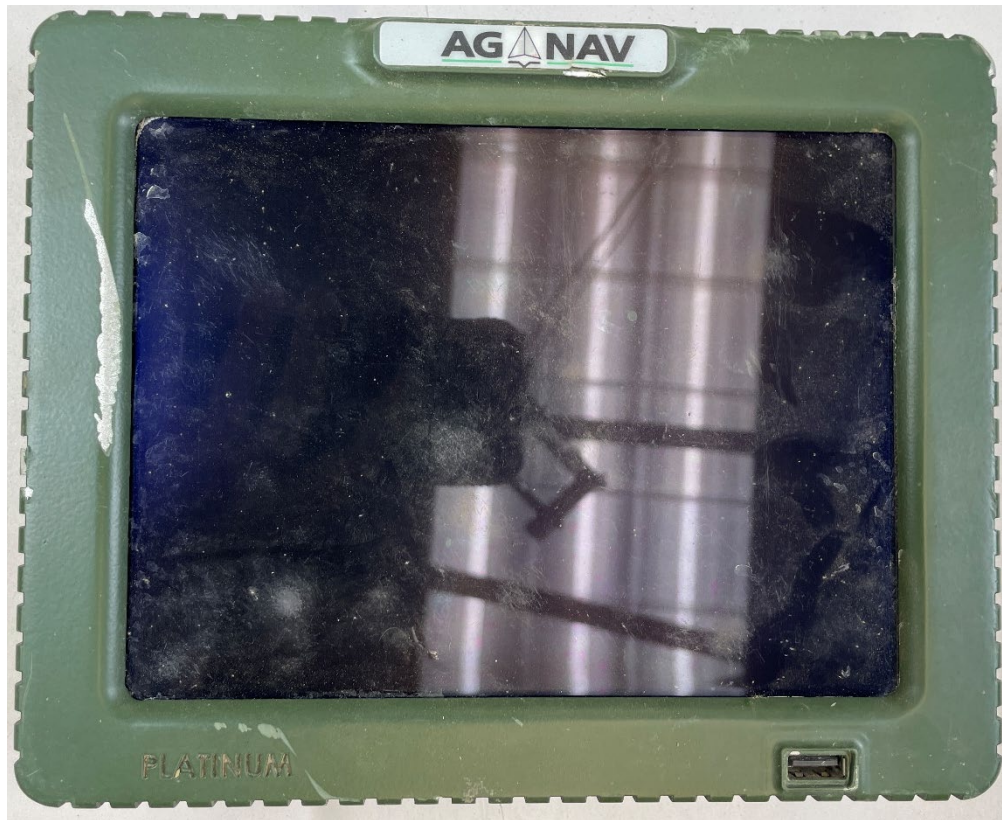
**Figure 1.** AG-NAV Guia Platinum front as received by the NTSB Vehicle Recorder Laboratory.

The AG-NAV Guia Platinum was in good condition, as shown in figures 1 and 2, and powered on normally. Data from the device's hard drive were recovered utilizing the manufacturer's procedure.

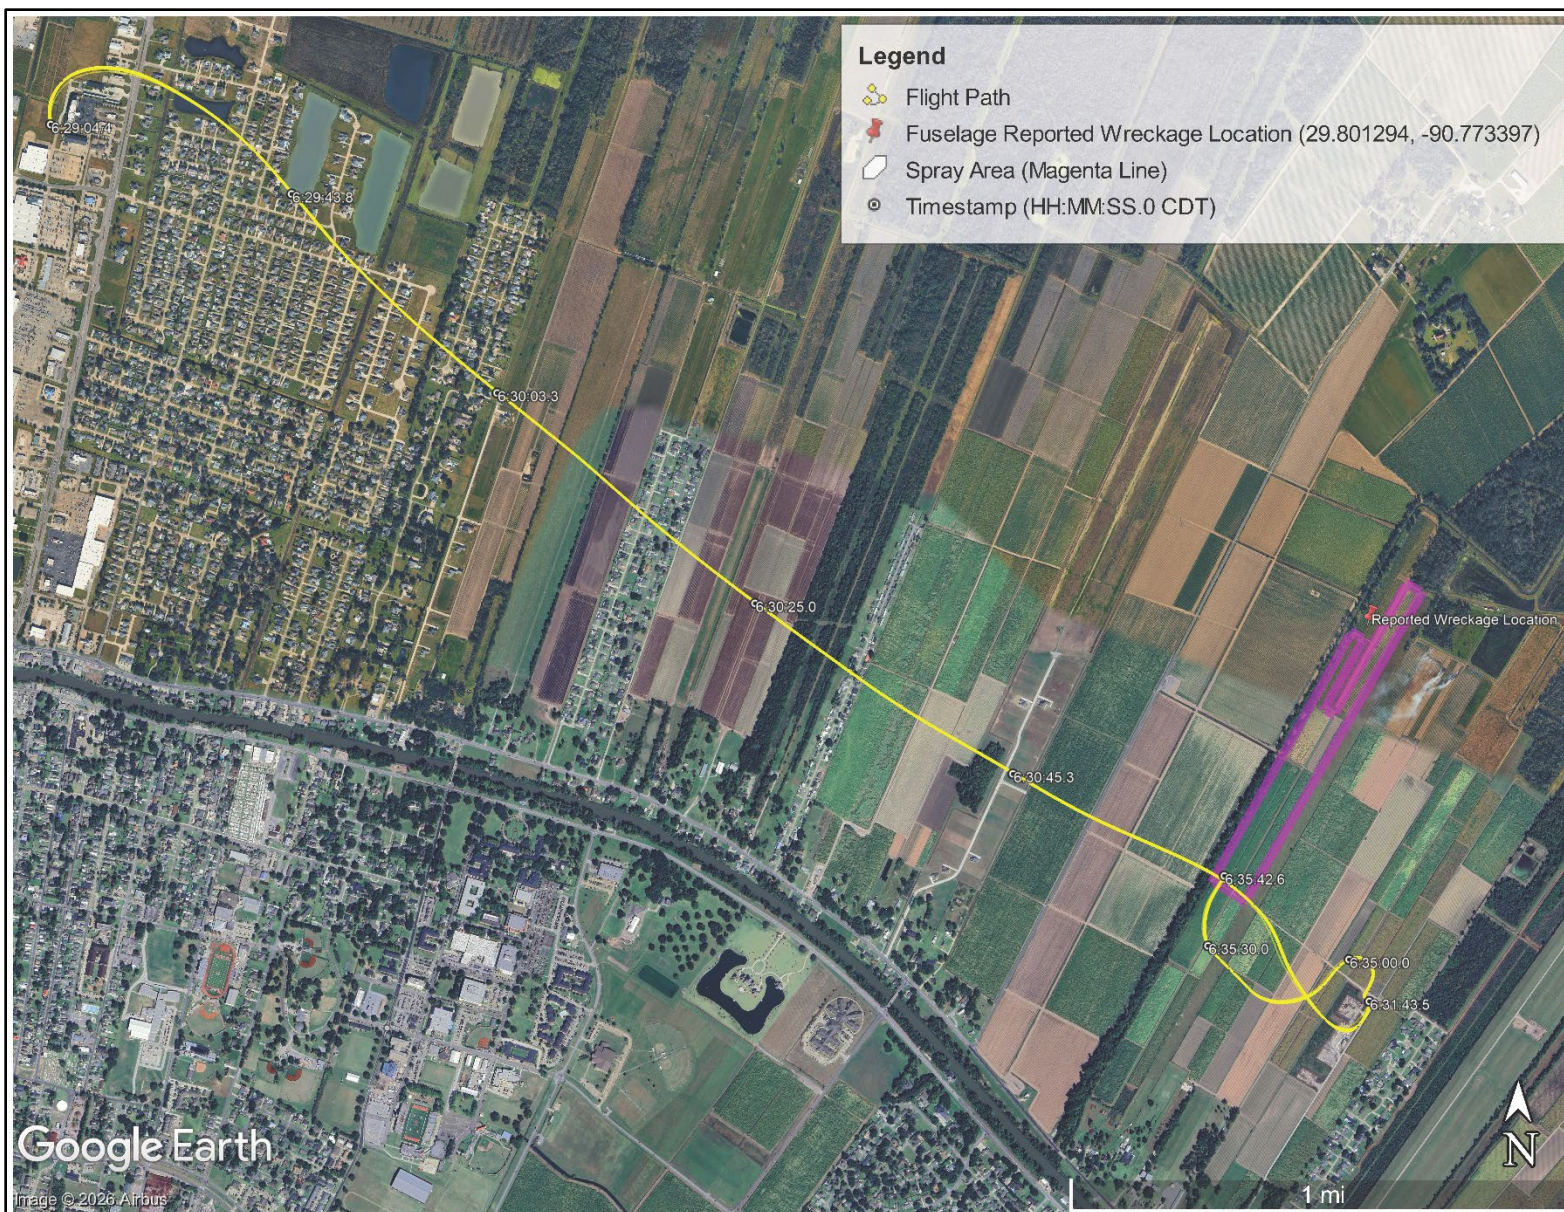
**Figure 5.** Google Earth overlay of the entire recorded data.

Figures 5 through 7 are graphical overlays of the entire accident flight, the spray area, and the spray area and location where the spray system was recorded on, respectively. The weather and lighting conditions in Google Earth are not necessarily representative of the weather and lighting conditions present at the time of the recording.

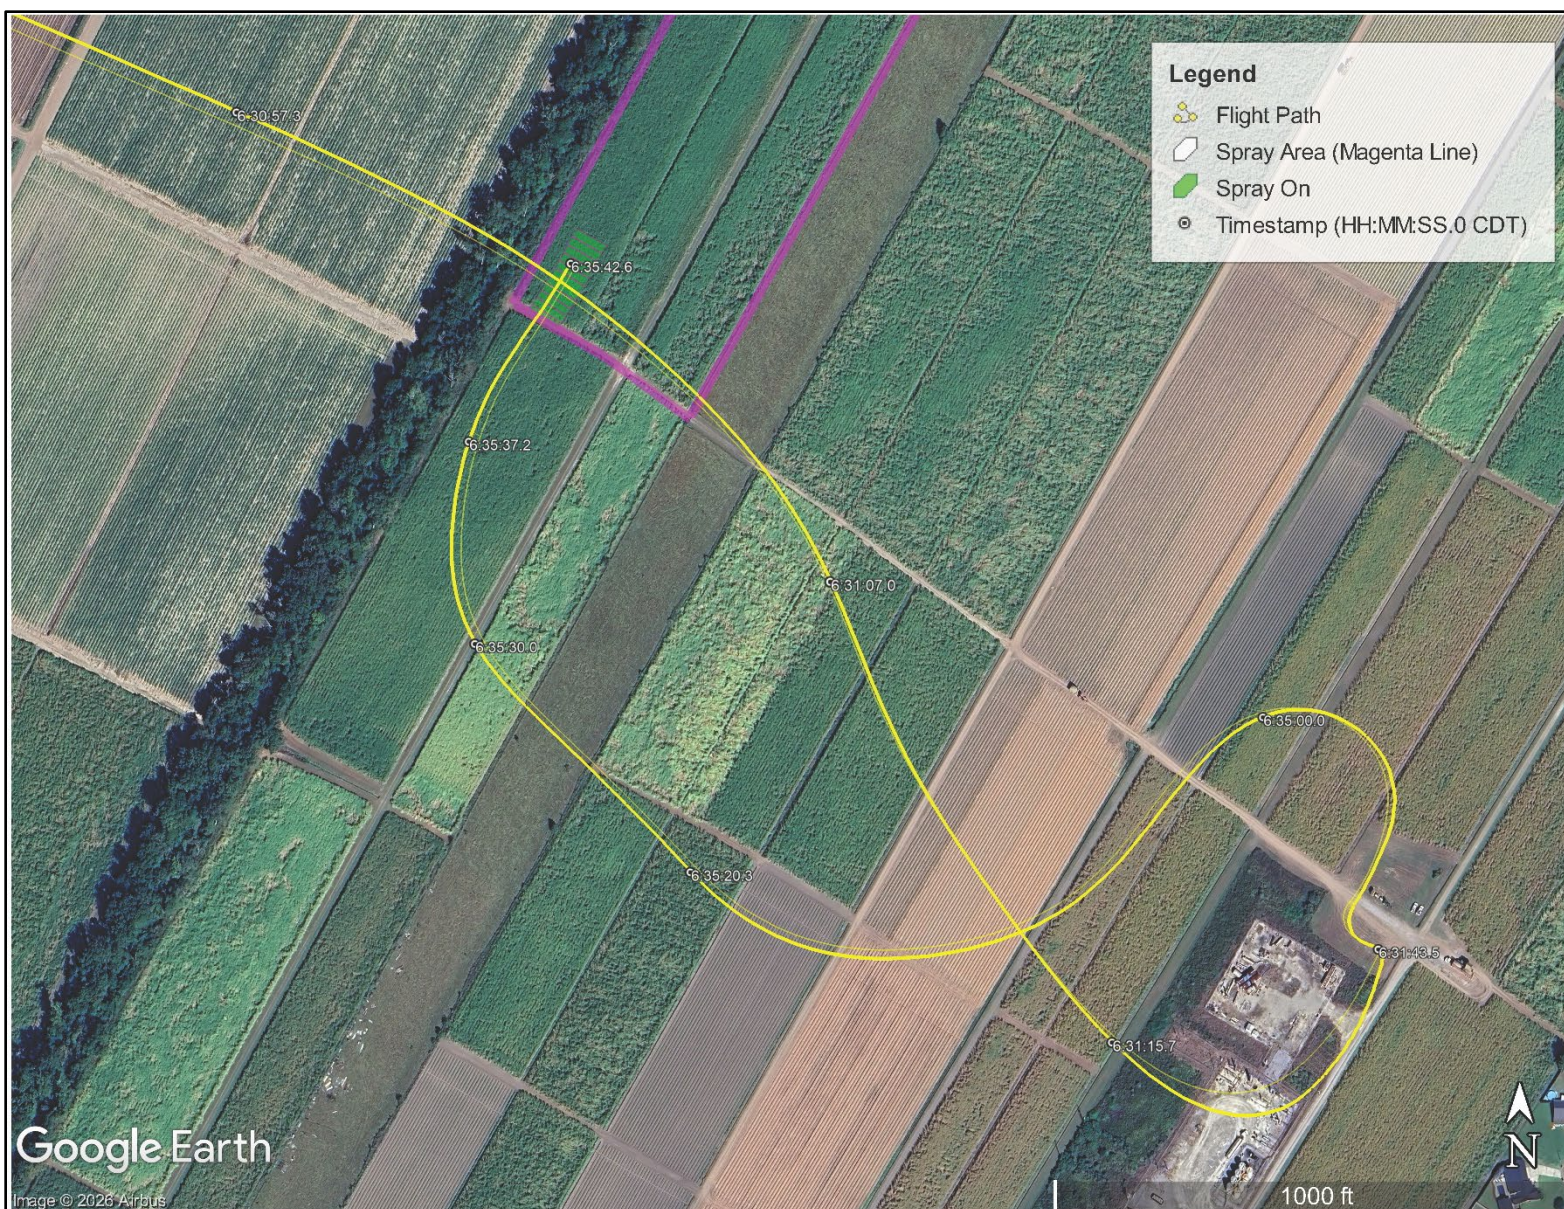
**Figure 7.** Google Earth overlay of the spray area and where the spray system was recorded on.
