RE: N81481 fuel records

RE: N8141, 17<sup>th</sup> October, 2024

As requested, here is a detailed description of my interaction with the aircraft N81481 and its crew and passengers on the 17<sup>th</sup> of October, 2024.

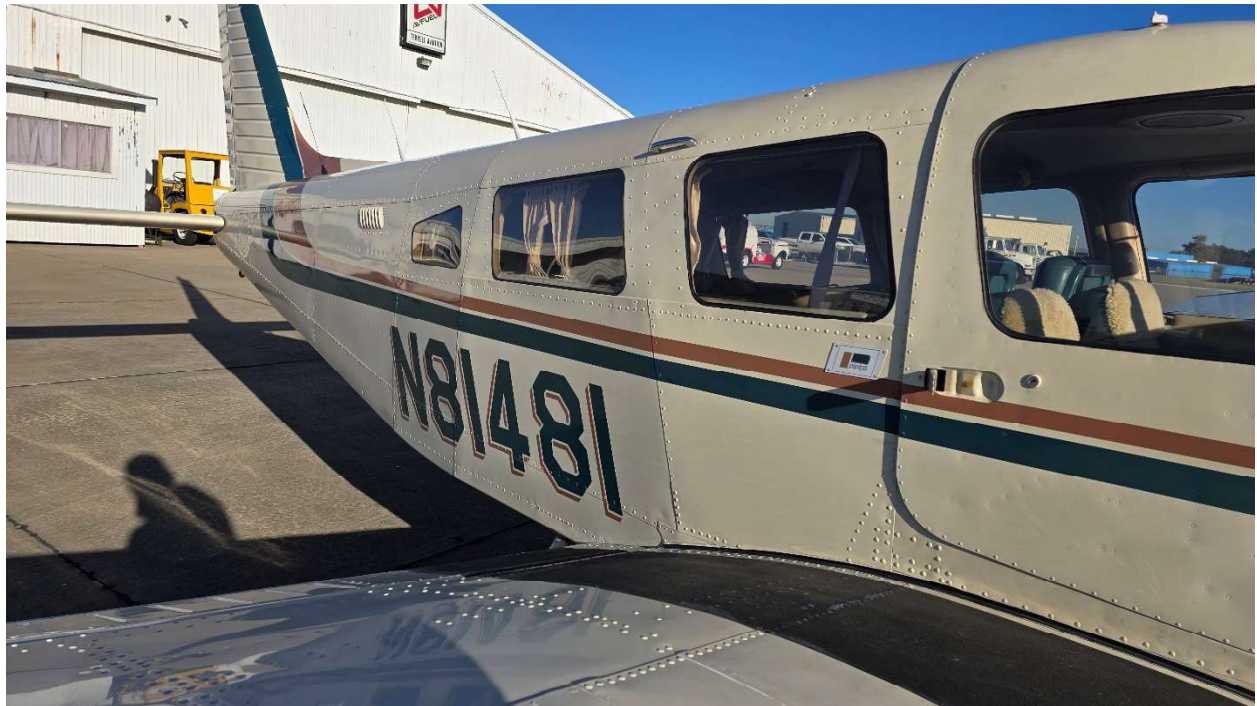
Attachment 1:

I arrived to commence my workday at approximately 0750hrs, at 0757hrs I refueled N64367 with 100LL using our fuel truck. At approximately 0900hrs, I observed Piper Saratoga/Lance land on runway 18. It taxied to Terrell Aviation and shut down in front of the building. I left the building as the occupants exited and greeted them, as far as I recall George was the older left seat pilot, and Jonathan was in the right seat and Brandon was seated in the back behind the pilot. They requested a top-off of 100LL, so I retrieved the truck and parked it in front of the plane. I attached the grounding strap to the nosewheel, and proceeded to unreel the hose to my left, the airplanes right wingtip. I filled the tank on the right wing before walking to the other side and filled the left wing. During fueling, I observed a standard colour (light blue) and no unusual smell. I do not recall the exact breakdown of how much each wing tank received, but after fueling I took a photo of both the fuel truck totalizer, 60.3 gal, and the tail number of the aircraft, N81481, for records and fuel log entries (see attachment 1 & 2). After parking the truck back, I headed inside to take payment. The transaction was processed at 9:08:55am per the receipt. After payment, I requested from George that I be allowed to take photos of the aircraft for social media, to which he consented but requested his name be withheld. I took 2 photos from approximately 3 metres from the right wingtip, at an angle which obscured the tail number (see attachment 3 & 4). After taking these photos, I proceeded to the front right of the aircraft, to get a closer look at the interior as I was interested in the instrument panel and the room inside. Inside, there were several fishing rods and some personal gear on the right-hand side behind the co-pilots seat, and they mentioned they were going on a fishing trip to Louisiana. As I looked, they proceeded to load back into the aircraft, while I did not pay close attention it seemed as they were loading in the order that they got out, with George flying, Jonathan right seat and Brandon behind the pilot. I walked back inside, and they started up shortly after. I did not pay close attention to the time they started to the time they left, but after a brief delay, they taxied to runway 18 and departed not long after.
