# NATIONAL TRANSPORTATION SAFETY BOARD

## Non-Volatile Memory Devices

### Specialist's Factual Report By Ben Hsu

Location: Soldotna, Alaska  
Date: July 7, 2013  
Aircraft/ID: DeHavilland DHC-3 / N93PC  
Operator: Rediske Air  
NTSB Number: DCA13MA121

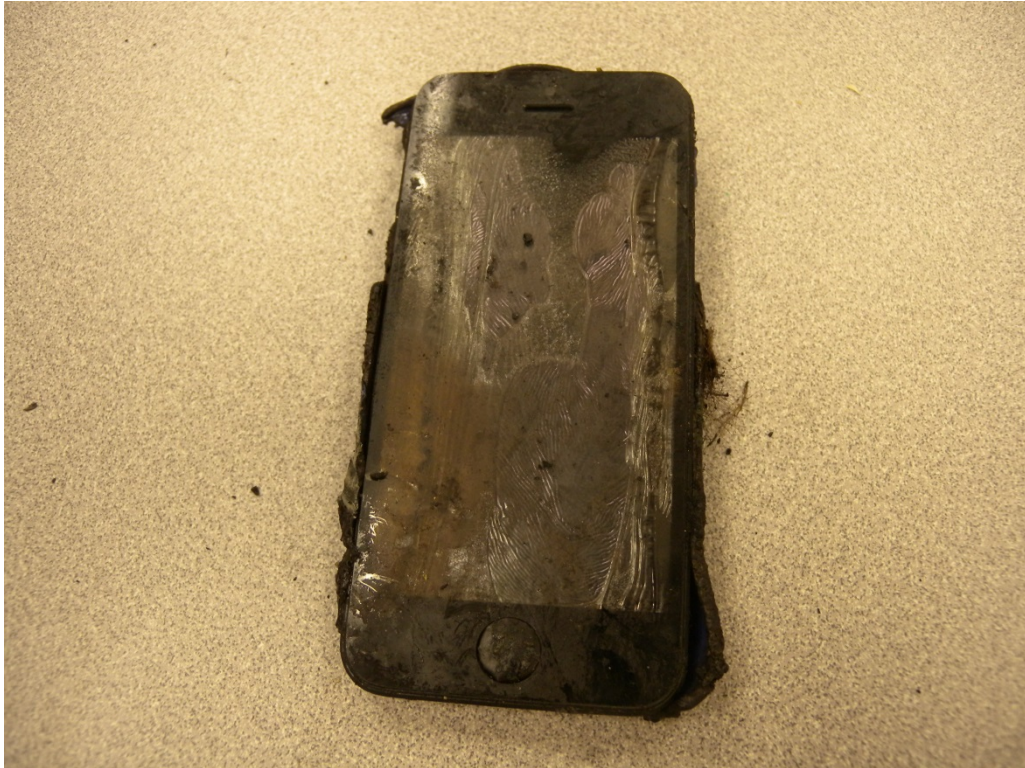
**Figure 1: iPhone 5 (S/N F2LJMGLWF8H2)**

All devices were severely damaged by impact forces and fire. Each device was examined using NTSB laboratory equipment and accident-related data was recovered where possible.

The Apple iPhone 5 (Device 1, S/N F2LJMGLWF8H2) recorded photos and videos prior to the accident. A video of the take-off and impact was also recorded on this device.

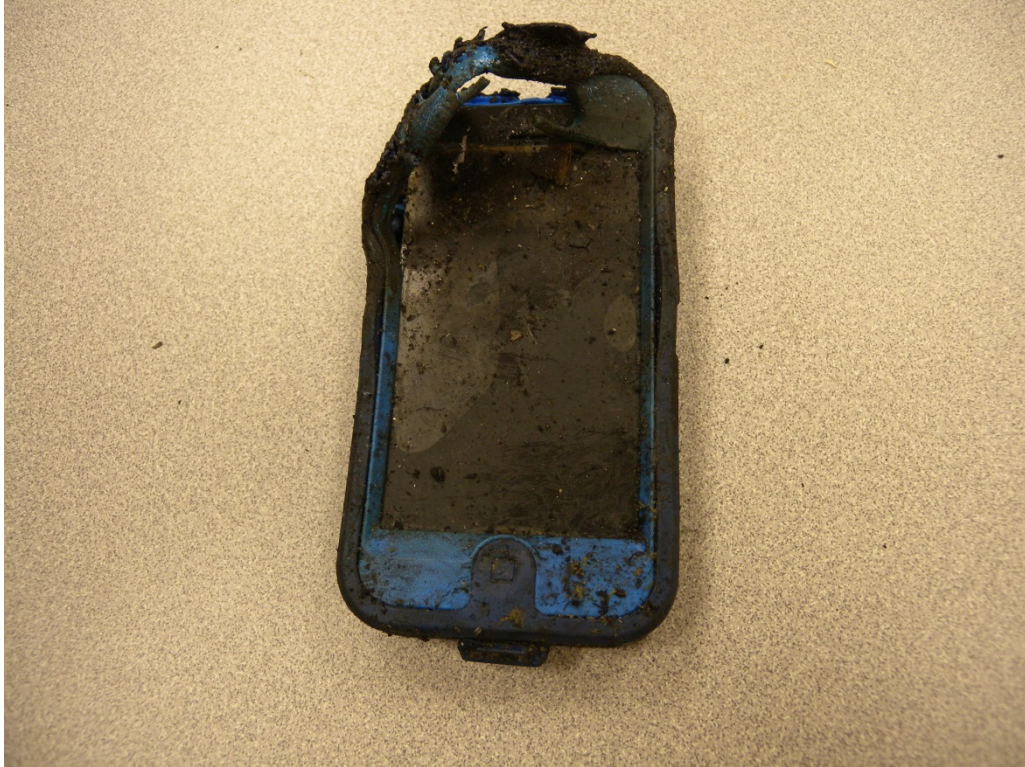
**Figure 2: iPhone 5 (S/N Unknown)**

No accident-related data was recovered from the other devices.

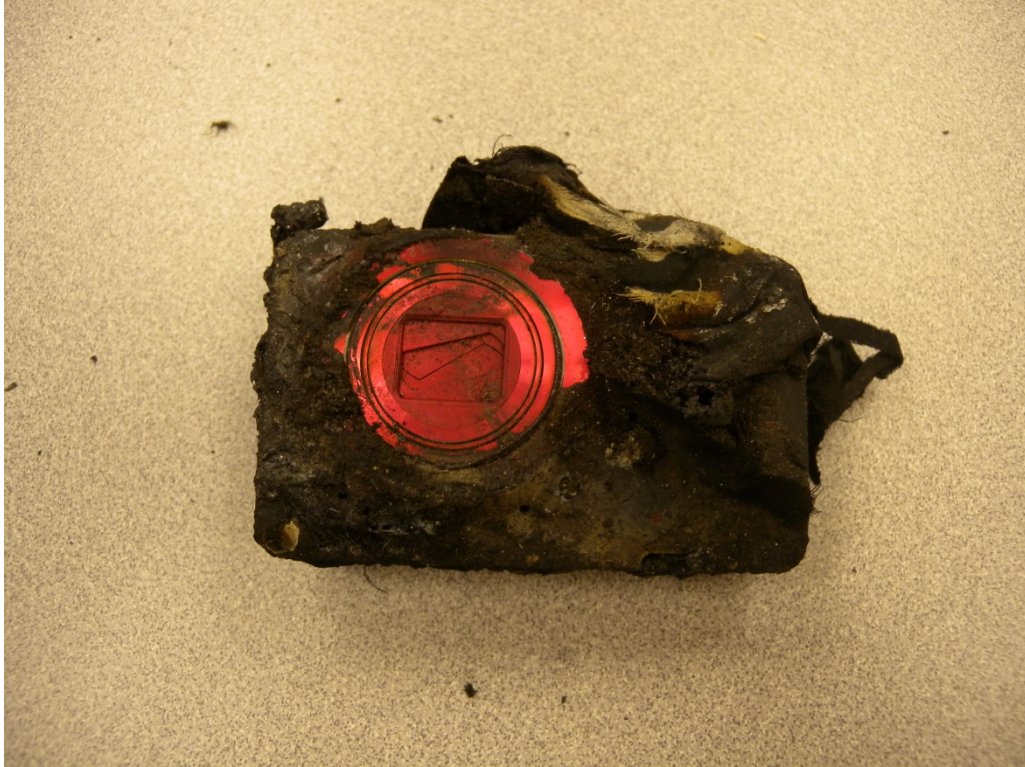
**Figure 6: Nikon Coolpix S6300 (S/N Unknown)**

The Nikon Coolpix S6300 (Device 6, S/N Unknown) recorded photos prior to the accident. A summary of these data is included in this report.
