## **NATIONAL TRANSPORTATION SAFETY BOARD**

**Group Chairman's Factual Report**

# **METEOROLOGICAL FACTUAL REPORT**

**DCA15LA173**

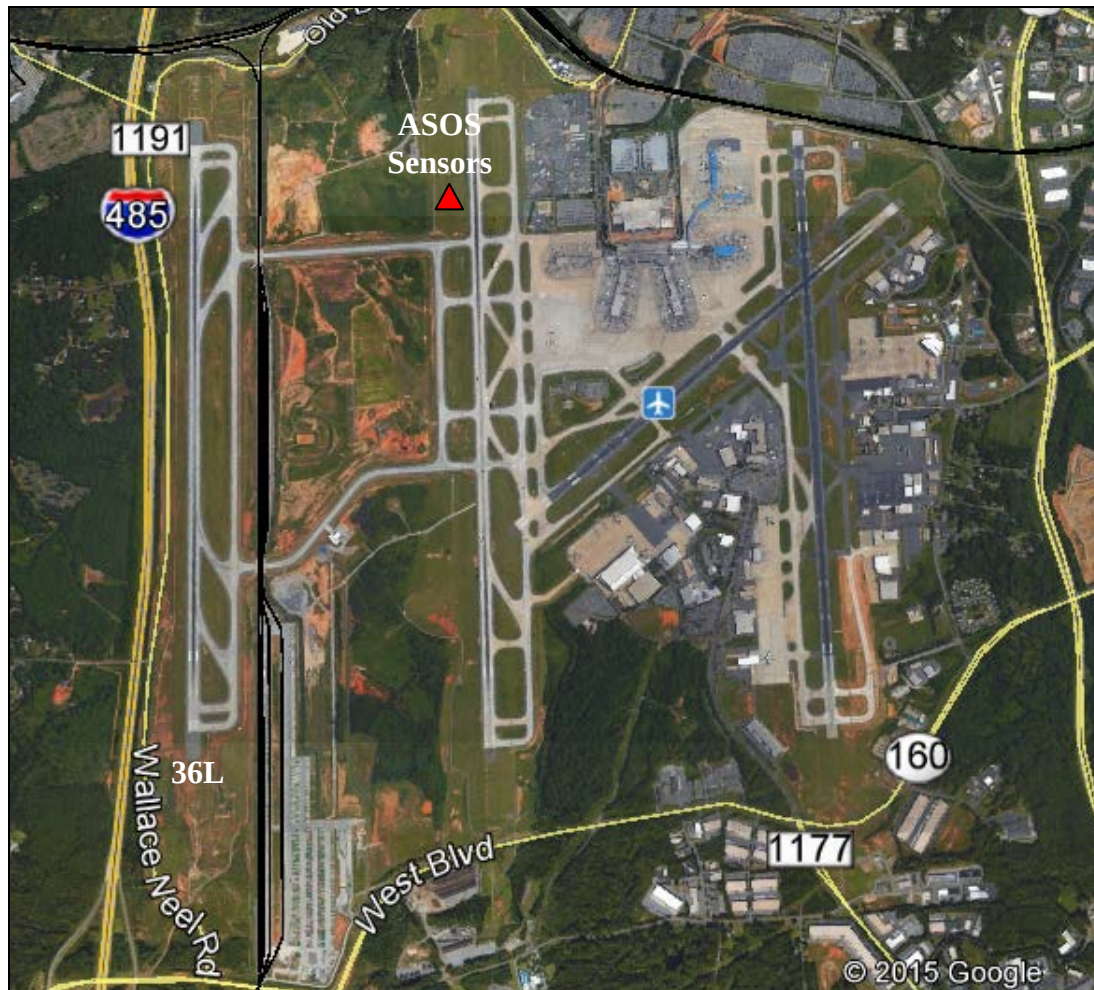
Figure 8 - ASOS location and accident site

The physical location of the ASOS sensors on Charlotte/Douglas International Airport are indicated in figure 8, or approximately 1,700 feet south of the touchdown zone on runway 18C and 750 feet west of the runway 18C/36C. The coordinates were latitude 35.2225° N and longitude -80.95431° W. With respect to the accident, the ASOS was located approximately 8,700 feet north-northeast or 1.4 miles from the accident site.
