**NATIONAL TRANSPORTATION SAFETY BOARD**

**Aerial Imagery Factual Report**

**Hangar, Parking Area and Surrounding Terrain Mapping**

**DCA17FA076**

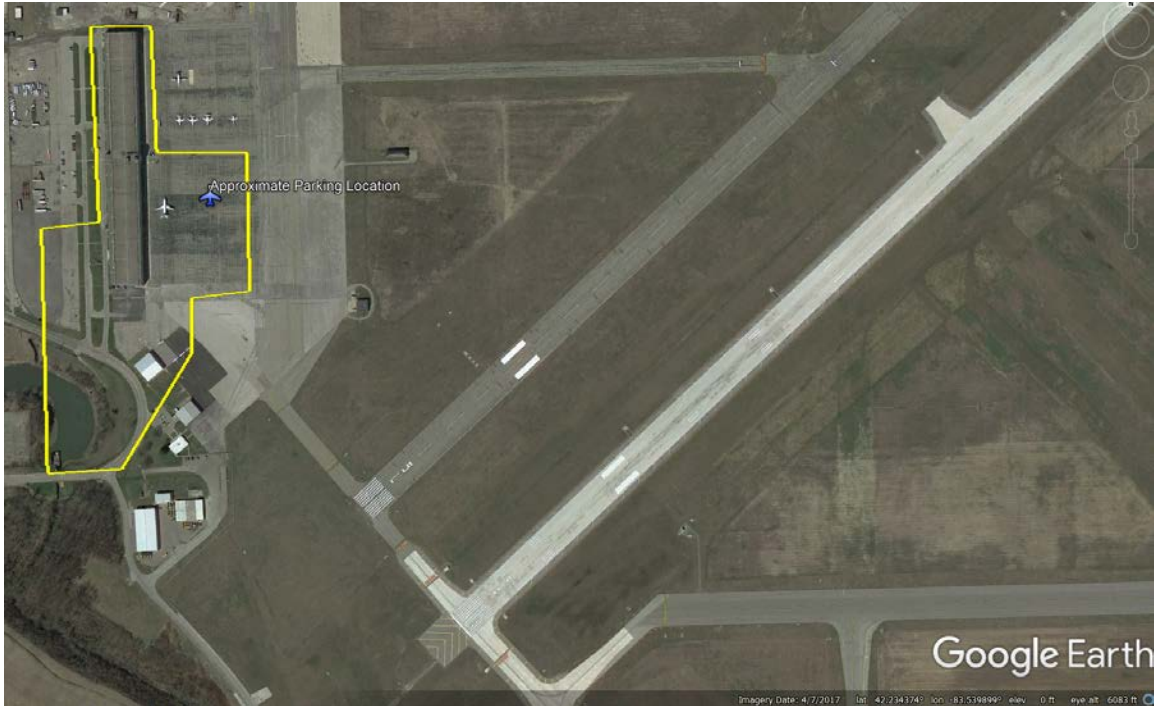
Figure 1 - Area (denoted by yellow outline) of planned mapping flights at YIP (north up)

The meteorology group, in conjunction with a request from the systems group, commissioned a wind study of the area around the approximate location where the aircraft was parked the day of the accident. The study utilized a computational fluid dynamics (CFD) model, which required a model of the local topography. The NTSB small unmanned aircraft system was utilized to conduct a mapping mission to generate a 3-dimensional (3D) model of the aircraft hangar and surrounding terrain in an area specified by the meteorology group, see Figure 1. Further details of the wind study can be found in Meteorology Group Chairman's Factual Report.

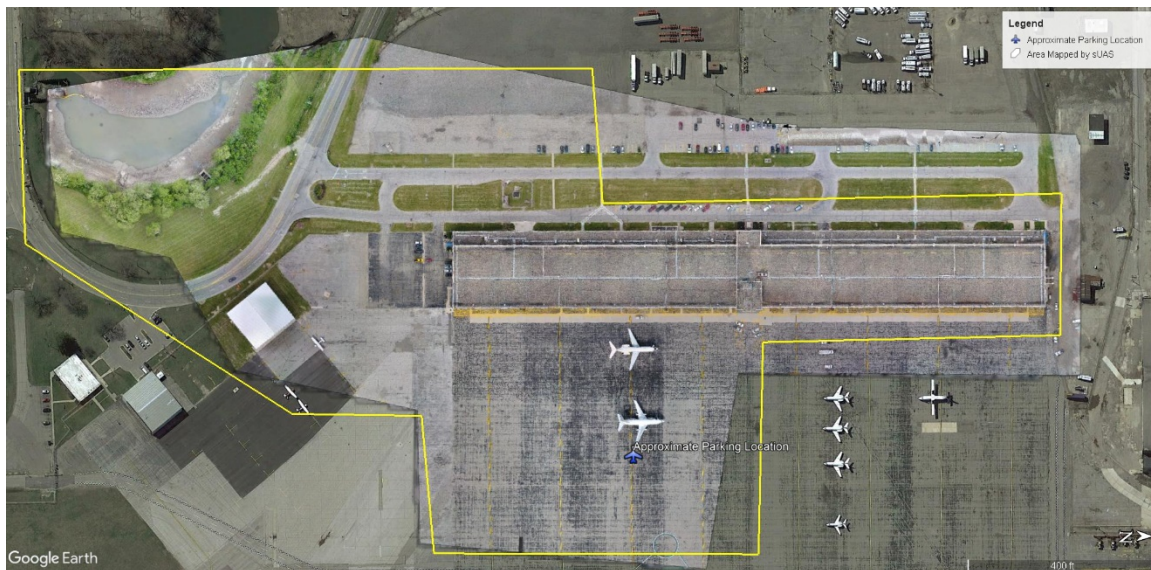
Figure 2 - Snapshot of orthomosaic with planned mapping area outlined in yellow.

A full-resolution orthomosaic .kmz file<sup>3</sup> was developed and is included as Attachment 1. Figure 2 shows the orthomosaic overlaid on Google Earth.

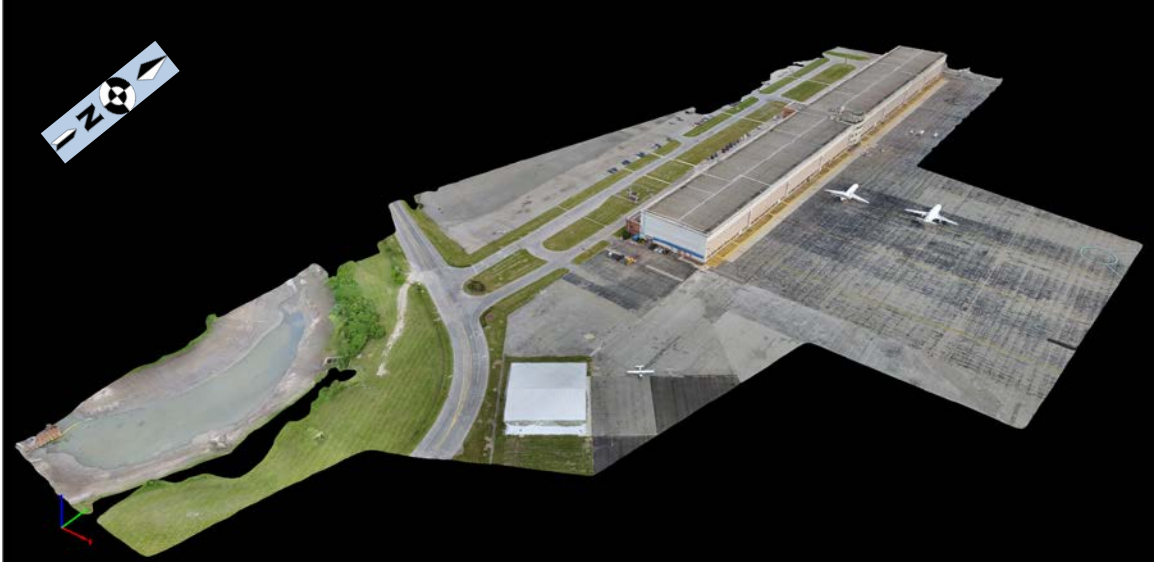
Figure 3 - Snapshot of mapped area 3D model

Figure 3 shows the output of the 3D model. Figure 4 shows as side by side comparison of a drone image and the 3D model output. Figure 5 and Figure 6 are selected snapshots from the 3D model.

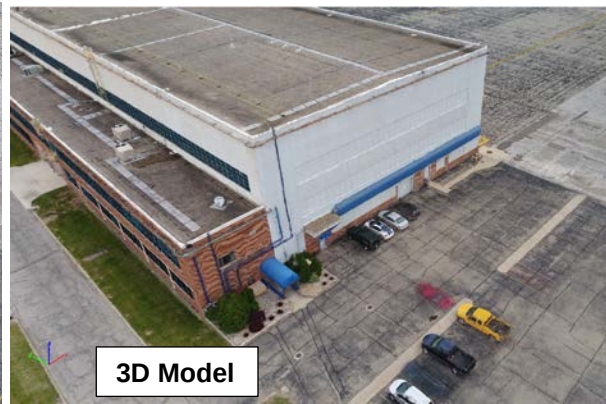
Drone Photo

3D Model

Figure 4 - Side by side view of drone photograph and 3D model of Hangar 1

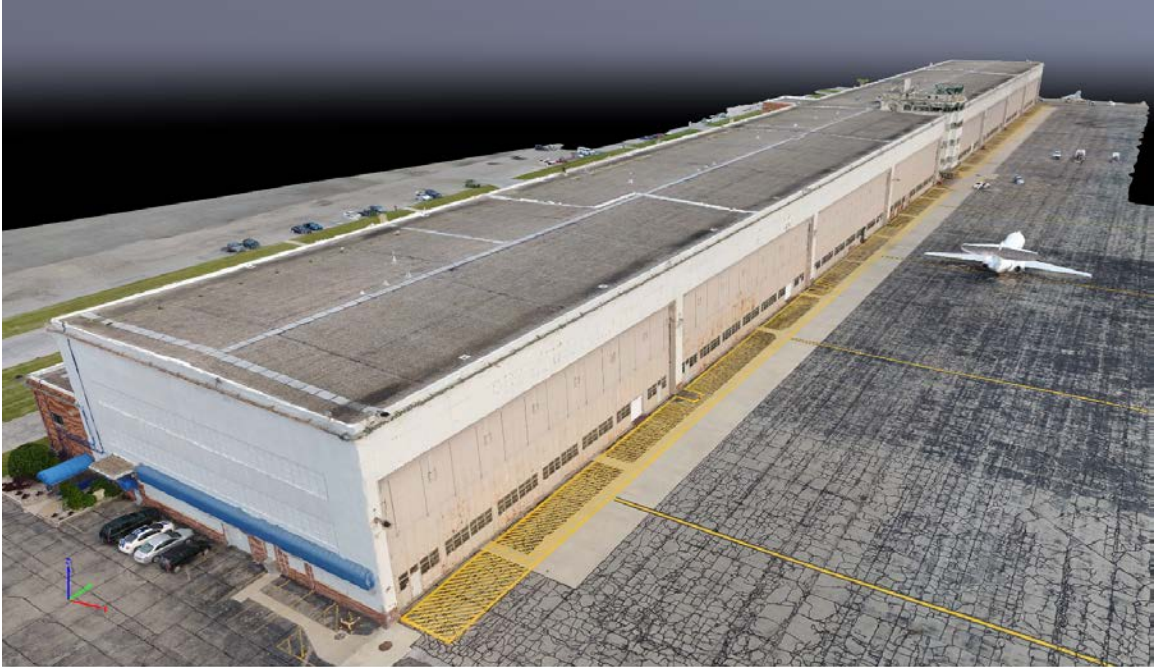
Figure 5 – Snapshot of southeastern corner Hangar 1 at YIP, 3D Model

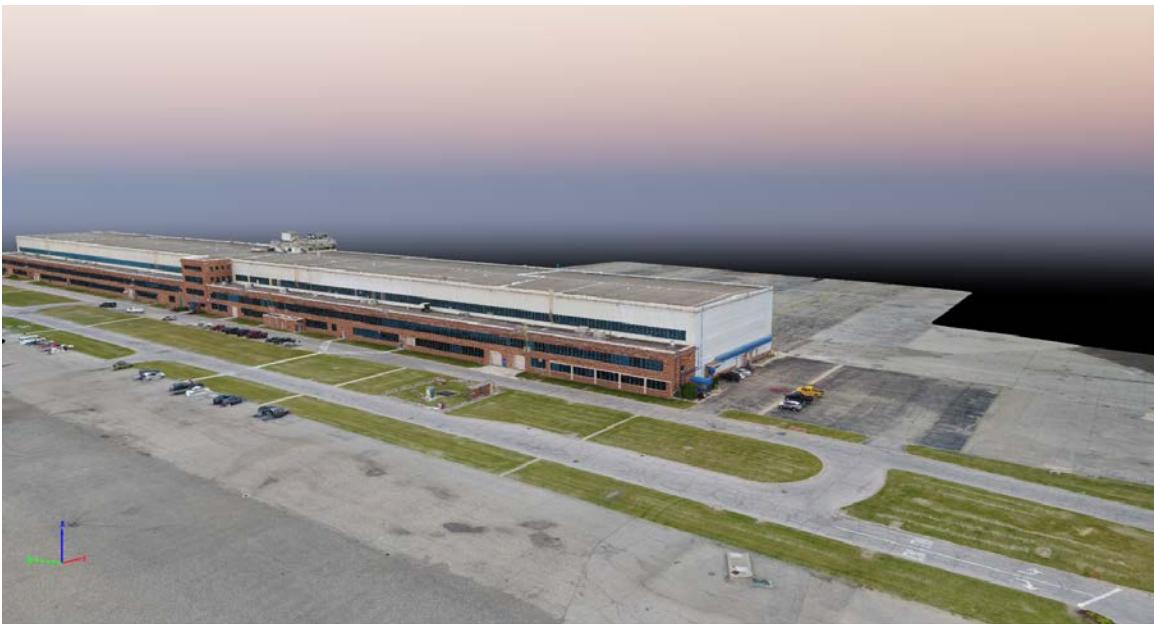
Figure 6 - View of southwestern corner of Hangar 1 at YIP, 3D Model
