# Overview of Failure Sequences and Root Cause Statements

# 777 UAL 1175 FBO Root Cause Investigation

- Plausible Inlet Failure Sequence Consistent with Analysis Simulation and Hardware Observation

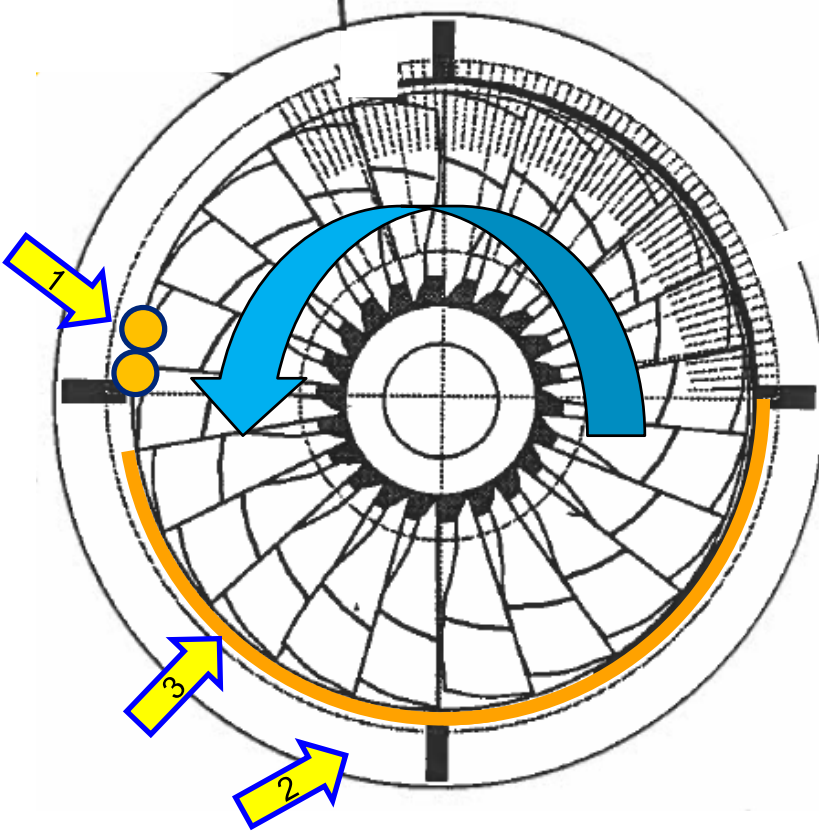
Forward  
Looking Aft

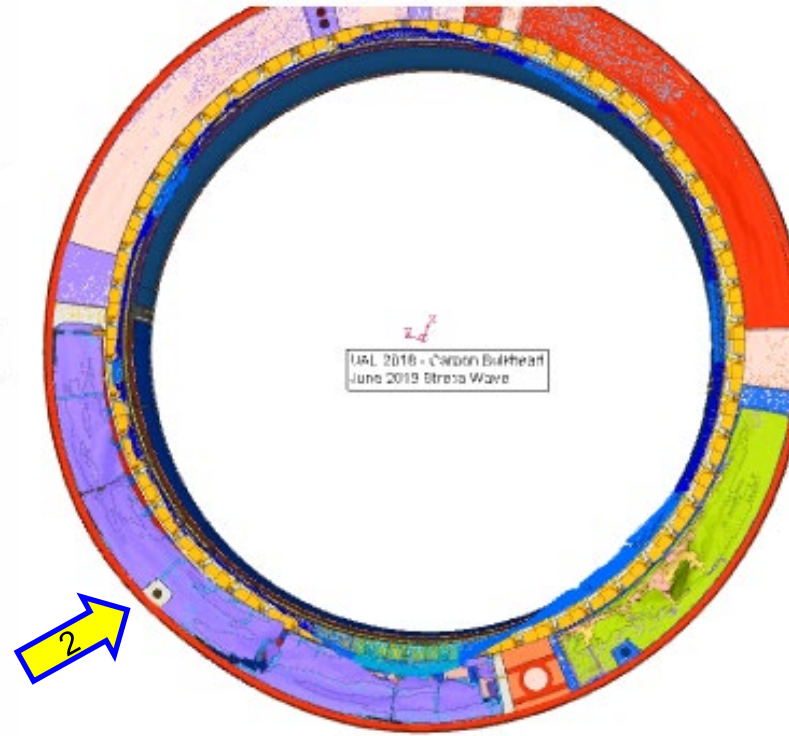
Aft Looking  
Forward

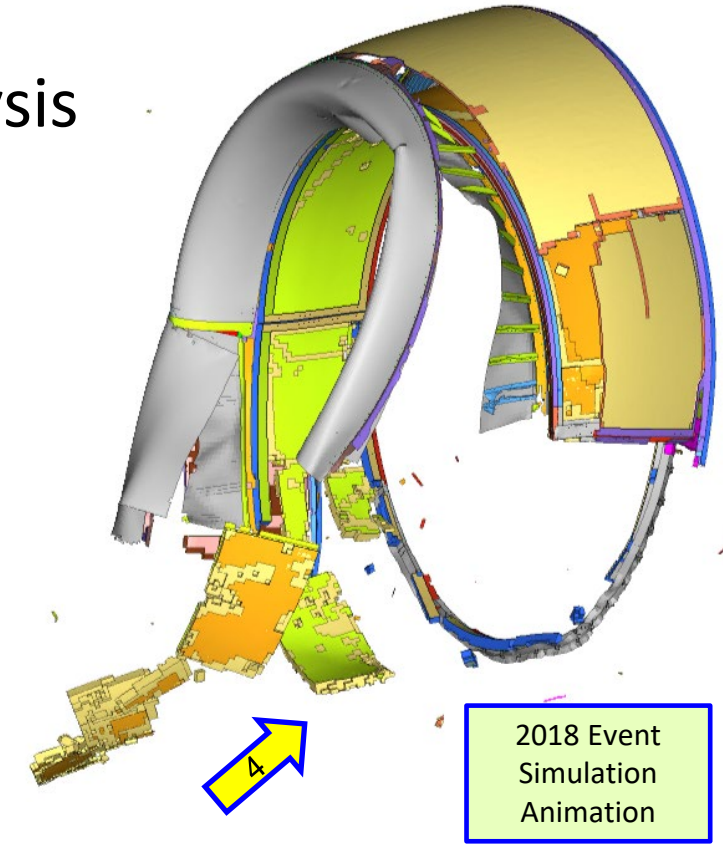
2018 Event  
Simulation  
Animation

| | time (sec) |
|---|---|
| 1 Fan Blades impact fan case | 0.005 |
| 2 170° structural damage to aft bulkhead (due to displacement wave) | 0.025 |
| 3 Blade fragments cut through inner barrel | 0.025 |
| 4 Major portions of inlet depart | <1.00 |

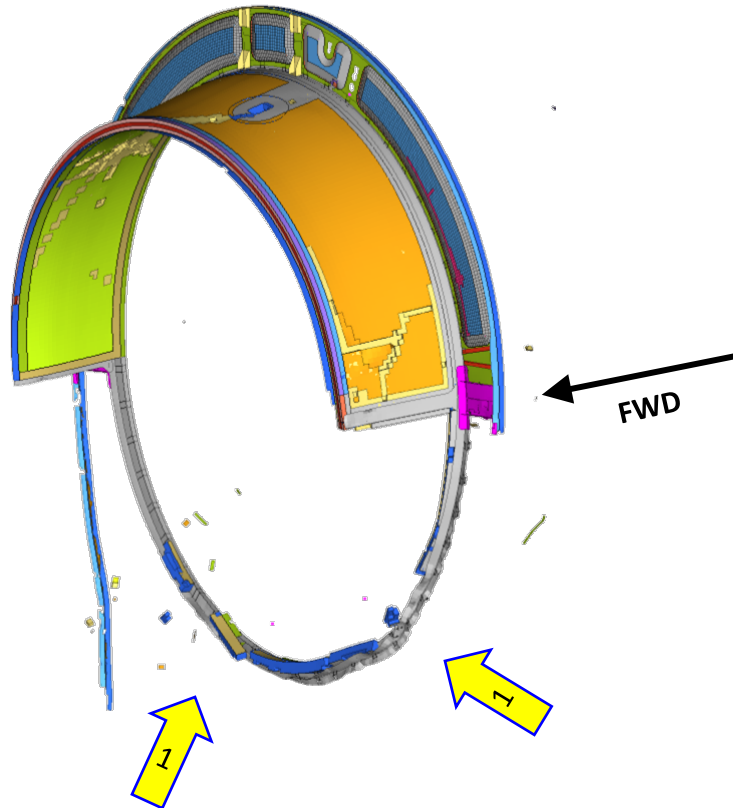
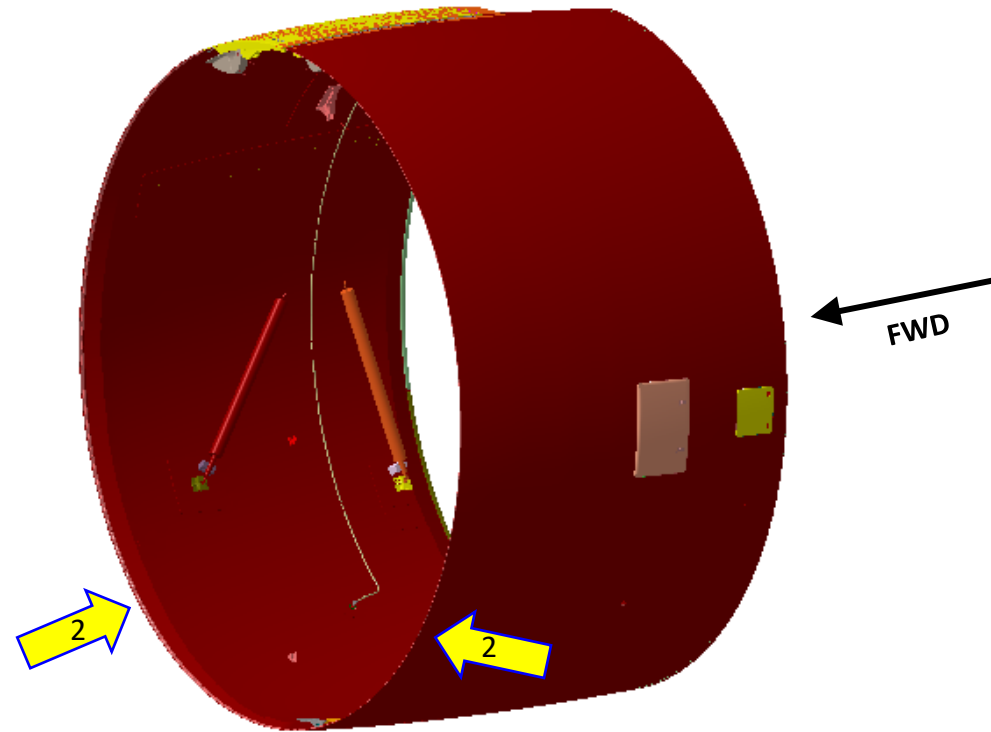
- Plausible Fan Cowl Failure Sequence Consistent with Analysis Simulation and Hardware Observation
- Scenario 1: Instability

| | | <u>time (sec)</u> |
|---|---|---|
| | Inlet aft bulkhead and v-groove damaged | <1.00 |
| | Front edges of fan cowl destabilized by buffeting | <1.05 |
| | Majority of fan cowl departs | <2.00 |

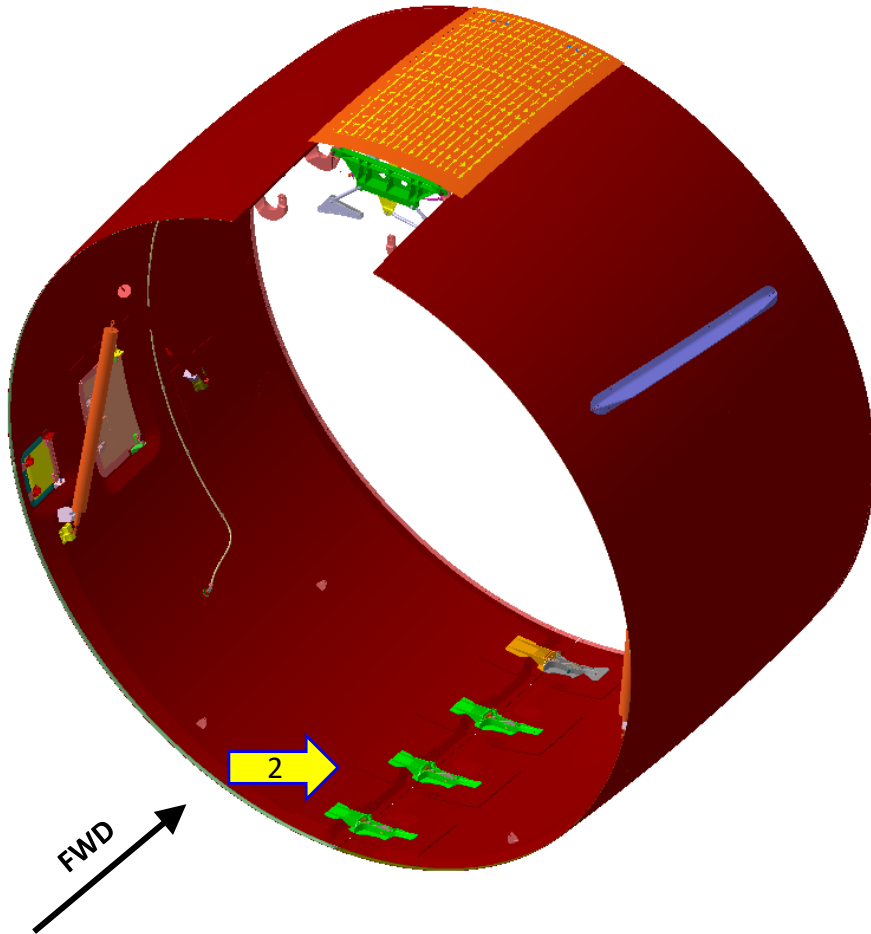
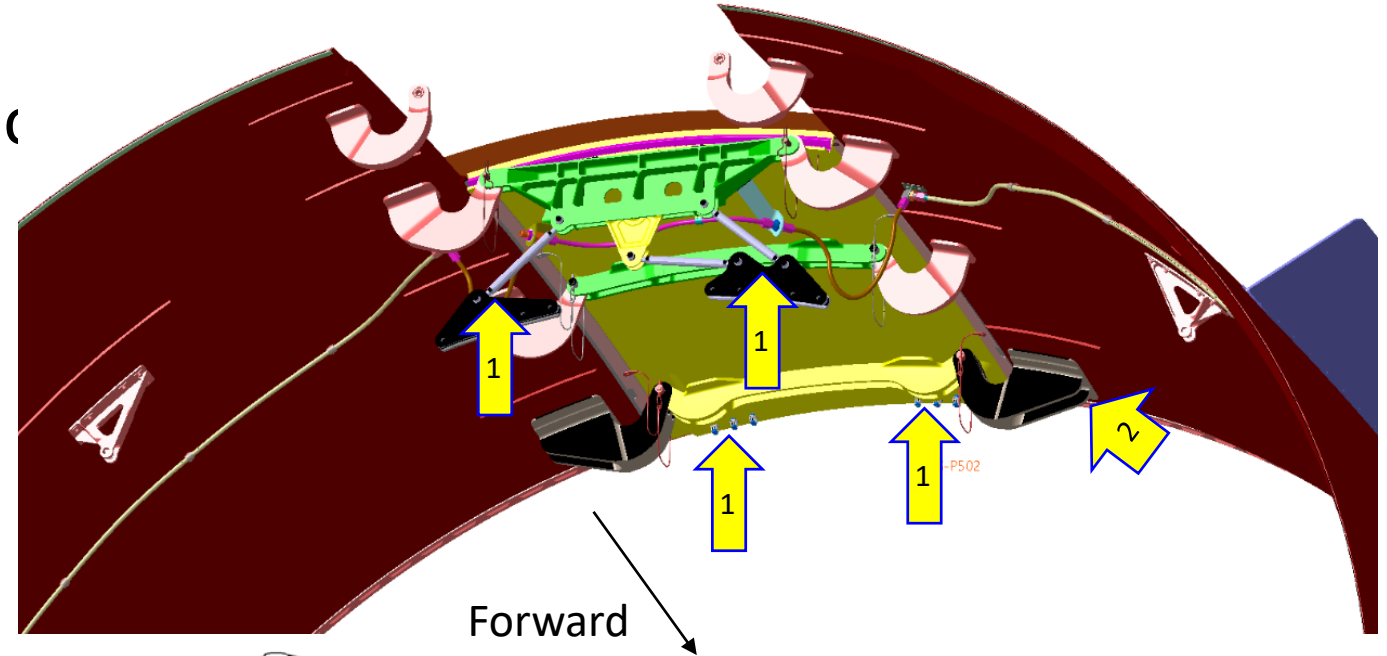
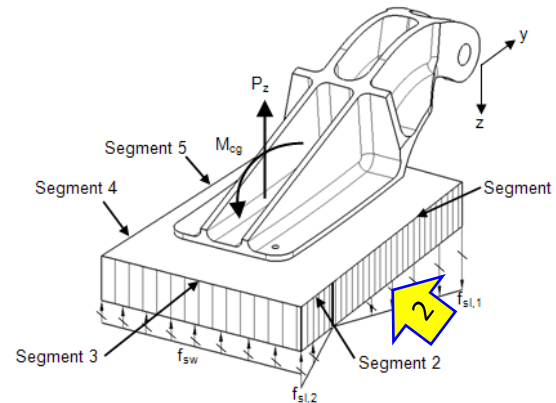
- Plausible Fan Cowl Failure Sequence Consistent with Analysis Simulation and Hardware Observation

| | | <u>time (sec)</u> |
|---|---|---|
| | Imbalance loads | <0.03 |
| | Low density core failure (moisture ingress) | <0.50 |
| | Majority of fan cowl departs | <1.00 |

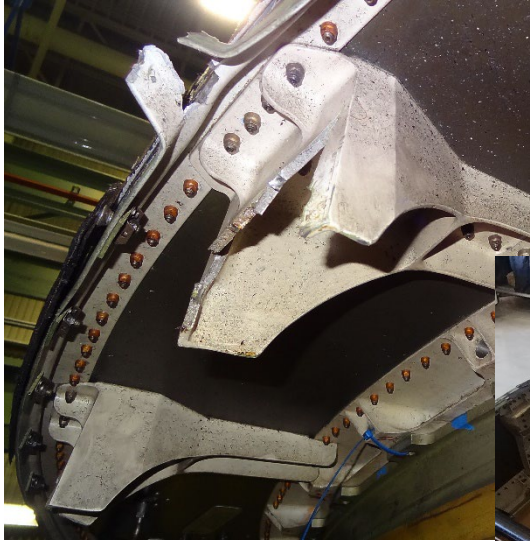
Fan Cowl Support Beam Fitting Attached to Inlet Aft Bulkhead

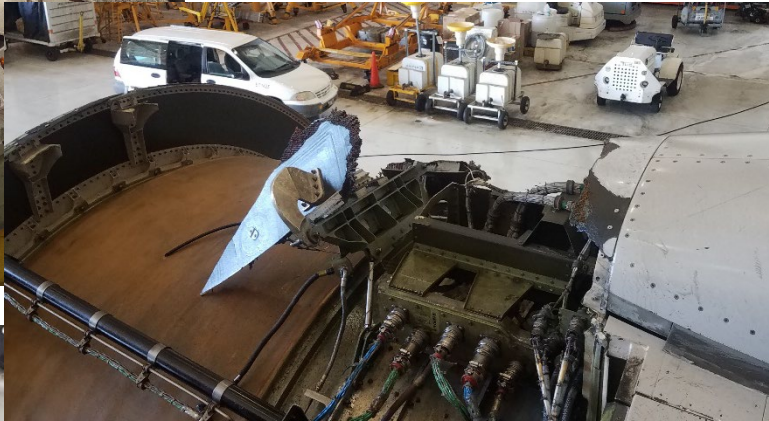
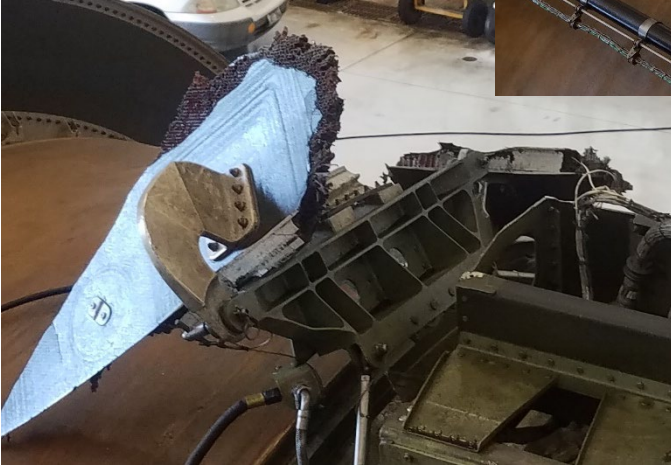
Fan Cowl Support Beam Fitting Attached to Fan Case

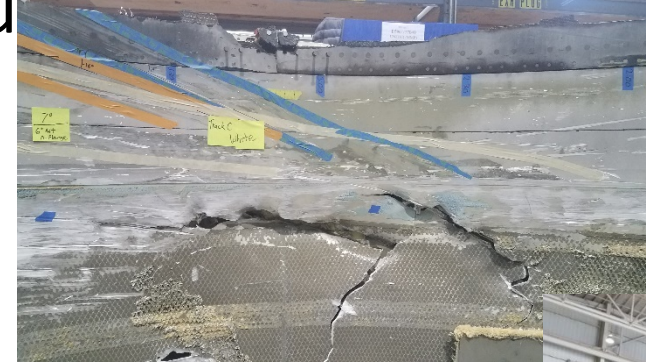
Fan Blade Impact Damage and Witness Marks

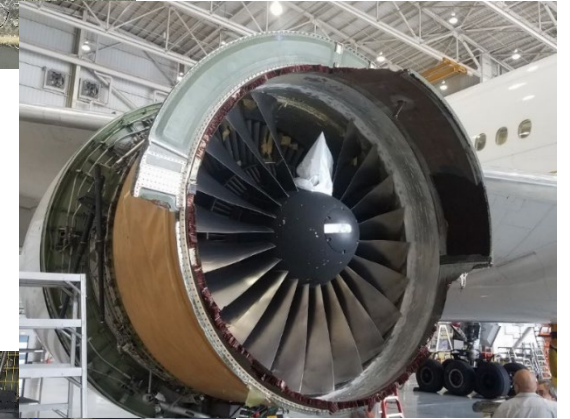
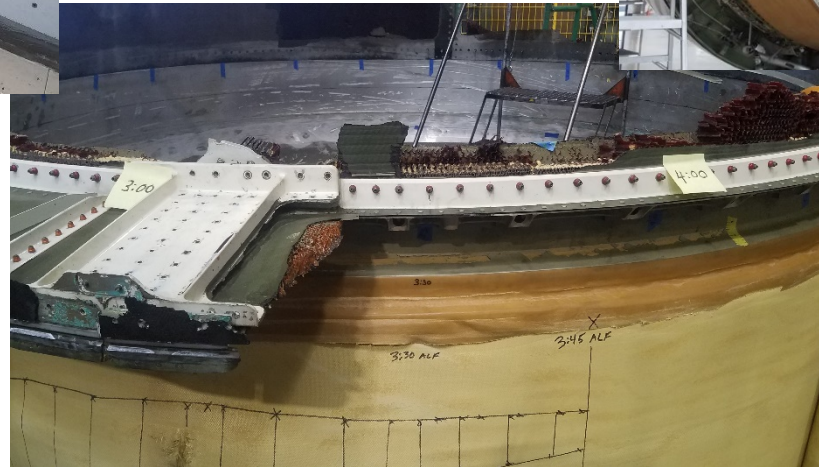
Remaining Portions of Inlet Lower Aft Bulkhead
