**Docket No. SA-542**

**Exhibit No.: 8-B**

CFM Supporting Material  
(13 Pages)

# CFM56-7B Engine

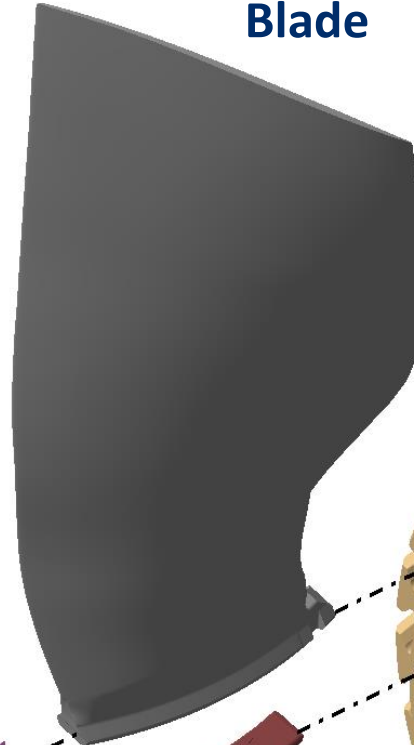
# Fan Blade / Rotor Assembly

Fan Case

Blade

Platform

Disk

Shim

Spacer

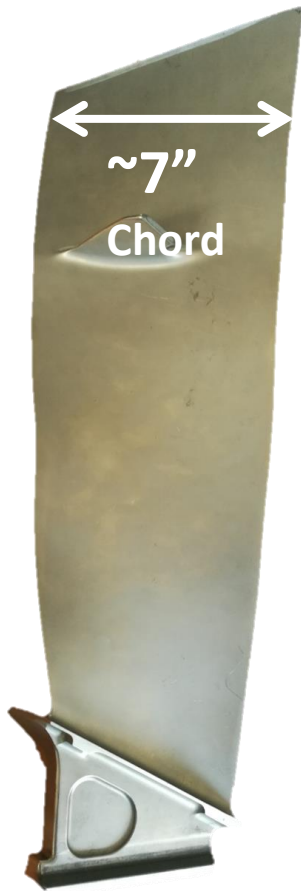
## Narrow Chord

- Improved fuel burn & thrust
- Increased impact capability
- Ease of maintenance

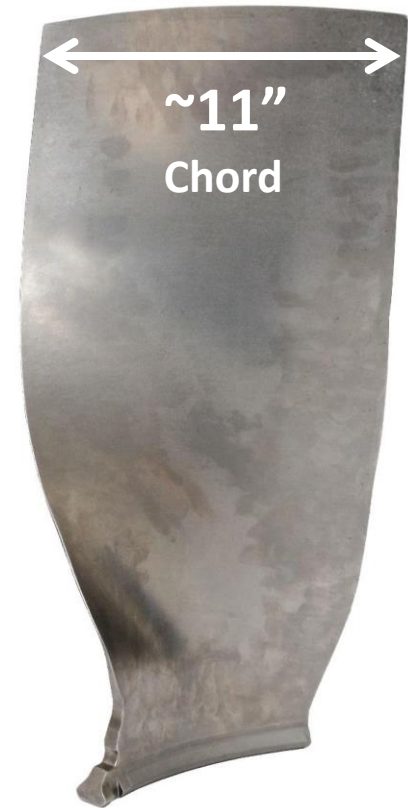
## CFM56-7B Wide Chord

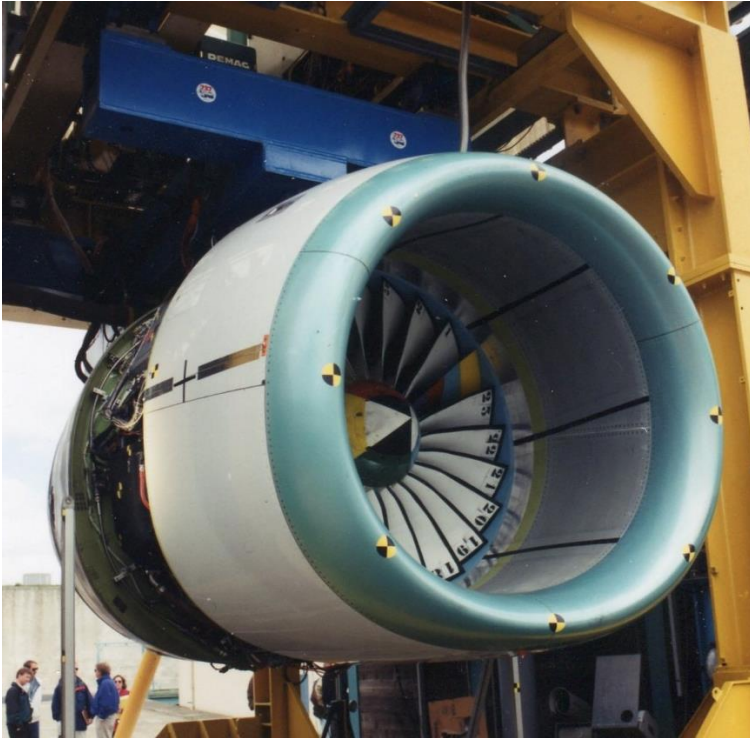
# Fan Blade Out Certification Engine Test

## Test Configuration

- Full engine test
- Certification configuration

## Test conditions

- Engine drives fan
- Run at maximum speed

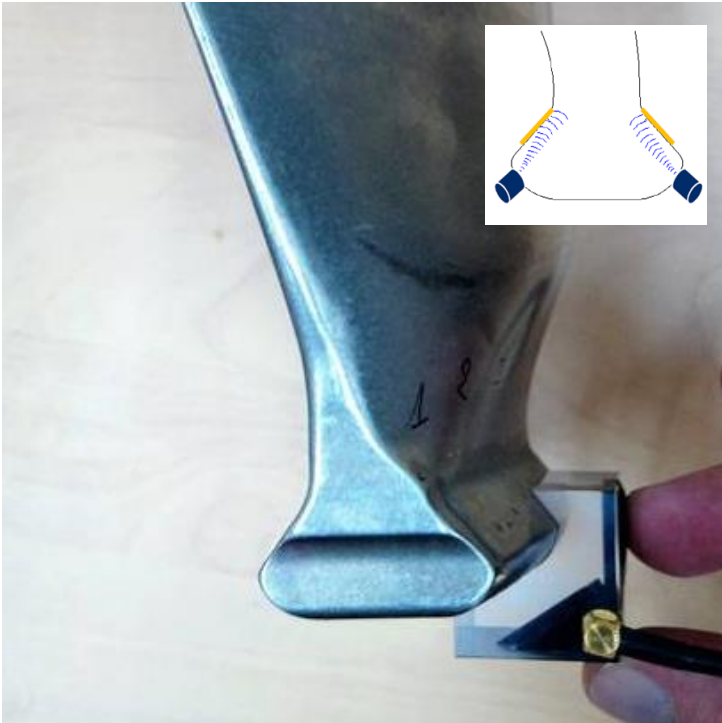
## Ultrasonic (UTI)

- Inspected in field
- Blade with coating

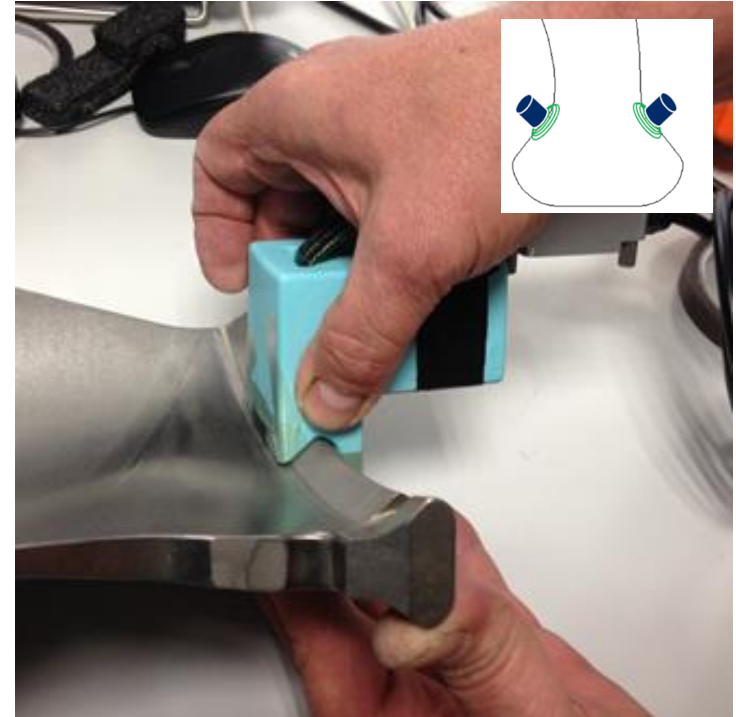
## Eddy Current (ECI)

- Inspected in repair facility
- Blade without coating

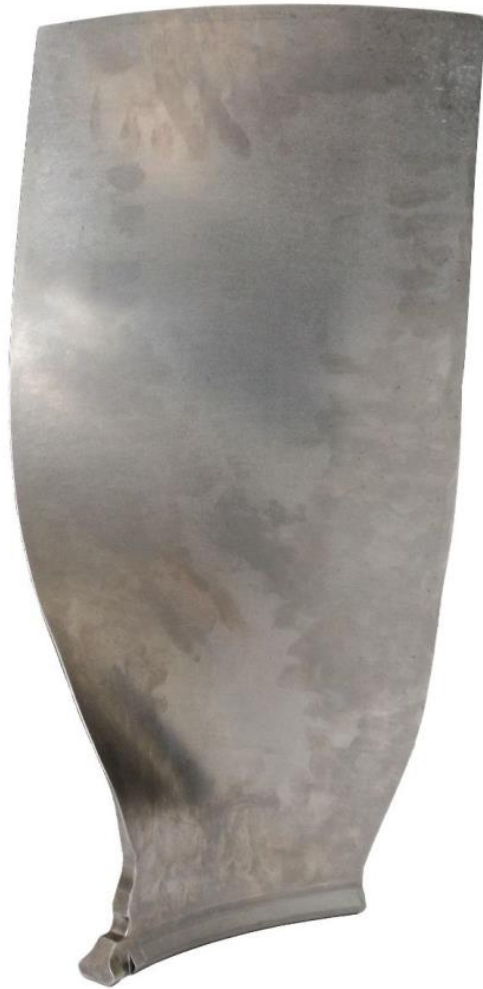
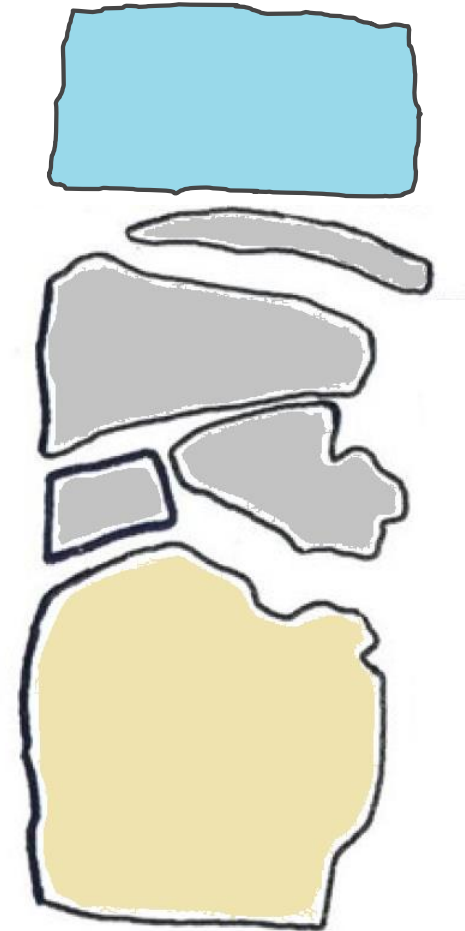
# Fan Blade After FBO Event

**TIP PANEL**

**MID-SPAN  
FRAGMENTS**

**ROOT  
FRAGMENT**

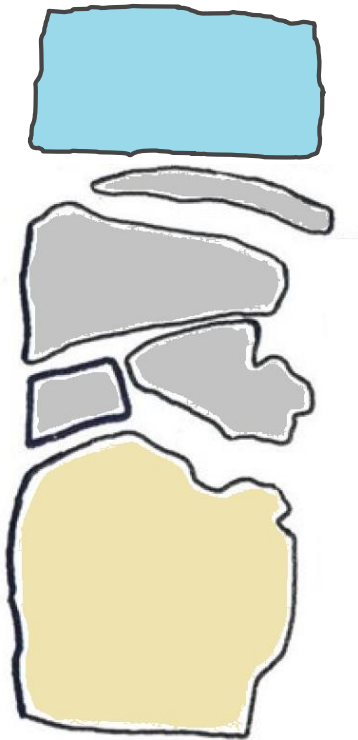
**Certification  
Blade**

# Fan Blade After FBO Event
