**National Transportation Safety Board**  
Office of Research and Engineering  
Washington, D.C. 20594

## Airplane Performance Study

**Location:** Trinity Bay, Texas  
**Date:** February 23, 2019  
**Time:** 1839 GMT (12:39 pm CST)  
**Airplane:** Boeing 767-300, N1217A  
**NTSB Number:** DCA19MA086

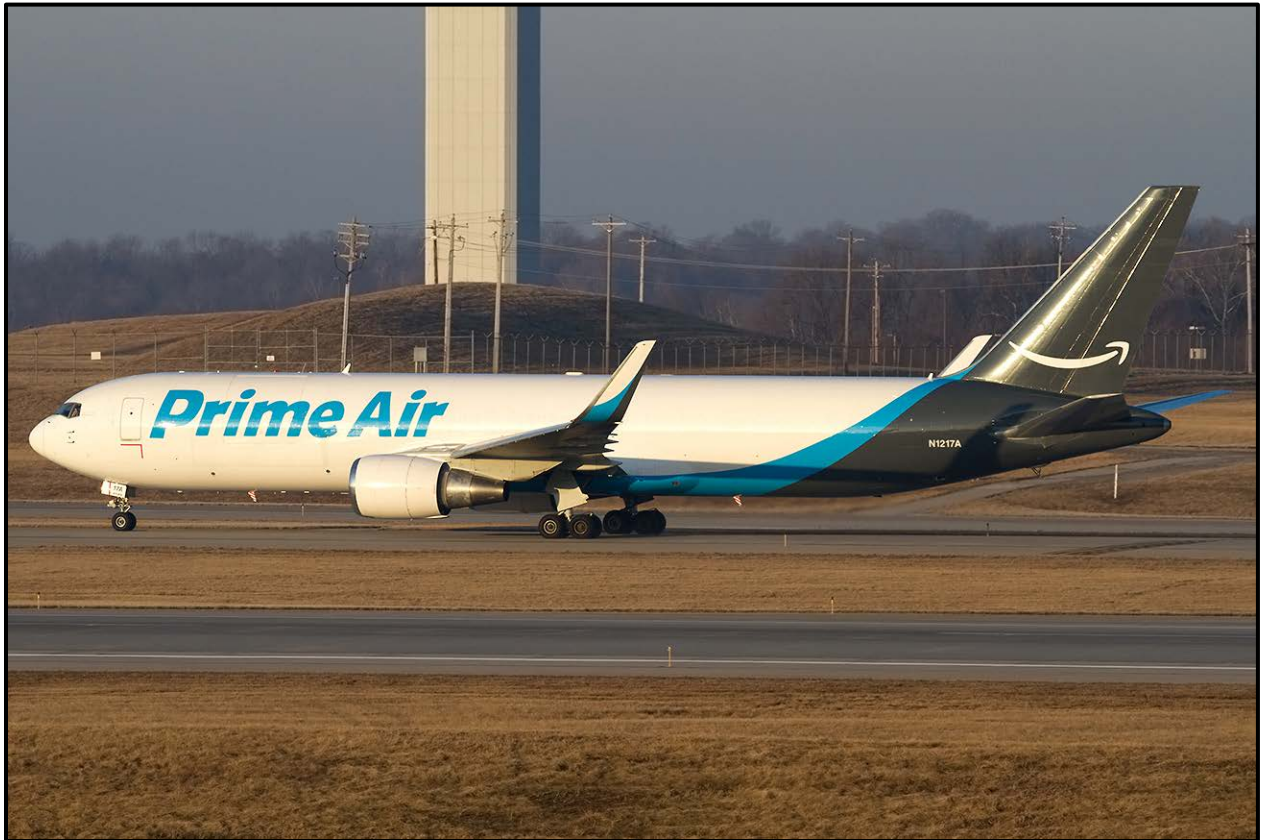
**Figure 1: Accident Airplane, N1217A, a Boeing 767-300**

A picture of the accident airplane, a Boeing 767-300, is shown in Figure 1. The airplane was manufactured by Boeing in 1992 and was registered to Andromeda Leasing, LLC.

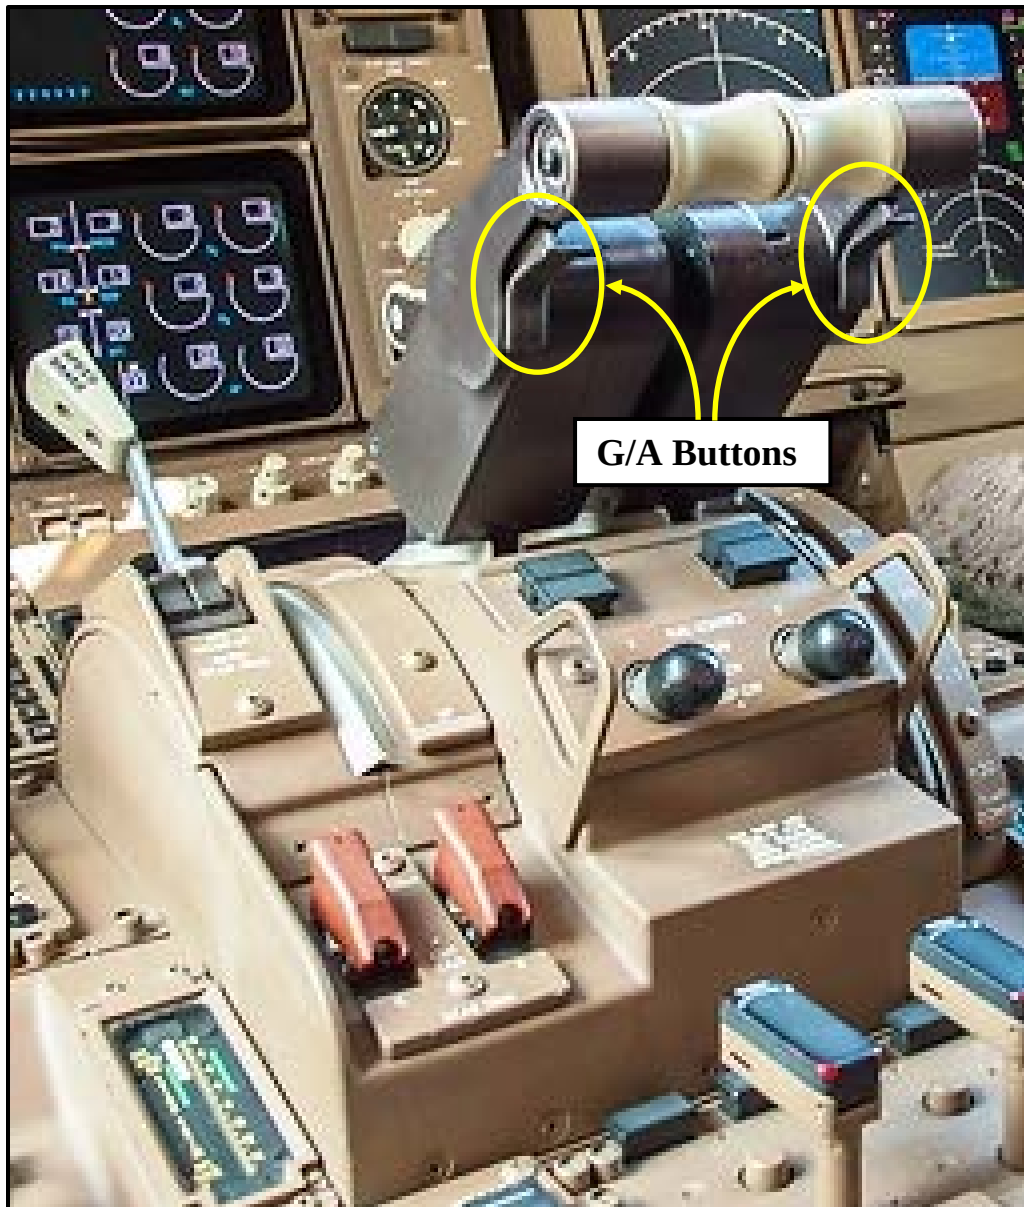
**Figure 4: Representative B-767 Throttle Quadrant with G/A Buttons**

Figure 3 highlights the descent during the last two minutes of the flight with select paraphrased CVR comments overlaid. The descent appears normal until about 1238:31 and approximately 6,300 ft pressure altitude when the go-around mode was activated using one of the Go-around (G/A) buttons on the throttle quadrant: see Figure 4. There was no mention of initiating a go-around by the flight crew on the cockpit voice recorder (CVR), and flight 3591 had been cleared to descend to 3,000 ft. (The normal load factor,  $a_n$ , in Figure 6 shows that the airplane
