# National Transportation Safety Board

DCA22FA082

## **ELECTRONIC DEVICES**

Location: Jolon, CA  
Date: February 16, 2022  
Time: 09:58 pacific standard time (PST)  
UAS: Joby Aero Inc. JAS4-2, N542AJ

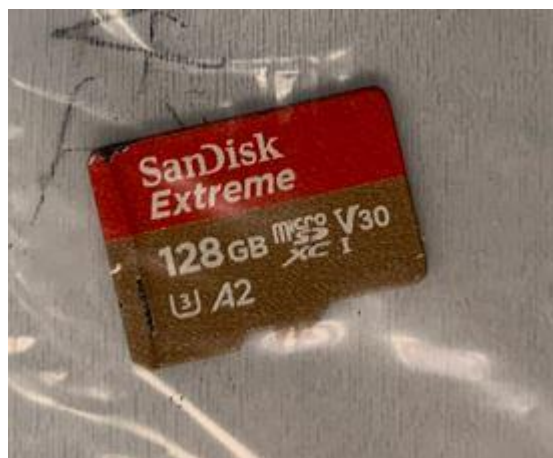
The microSD card from the GoPro HERO is pictured in figure 1. The device appeared intact, with evidence of some slight external physical damage. The device was examined under a digital stereo microscope for cracks and other signs of damage. Only areas of nominal wear and small portions of abrasive damage in the edge areas of the package were detected with the visual inspection. The device was attempted to be readout with a forensic write blocker and failed to mount. The device was then re-examined using an x-ray machine. The x-ray examination produced no obvious defects, however, x-rays are typically ineffective at showing damage to the memory's internal silicon die.

**Figure 1.** Photo of microSD card from the GoPro HERO camera, as received.

The microSD card was sent to a third-party lab for subsequent evaluation. The third-party lab reported back that they were unable to recover data.

No data was recovered from this device.

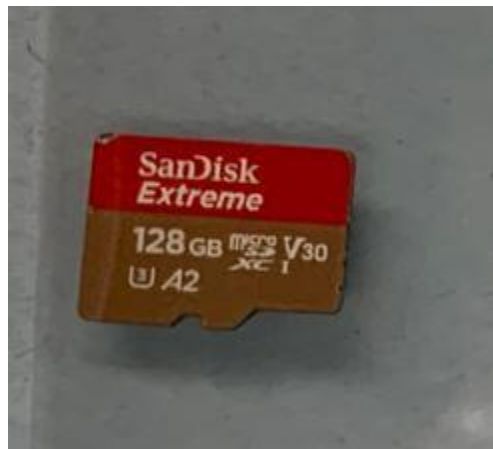
The microSD card from the GoPro HERO MAX is pictured in figure 2. The device appeared intact, with evidence of some slight external physical damage. The device was examined under a digital stereomicroscope for cracks and other signs of damage. Only areas of nominal wear and small portions of abrasive damage in the edge areas of the package were detected with the visual inspection. The device was read out with a forensic write blocker and the memory was successfully accessed. The memory contained a number of image recordings consistent with capturing flight test operations. The last file present on the card was corrupted and unplayable. The NTSB lab employed a software process used for corrupted file recovery and was able to copy and play back the file successfully. The camera manufacturer's supplied software was used to facilitate playback, and screen captures were generated for use in the investigation and this report. The repaired file was provided to Joby Aero Inc for further analysis and use in the generation of their party submission.

**Figure 2.** Photo of microSD card from the GoPro HERO MAX camera, as received.
