# National Transportation Safety Board

DCA23LA096

## **SURVIVAL FACTORS**

Specialist's Factual Report

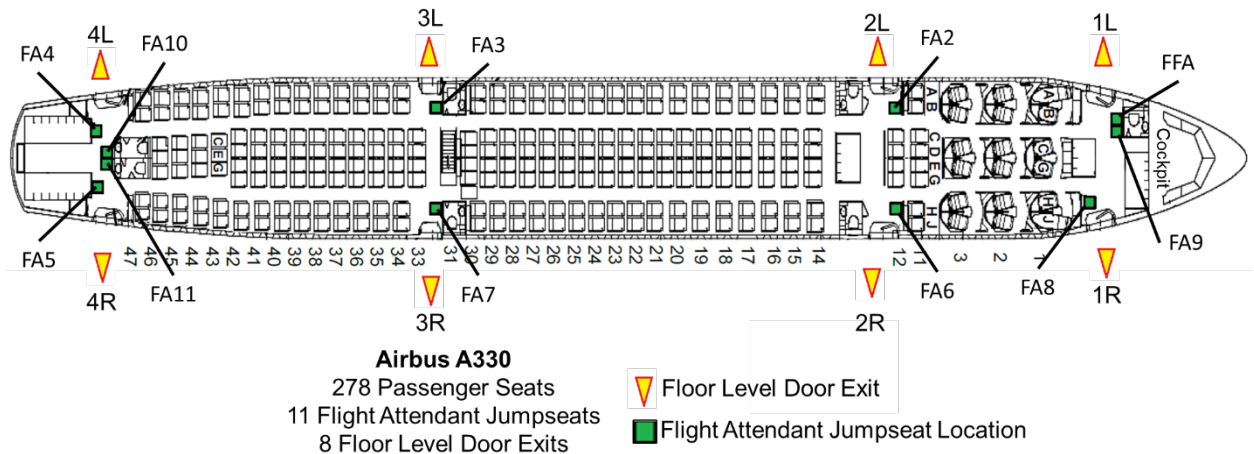
The airplane was equipped with 278 passenger seats, two pilot seats and two jumpseats in the cockpit, and 11 flight attendant jumpseats (see figure 1). There were eight floor level Type I emergency exits on the airplane. All occupants entered and exited through the 2L door via jet bridge, according to passenger statements.

**Figure 1** Interior configuration of N393HA.

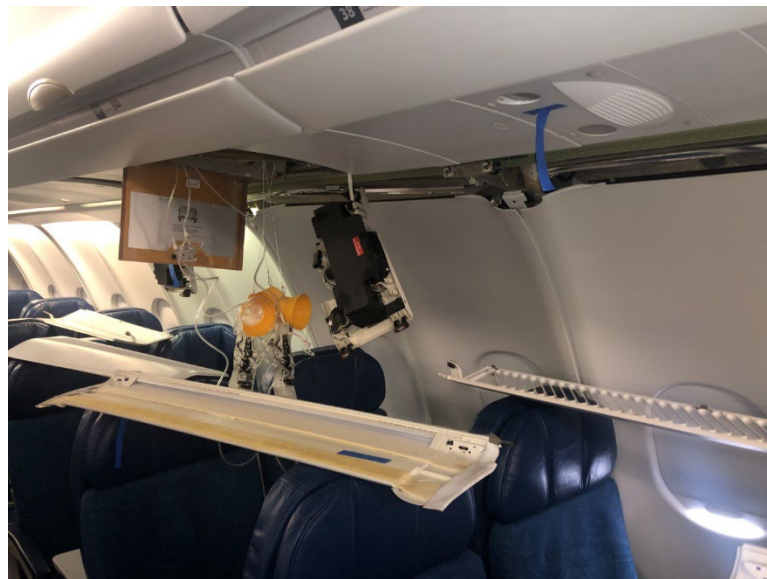
Damage occurred throughout the cabin area including passenger service units, ceiling panels, overhead bin components, light panels, exit signs, and the 4L flight attendant handset (see figures 2 to 5).

**Figure 2.** A passenger service unit in row 39 that fell during the turbulence.

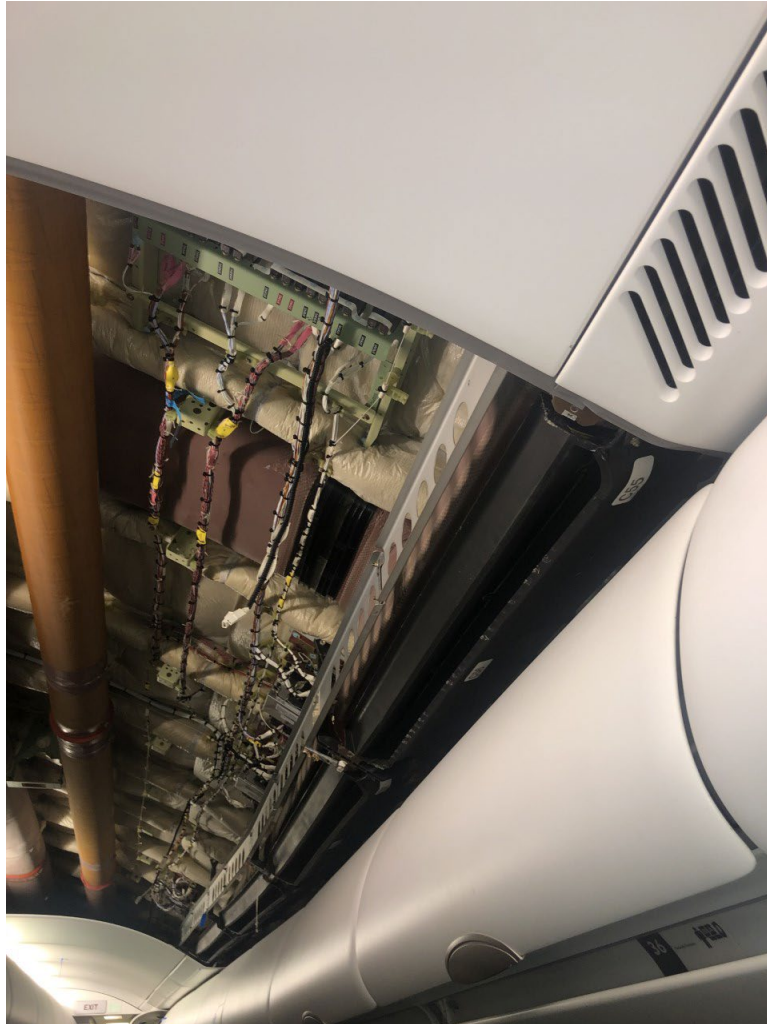
**Figure 3.** Missing ceiling panels near rows 36 through 41.

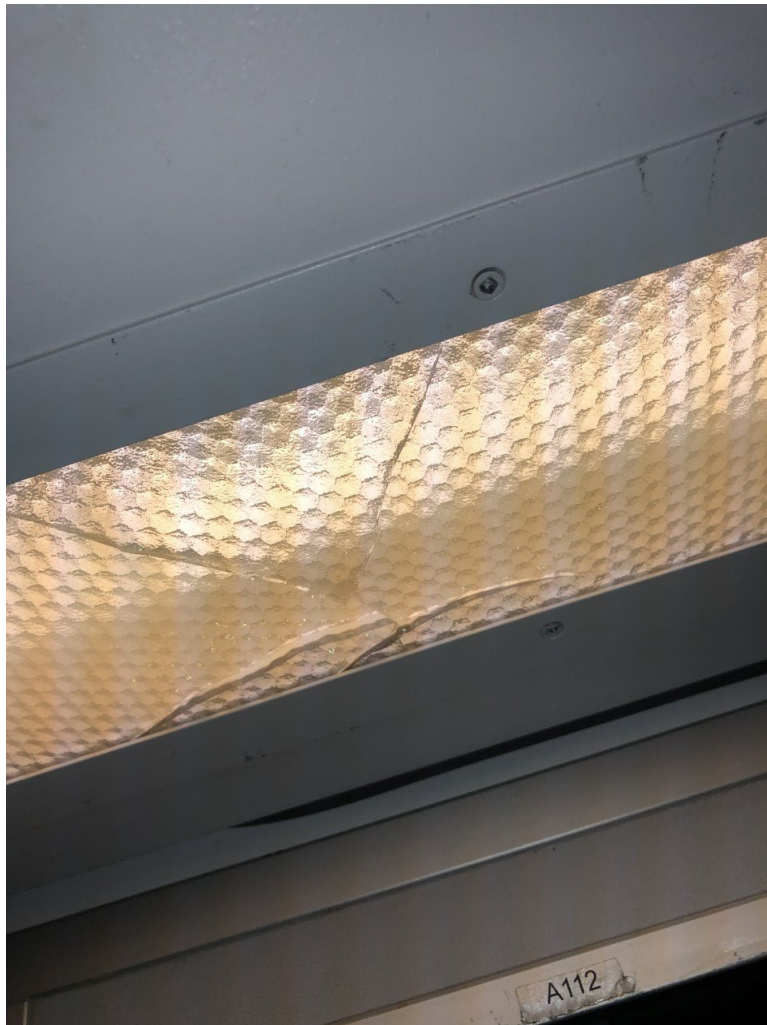
**Figure 4.** Crack in an overhead light in the rear galley area.

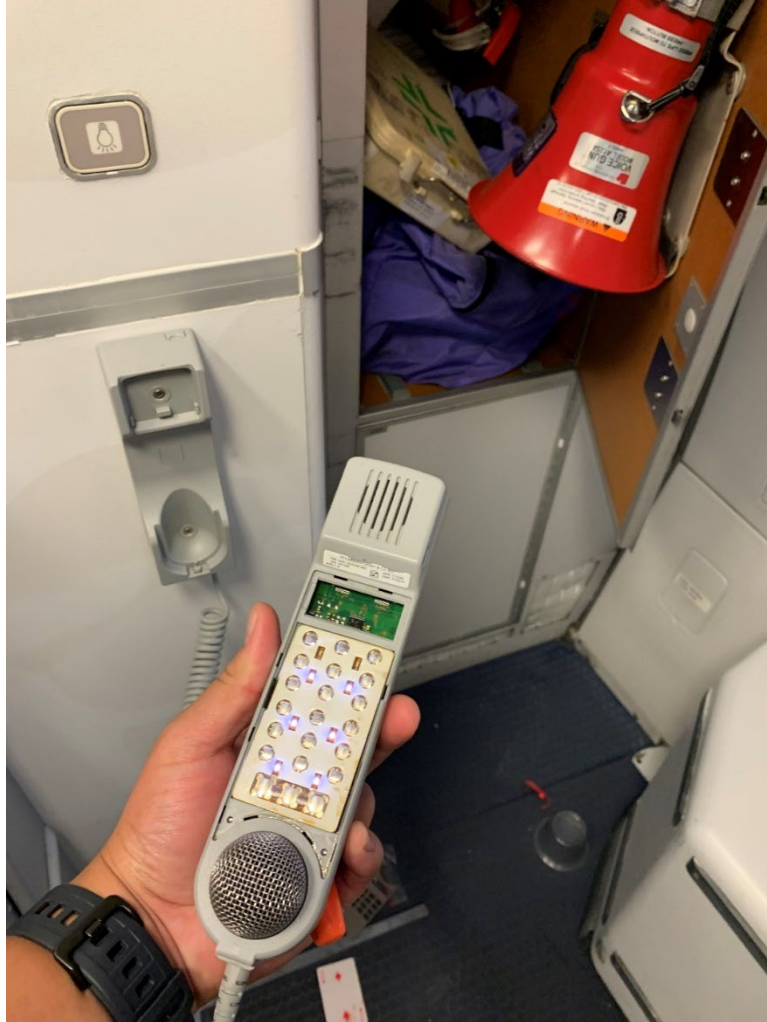
**Figure 5.** Damaged 4L flight attendant handset.

Once the plane had stabilized, passenger 31C crawled back to her seat and was helped by a couple seated next to her to get into the seat and secure herself. FA 5 was also helped into her seat and secured. FA 4 secured herself in her seat at door 4L, however the handset was broken so she unbuckled and crawled to the flight attendant seat by door 4R and secured herself there while using that handset to call for assistance.

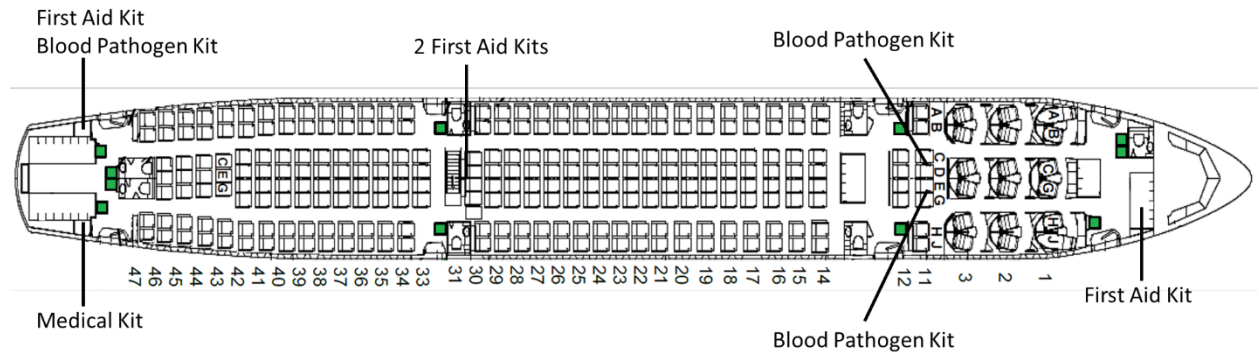
Emergency medical equipment was stowed throughout the cabin (see figure 11).

**Figure 11.** Locations of the first aid kits, blood pathogen kits, and medical kits.

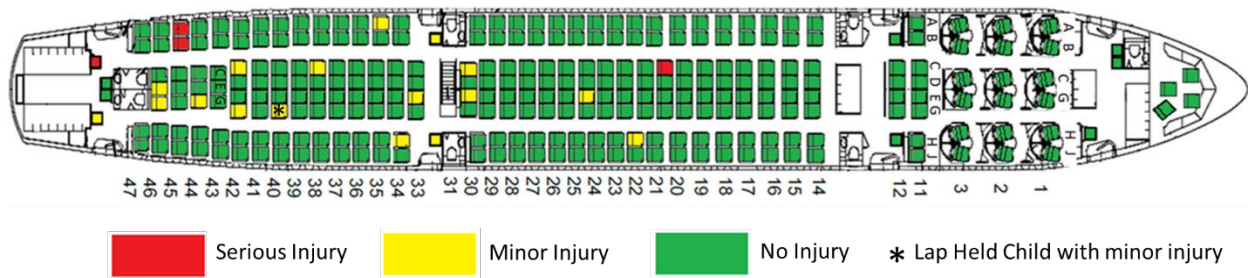
**Figure 12.** Injury level at each seating position.
