# National Transportation Safety Board

DCA23LA179

## **AIR TRAFFIC CONTROL**

Group Chair's Factual Report

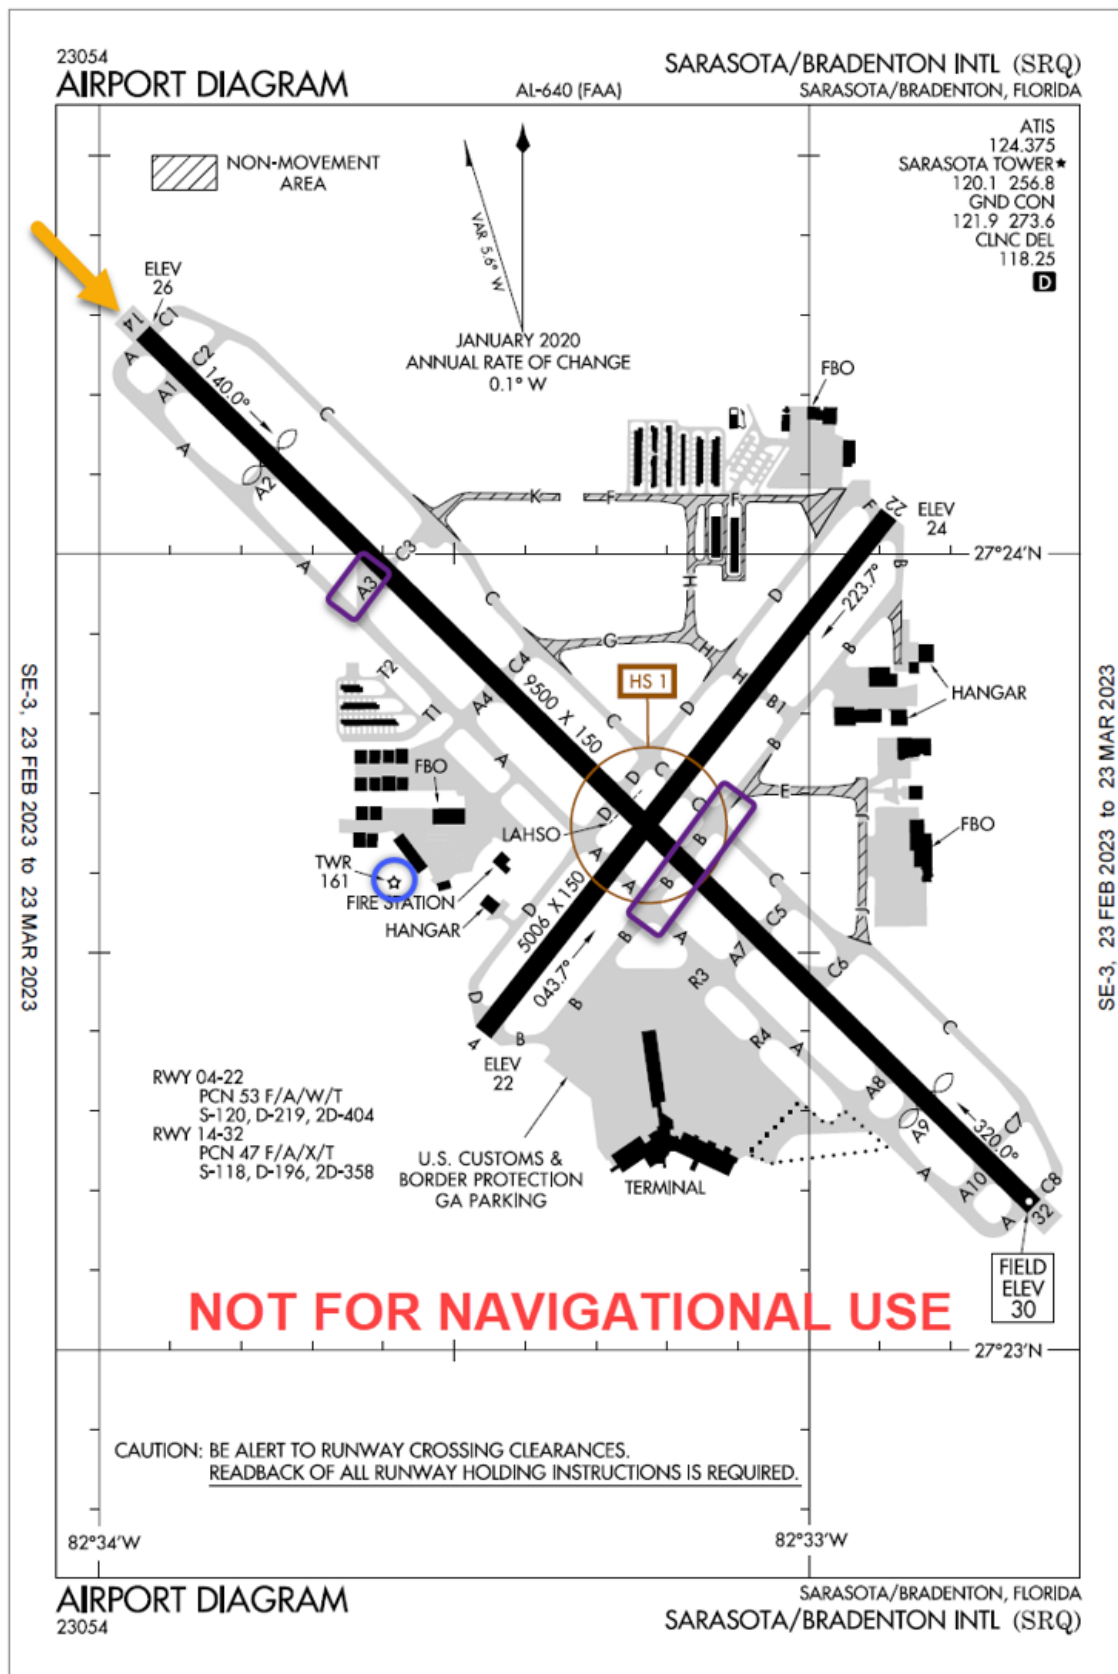
Figure 1. SRQ airport diagram.

Figure 1 is the SRQ airport diagram depicts the location of runway 14 (orange arrow), taxiways Alpha 3 (A3) and Bravo (B) (purple rectangles), and the airport traffic control tower (blue circle). Other inconsequential locations mentioned in the history of flight can be found on the airport diagram but are not emphasized with symbols.

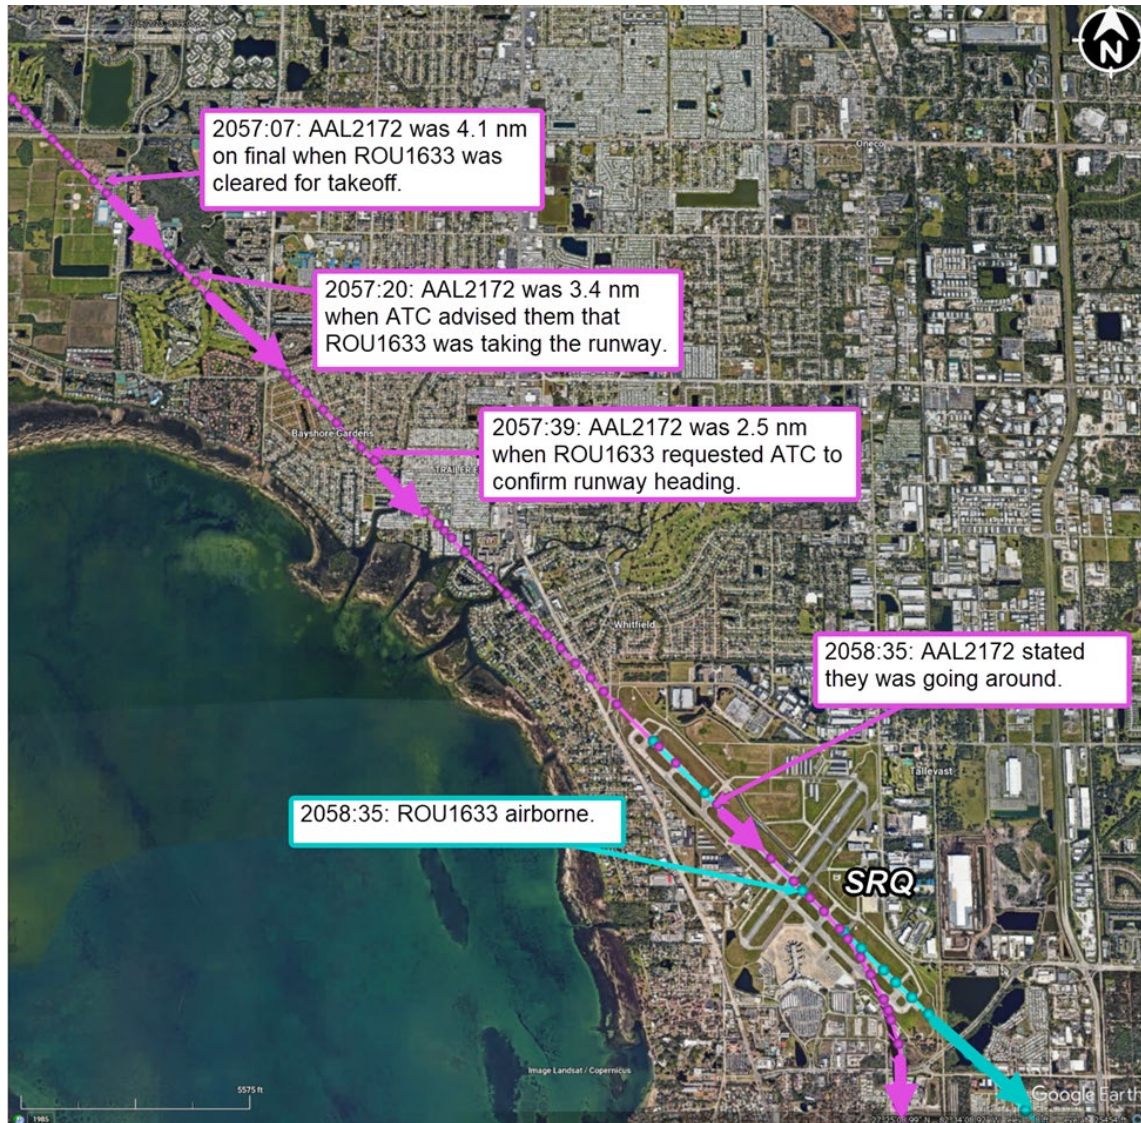
**Figure 2. Graphic depicts the location AAL2172 and ROU1633 during noted times.**

- 2058:35 The crew of AAL2172 stated they he was going around. The LC controller stated roger. ADS-B data indicated that AAL2172 had crossed the threshold of runway 14 and was abeam taxiway Alpha 3 (A3), and ROU1633 was airborne from runway 14 and abeam taxiway B.

Figure 2 is a satellite aerial view graphic depicting the location AAL2172 and ROU1633, for the specific times and locations noted. The graphic was produced by overlaying ADS-B flight track data from AAL2172 and ROU1633 onto satellite imagery in Google Earth. AAL2172's targets and flight track are indicated in magenta, and ROU1633's targets and flight tracks are indicated in cyan. A scale is located in the lower left hand corner of the chart and a compass rose is located in the upper right hand corner of the chart. Arrows associated with the flight tracks indicate the direction of flight. Callout icons contain information about the flight(s). The graphic is a satellite aerial view depicting the location AAL2172 and ROU1633, for the specific times and locations noted in the above timeline.

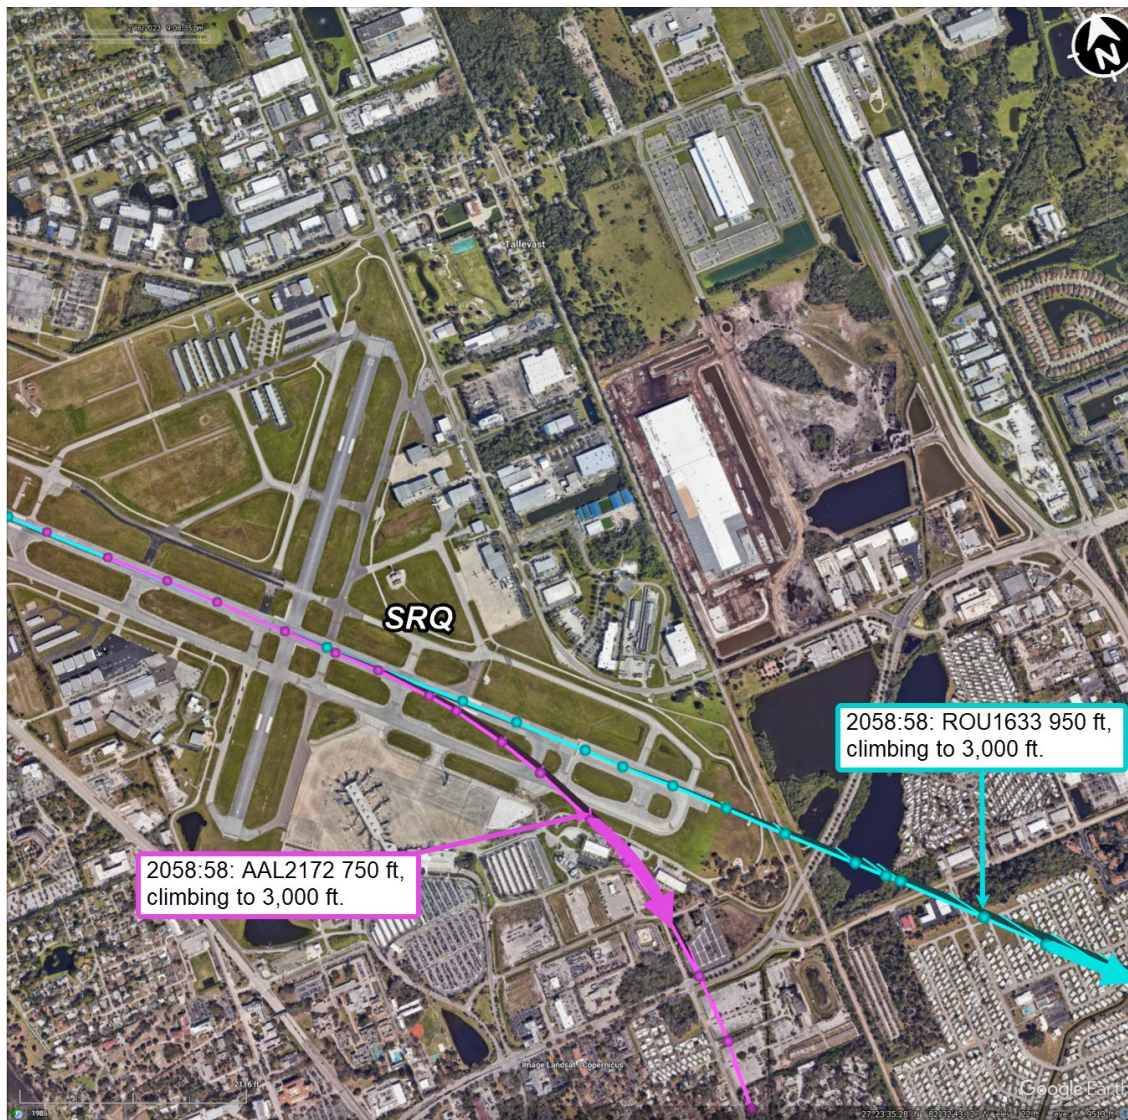
**Figure 3. Graphic depicts the locations of AAL2172 and ROU1633 at 2058:58.**

2058:58 The crew of AAL2172 asked the LC controller if they could get an altitude [to climb]. The LC controller instructed the crew to maintain 3,000 feet<sup>6</sup>. The crew readback the altitude. ADS-B data indicated that AAL2172 had

been on a 154 degree heading and turning right at 750 feet and climbing to 3,000 feet, and ROU1633 had been on a 270 degree heading at 950 feet and climbing to 3,000 feet.

Figure 3 is a satellite aerial view graphic depicting the location AAL2172 and ROU1633 at 2058:58, when both airplanes were turning and climbing for separation. The graphic was produced by overlaying ADS-B flight track data from AAL2172 and ROU1633 onto satellite imagery in Google Earth. AAL2172's targets and flight track are indicated in magenta, and ROU1633's targets and flight tracks are indicated in cyan. A scale is located in the lower left hand corner of the chart and a compass rose is located in the upper right hand corner of the chart. Arrows associated with the flight tracks indicate the direction of flight. Callout icons contain information about the flight(s).

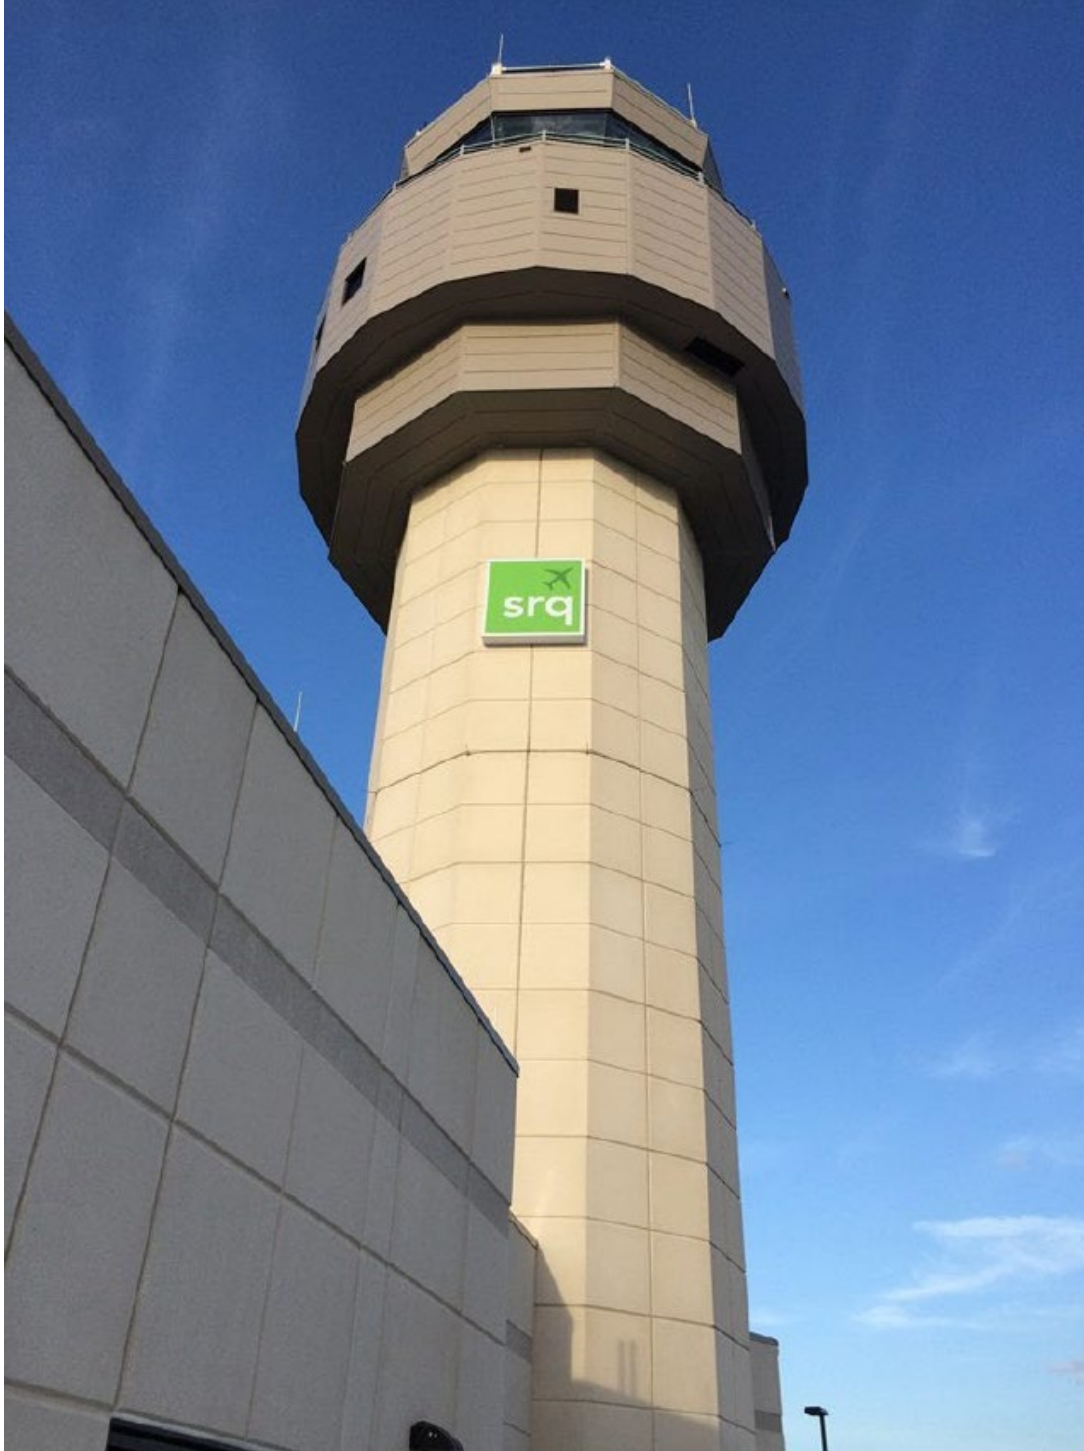
**Figure 5. Photo of SRQ ATCT. Photo credit: Unknown.**

SRQ ATCT operating hours were 0600 to midnight, 7 days a week. The FAA control tower was located on the west side of the airfield near the runways intersection and was 128 feet tall.

The design was a standard FAA low activity level tower with a 525 square foot (SF) control cab and a 9,000 SF administrative base building. The 10-sided polygon tower was integrated with the control cab.

For maximum visibility, the control cab had been designed to incorporate only four columns and used a butt-glazed cab window system. Insulated structural precast concrete panels were designed with interlocking edges to help ensure wind-driven rain would be kept out of the building during a major storm or hurricane.

Figure 5 is a photo of the SRQ airport traffic control tower.

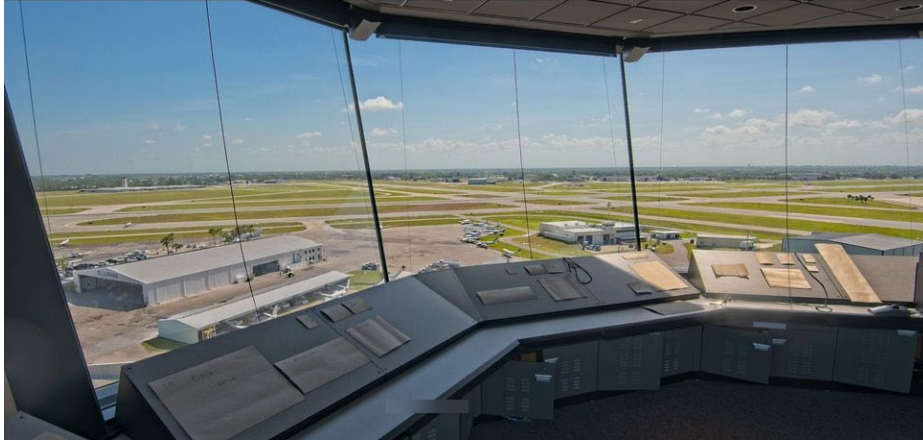
**Figure 6. Photo of the inside of the SRQ control tower. Photo Credit: Unknown.**

Figure 6 is a photo of the inside of the SRQ control tower during construction. The photo provides a view of the runways and taxiways from the control tower.

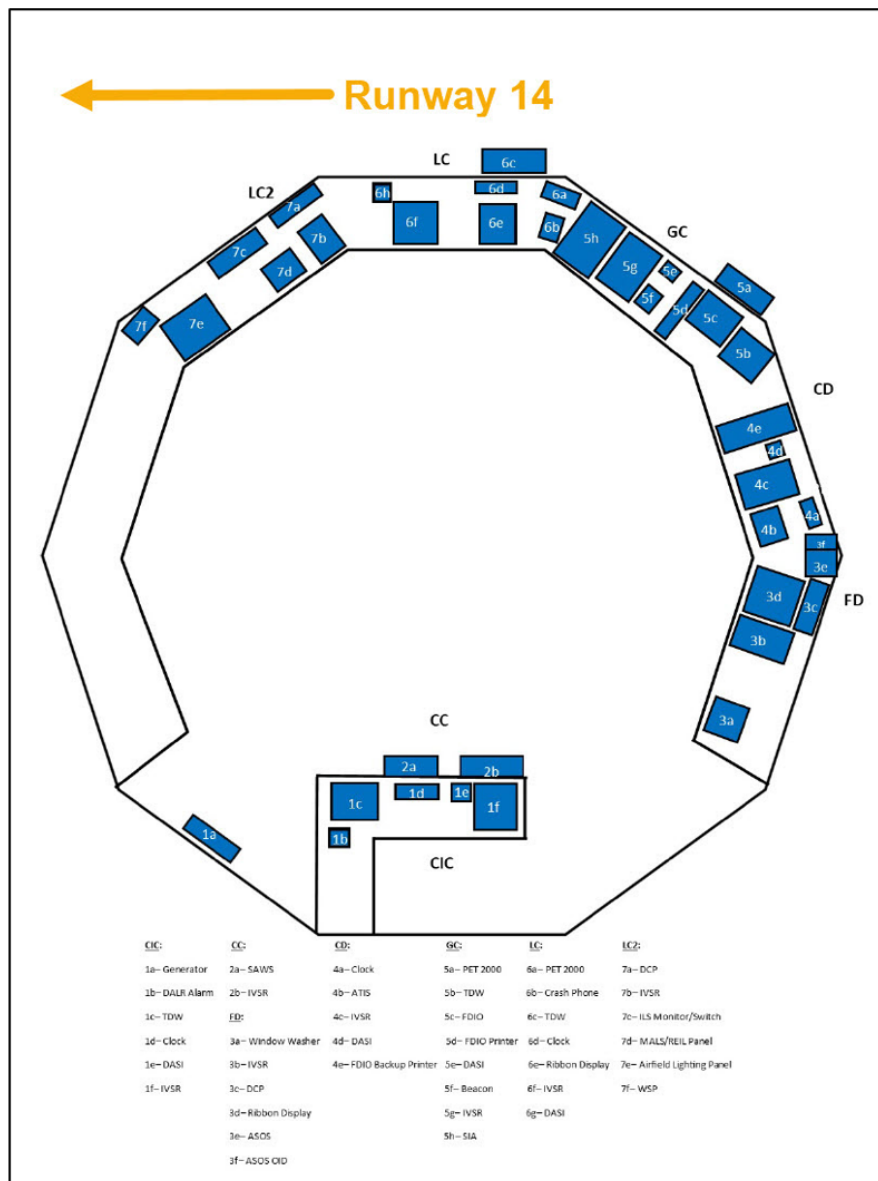
**Figure 7. Tower cab layout depicts the location of the workstations.**

Figure 7 is the tower cab layout depicting the location of the workstations.

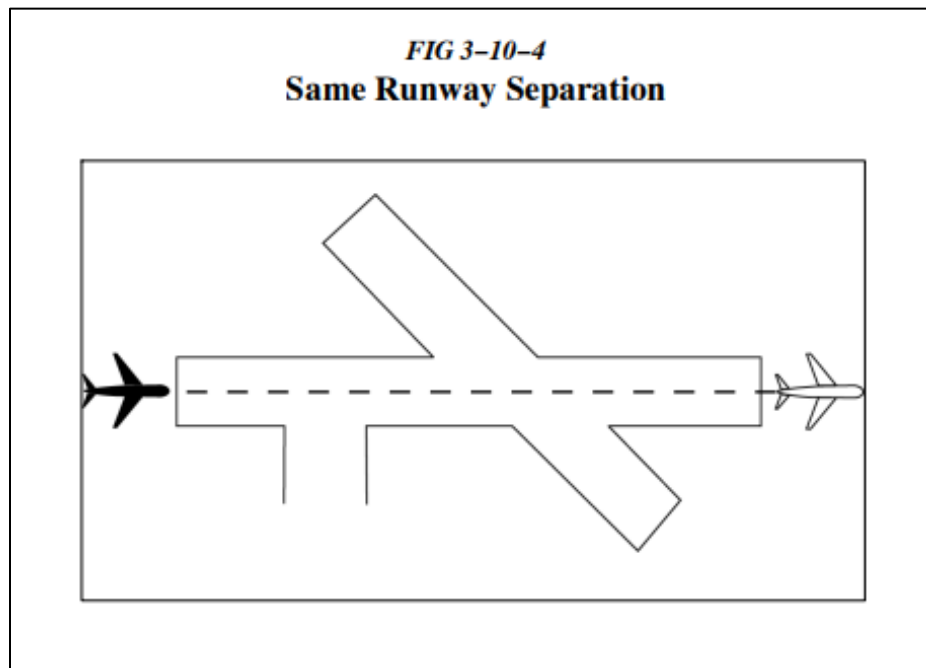
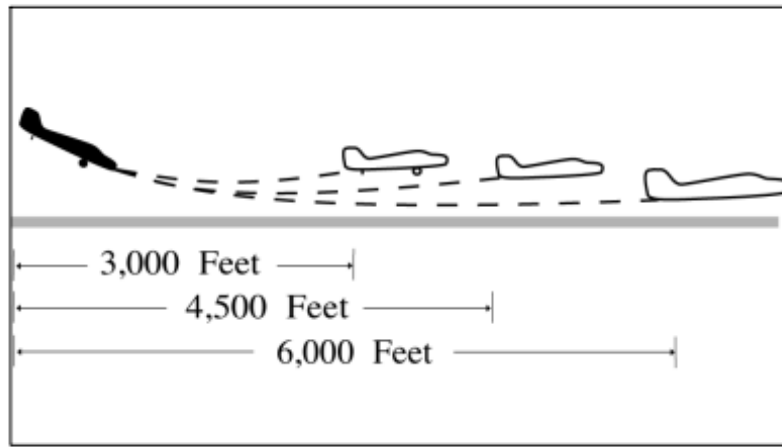
**FIG 3-10-5**  
**Same Runway Separation**

- a. *Separate an arriving aircraft from another aircraft using the same runway by ensuring that the arriving aircraft does not cross the landing threshold until one of the following conditions exists or unless authorized in paragraph 3-10-10, Altitude Restricted Low Approach.*
2. *The other aircraft has departed and crossed the runway end. (See FIG 3-10-4). If you can determine distances by reference to suitable landmarks and the other aircraft is airborne, it need not have crossed the runway end if the following minimum distance from the landing threshold exists:*

- (a) *Category I aircraft landing behind Category I or II— 3,000 feet.*
- (b) *Category II aircraft landing behind Category I or II— 4,500 feet.*
- (c) *When either is a category III aircraft—6,000 feet. (See FIG 3-10-5.)*
