# National Transportation Safety Board

DCA24FA017

## **COCKPIT VOICE RECORDER**

Specialist's Factual Report

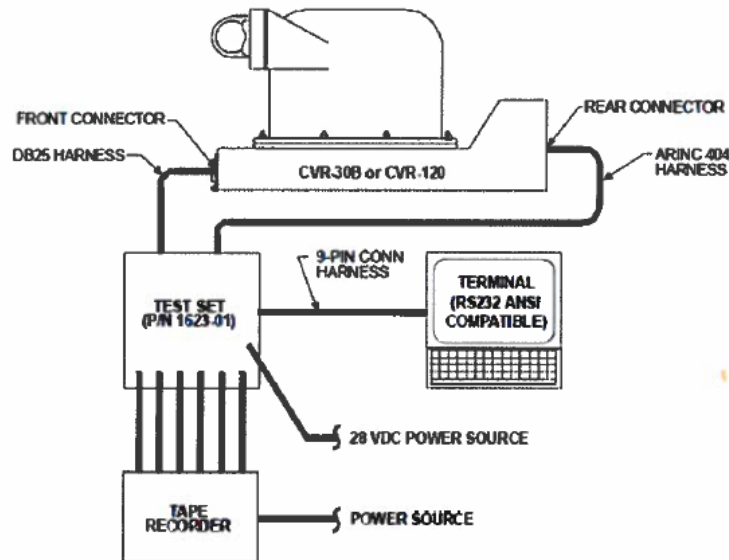
1623-01 Test Set Connections

Test setup diagram:

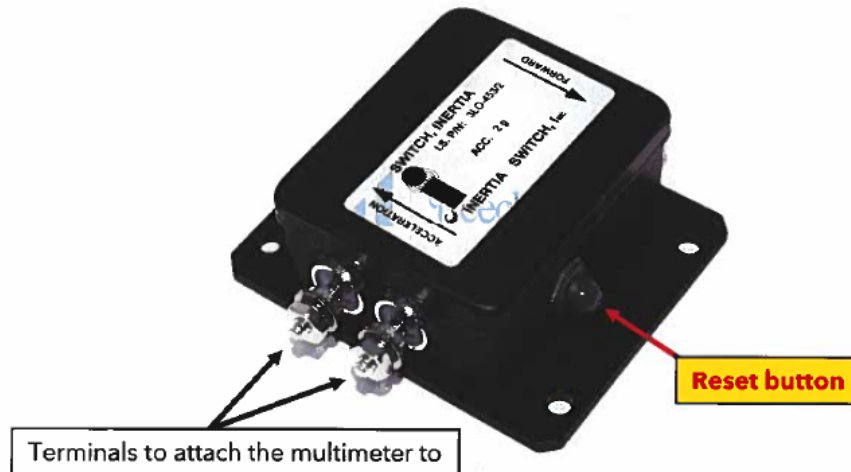
Test setup diagram:

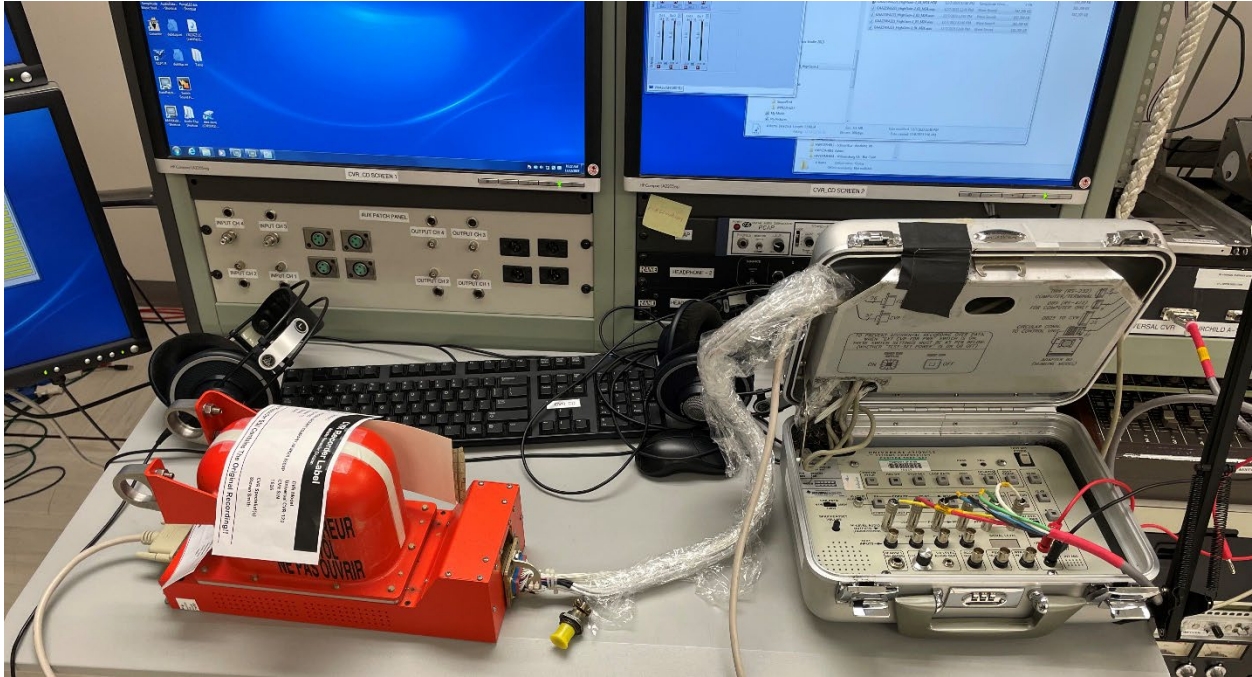
**Figure 1.** Bench Test Setup.

On December 13, 2023, specialists performed bench testing on the Universal CVR (P/N 1603-02-12 and S/N: 1626) at the NTSB Vehicle Recorder's Laboratory in Washington, DC. The bench test consisted of connecting the recorder to Universal Avionics Test Set (P/N: 1623-01 and S/N: 156) and simulating the recorder's self-test feature, as if the recorder was onboard an aircraft. The Universal Avionics Test Set was configured per the manufacturer's procedure and the self-test was conducted. The total test time from setup to completion was 35 minutes. The recorder self-test lasted 5 seconds. The result of the test was a PASS. It was observed that the pass/fail lights did not alternate on the test set. After discussions with the manufacturer, the NTSB determined that the test was successfully conducted with the results showing that the recorder had no malfunctions or faults that would hinder the ability for the recorder to write. The manufacturer dismissed the test set alternating lights as an issue, and said it was possible that the lights were out on the test set. Appendix C presents figures of the bench testing setup and results (figures 1 through 4).

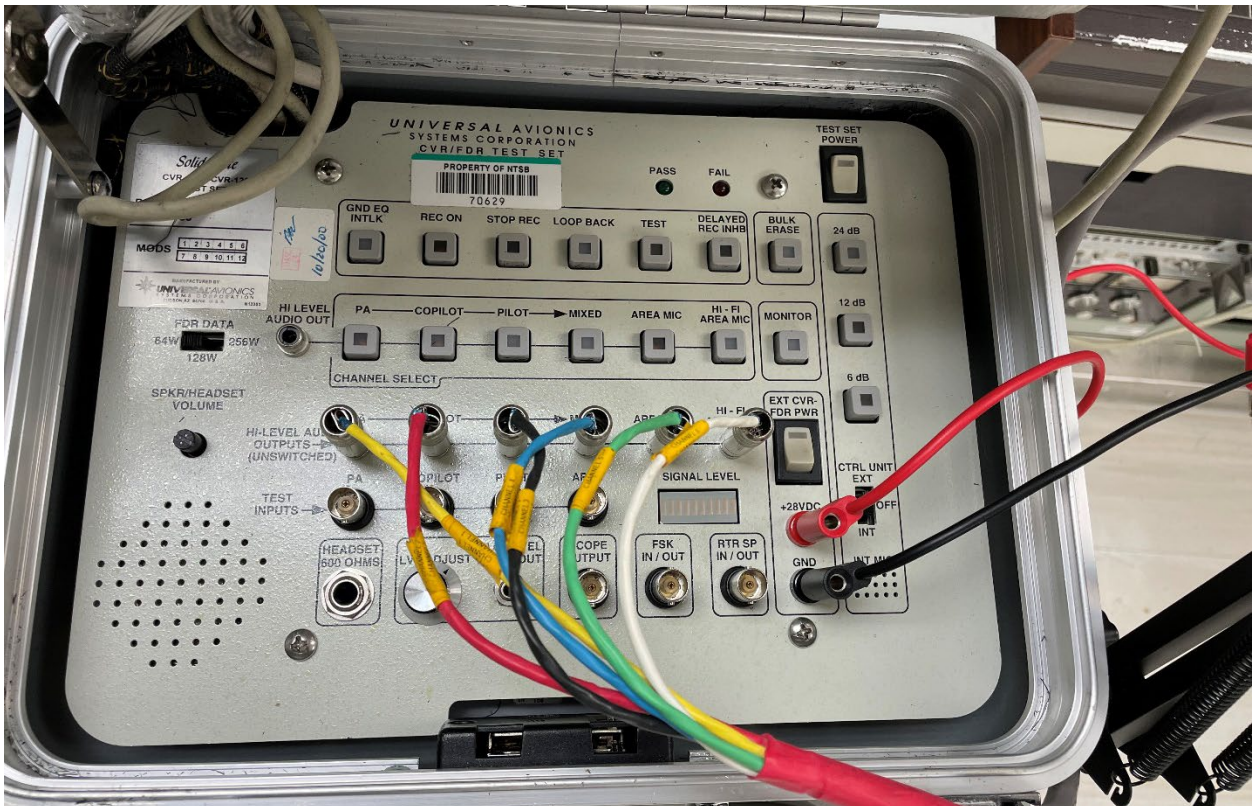
**Figure 2.** Universal Avionics CVR/FDR Test Set P/N: 1623-01 and S/N: 156.

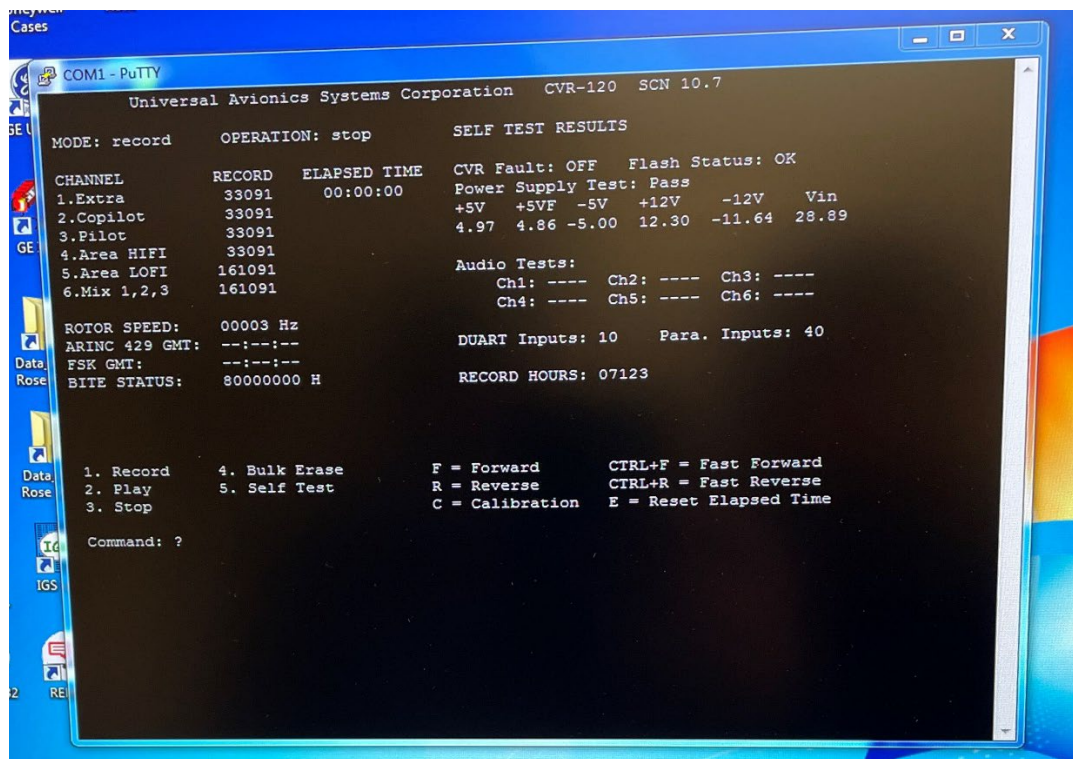
**Figure 3.** Test initialization prompt.

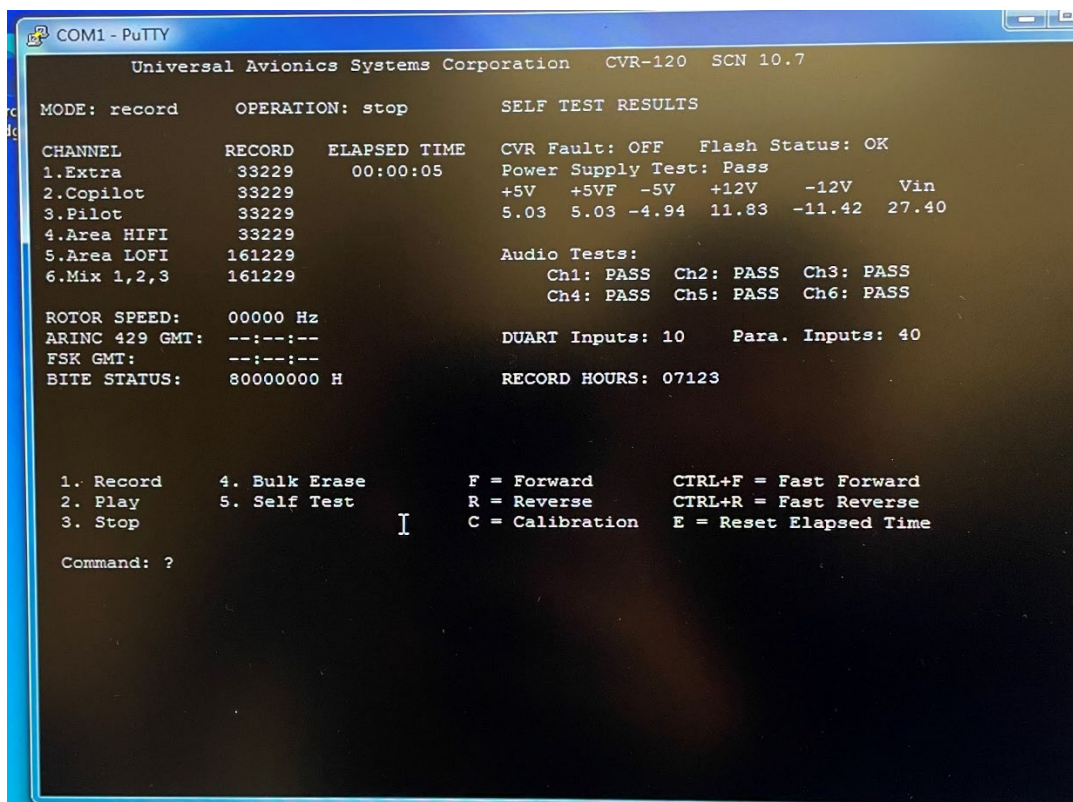
**Figure 4.** CVR bench test results displaying PASS results for all channels.

1. The CVR bench test was a PASS.
2. Noted observations from the bench test were:
  - a. The pass/fail lights did not alternate on the test set,
  - b. Universal Avionics, the manufacturer of the CVR, was contacted in regard to the pass/fail lights not operating on the test set. Based on the messages displayed during the test, it was concluded that a successful bench test was conducted, and

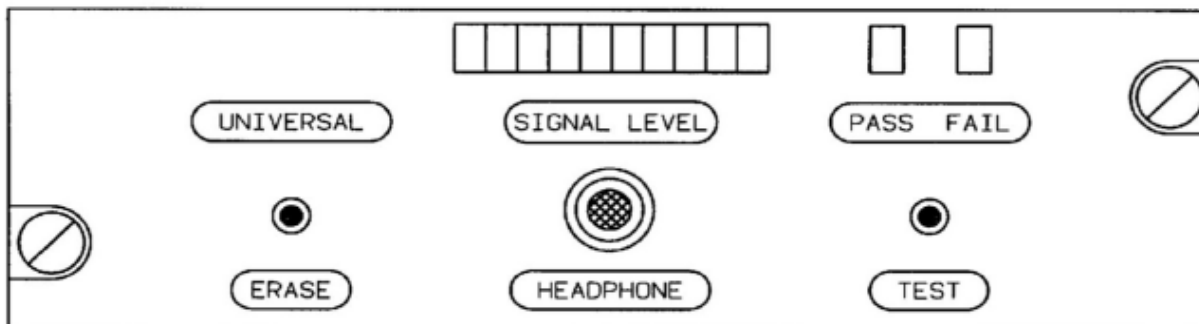
**Figure 5.** Cockpit voice control unit on the control unit.

Cockpit voice control unit buttons explained:

1. **ERASE:** Bulk erasure of the flash memory. May only be done on the ground with the weight on wheels relay made. Erasure button must be held for 5 seconds and will take 10 seconds to complete.
2. **TEST:** CVR self-test feature. The test circuit injects a signal, at a predetermined level, into each of the four record amplifiers alternately. This recording is played back through the monitor amplifier and can be monitored at the headset jack socket.
3. **PASS FAIL:** Will alternate during both the bulk erasure and CVR self-test. Any test result will display either a solid green (PASS) or solid red (FAIL) illumination.
4. **SIGNAL LEVEL:** Measures the audio signals sent to the headphone jack socket.
5. **HEADPHONE:** Headphone jack socket location.

The Hawker 850XP cockpit contains a CVR control unit and is shown in Appendix D, figure 5. The control unit allows pilots and maintenance personnel to perform a self-test of the CVR in order to ensure the CVR is functioning properly and recording audio. According to the operator, this test is to be performed by the crew before every flight during completion of the Before Engine Start checklist. A successful test is indicated by the solid illumination of the green PASS light at the completion of the test.

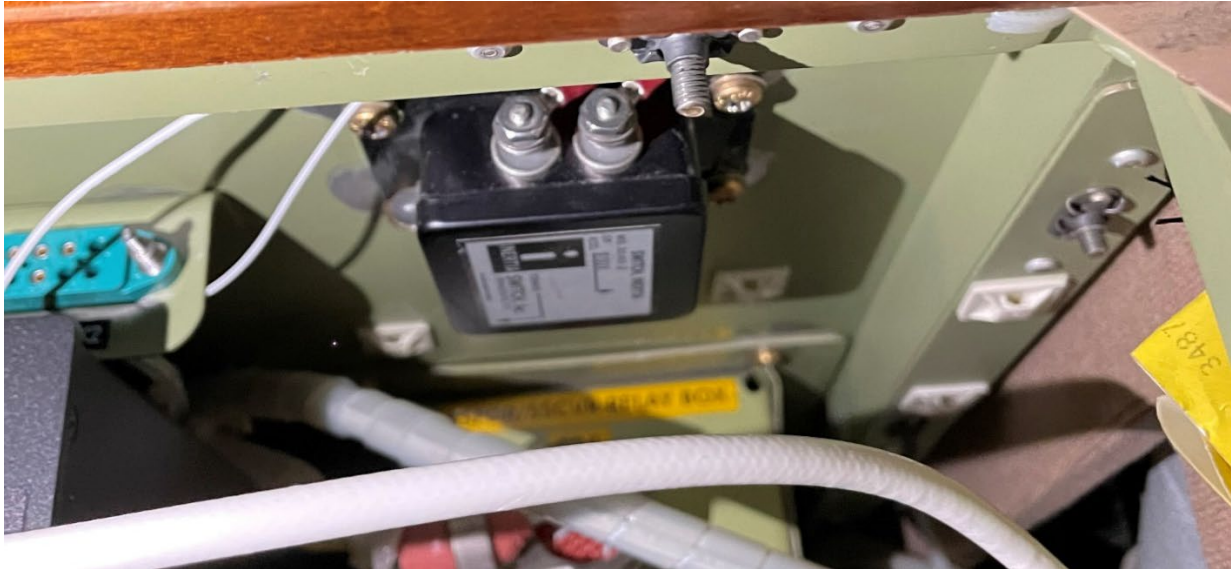
N269AA is equipped with an Inertia Switch Incorporated impact switch, part number 3LO-453/2, which is designed to remove power from the CVR when the aircraft experiences a 2 g longitudinal impact in order to preserve the recording. If the impact switch is tripped during normal flight operations, maintenance operations will manually reset the impact switch, which is located in the aft baggage/radio rack. The impact switch may only be reset at the switch with the aircraft power on. The switch cannot be reset from the cockpit.

**Figure 6.** Impact switch on N269AA located in the aft baggage compartment/radio rack.

On December 19, 2023, testing was performed on the accident airplane, N269AA at Houston William P. Hobby Airport, Houston, Texas. A technical expert and an avionics technician, both from Textron Aviation, were present and witnessed the test. The purpose of the first test was to determine whether the impact switch was open (no power provided to the CVR) or closed (power provided to the CVR). The test showed that the impact switch was tripped and was open, resulting in no power being provided to the CVR.

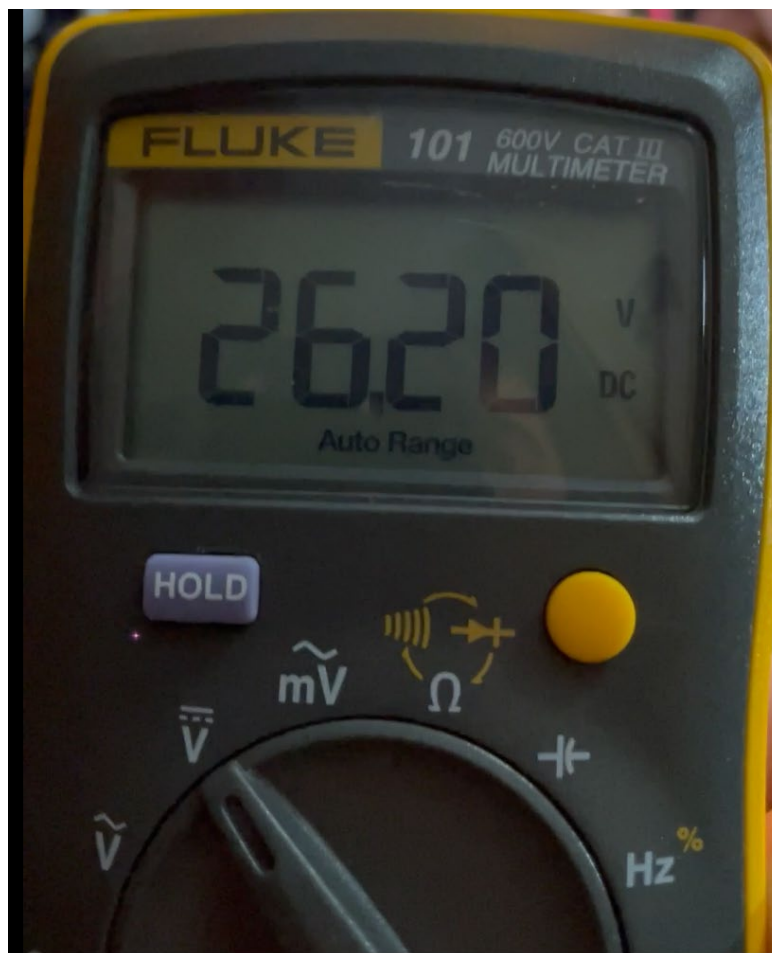
**Figure 7.** DC power indicated at CVR after the impact switch was reset.

The second portion of the test was conducted after powering on the aircraft and pressing the self-test CVR feature on the control unit at the left seat. On the first activation of the CVR self-test, the control unit did not power on. After the self-test failed, the impact switch was manually reset. A click noise was observed and 26.2 VDC was measured at the terminals of the impact switch. A self-test was

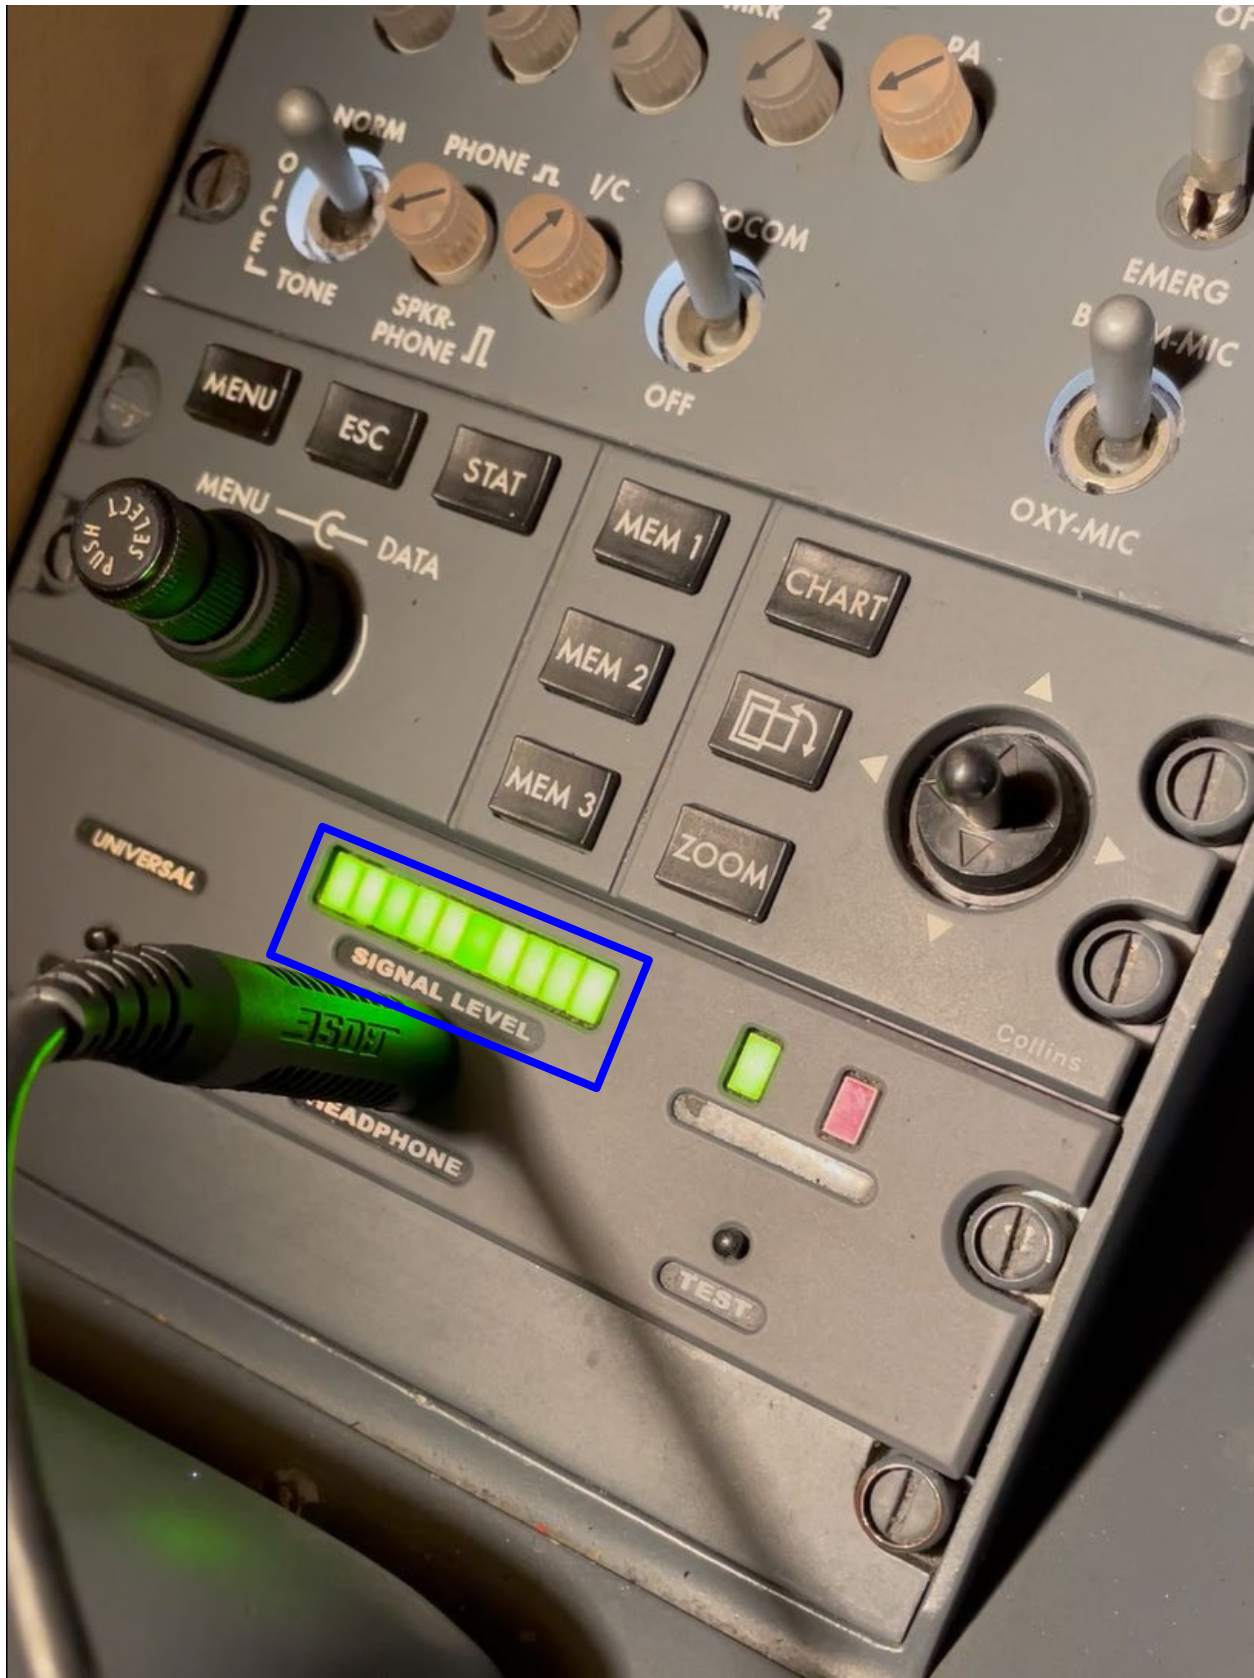
**Figure 8.** Control unit completing successful self-test after impact switch reset.

conducted for a second time, which resulted in a pass. The total test time was one hour. Appendix E includes figures from the onsite testing (figures 6 through 8).

- b. The CVR self-test was a FAIL.
4. The impact switch was reset, and the test was repeated and showed the following:
  - a. The impact switch continuity was CLOSED, and

- b. The CVR self-test was a PASS.
5. Notes and observations from testing on the accident vehicle:
  - a. The elapsed time of the onsite test was one hour,
