DCA26LA142

## INVESTIGATION PHOTOGRAPHS

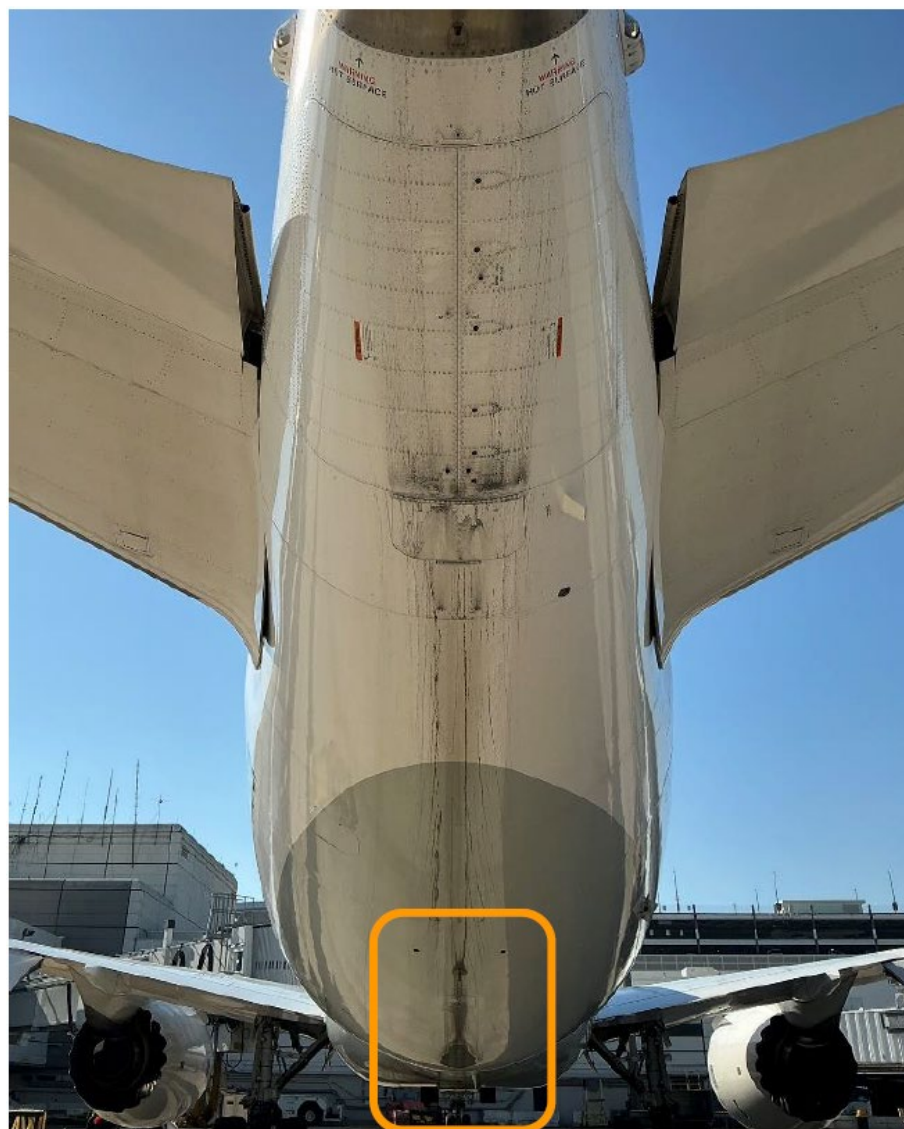
**Photograph 1 - Damage to the lower fuselage. See photograph 2 for the area highlighted in the orange box. (Courtesy of ANA)**

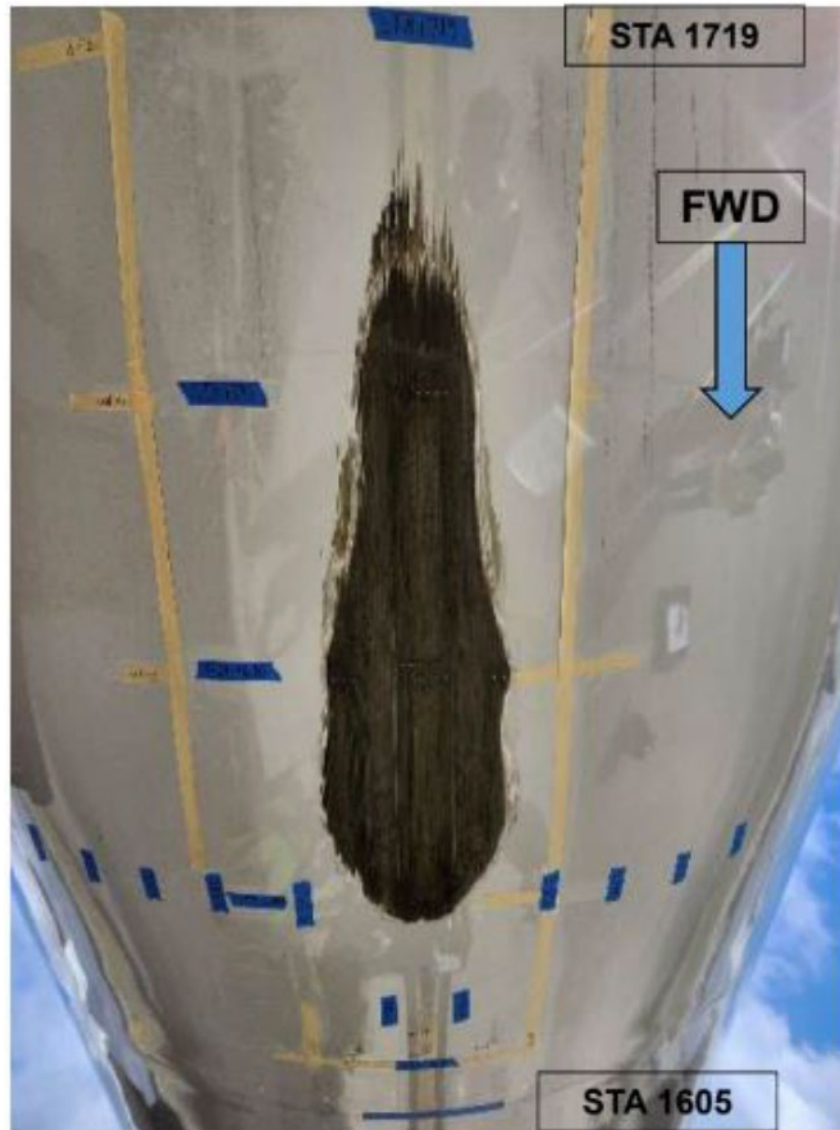
**Photograph 2 - Damage to the lower fuselage between stations 1605 and 1719.  
(Courtesy of ANA)**
