**Continental Motors, Inc.**

## **ENGINE EXAMINATION REPORT**

ENGINE MODEL: IO550N

REGISTRATION: N6506L

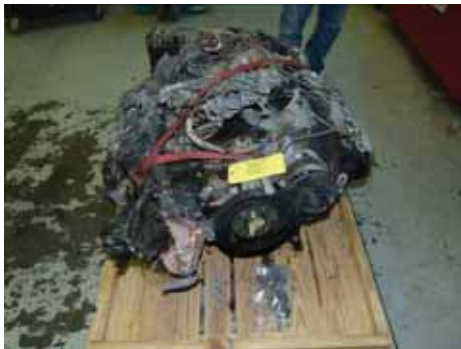
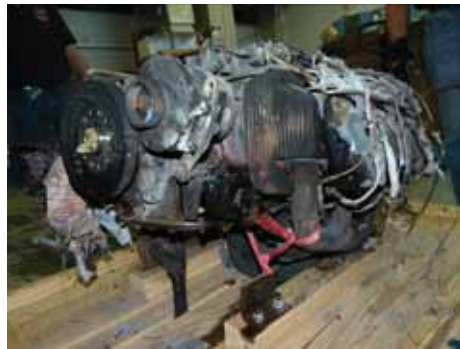
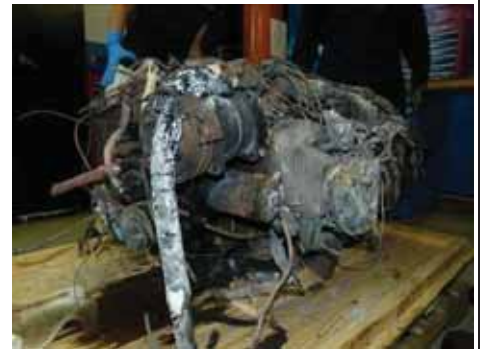
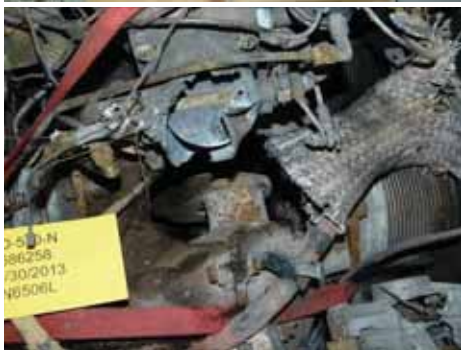
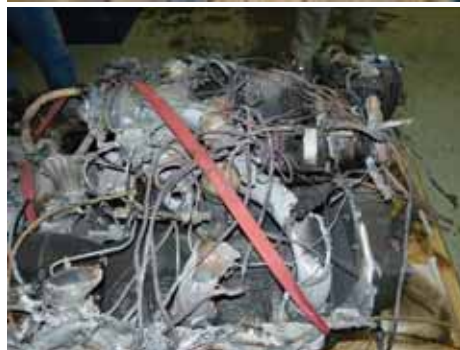
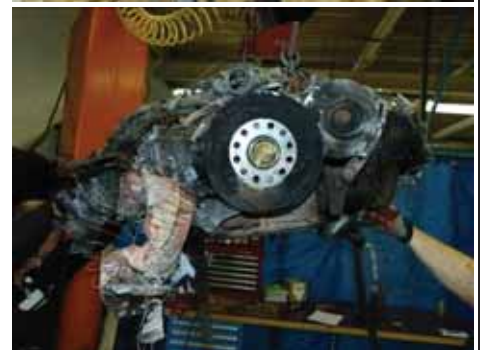
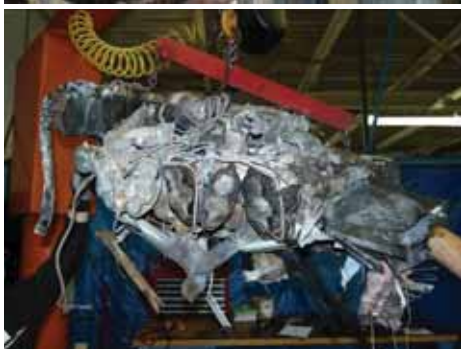
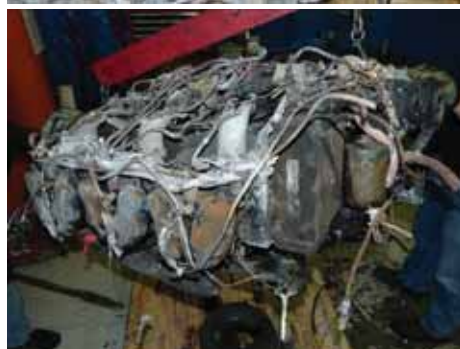
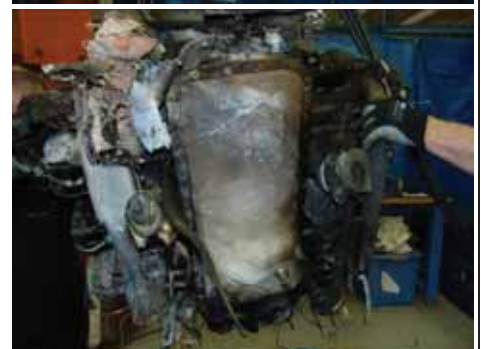
**EXTERNAL INSPECTION OF ENGINE:** The engine exhibits extreme thermal damage as a result of the post-crash fire. The crankcase is breached above the number four, five, and six cylinders.

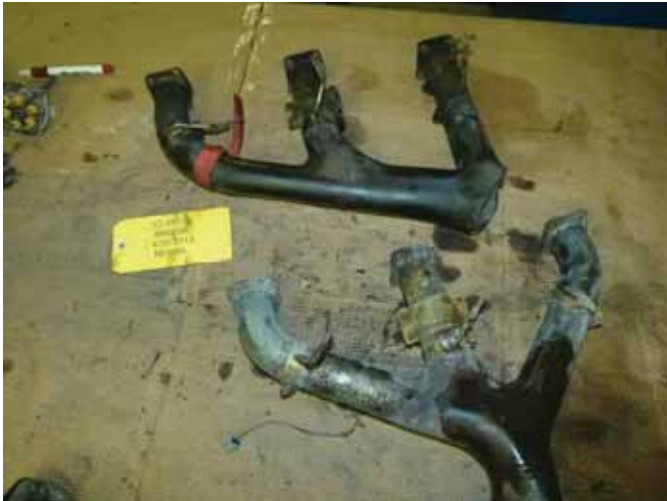
Exhaust System

Condition: Partial exhaust system components were returned with the engine.

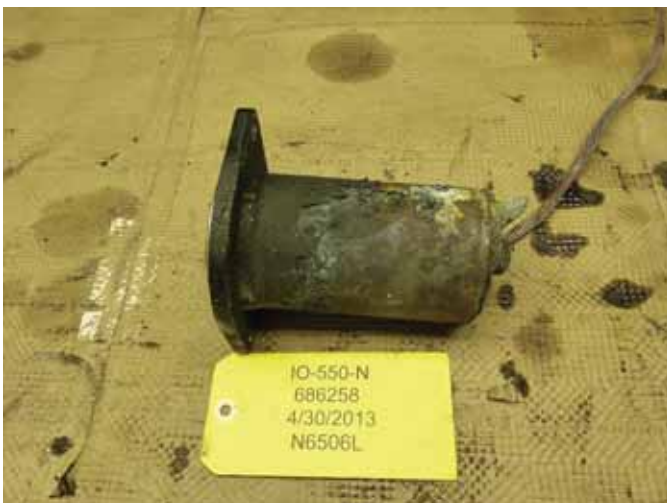
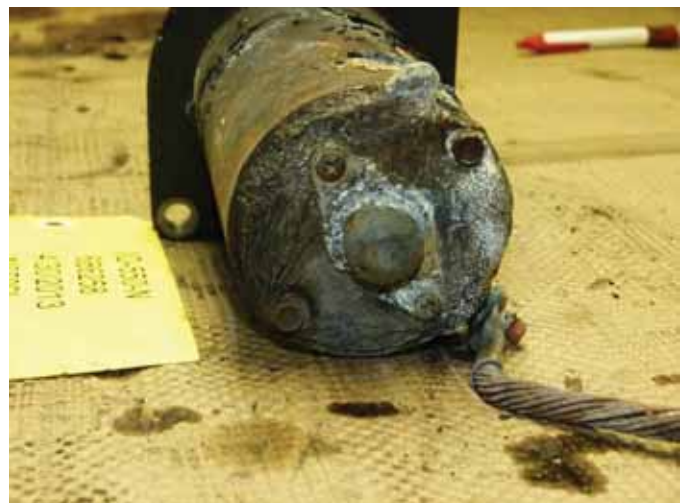
Starter Manufacturer: Illegible

Condition: The starter exhibited thermal damage and the drive did not rotate by hand.

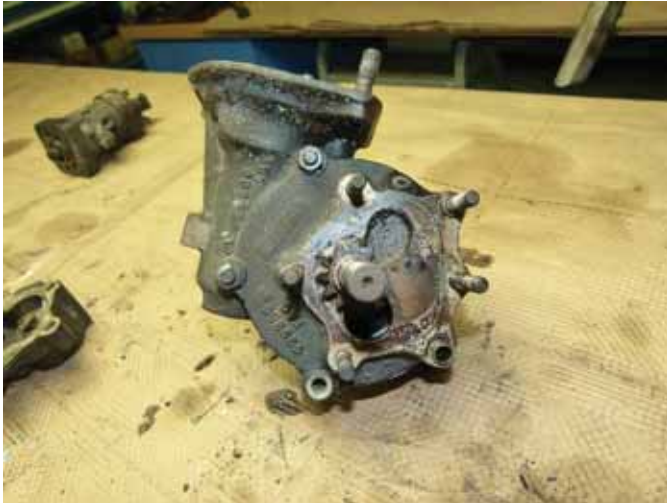
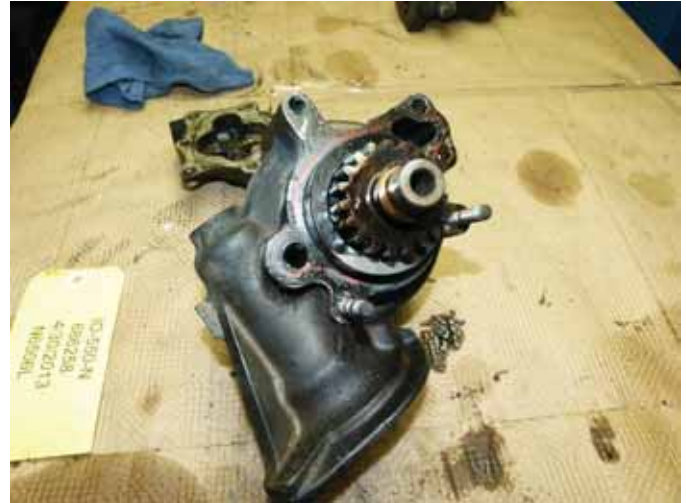
**Starter Adapter**    Part Number: Illegible.

Condition:    The starter adapter was intact, turned freely by hand and exhibited thermal damage.

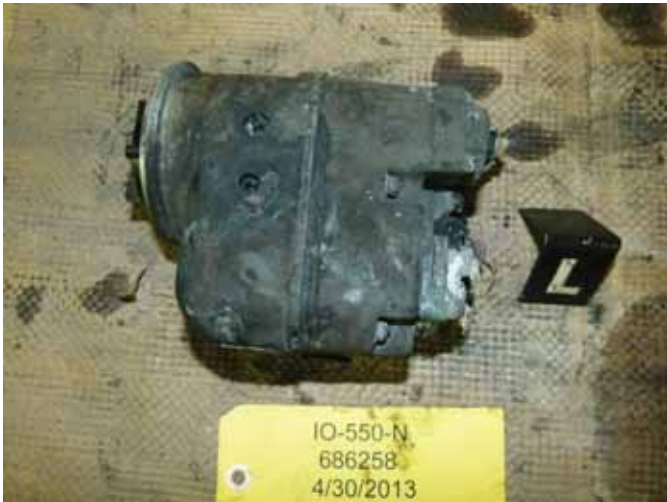
Condition:    The left-hand magneto exhibited thermal damage turned freely with impulse coupling engagement. The magneto was disassembled and the internal components exhibited thermal damage.

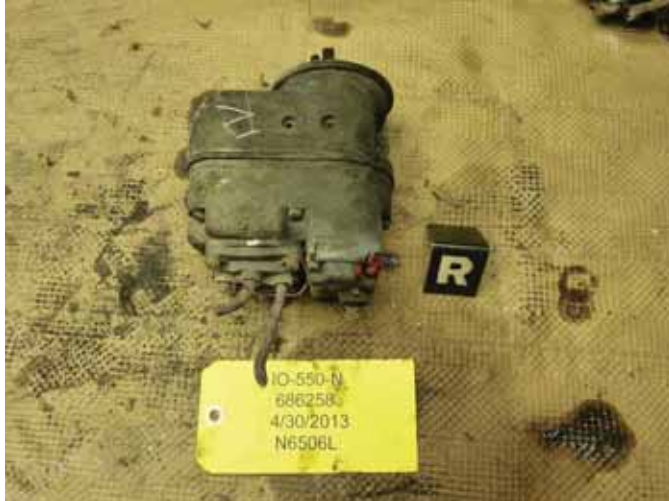
Condition: The right-hand magneto exhibited thermal damage and turned freely with impulse coupling engagement. The magneto was disassembled and the internal components exhibited damage.

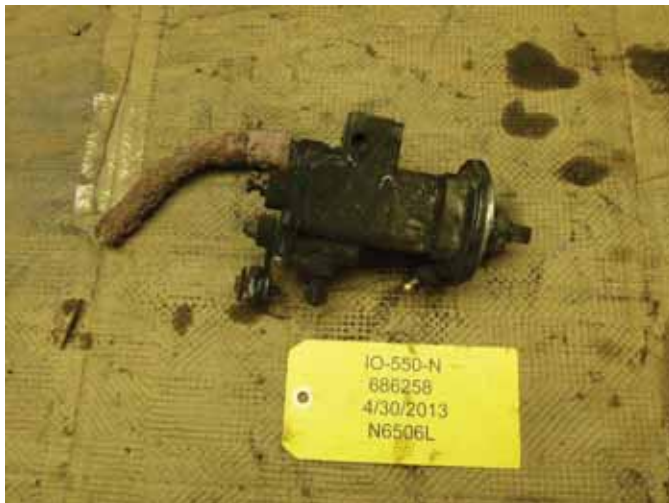
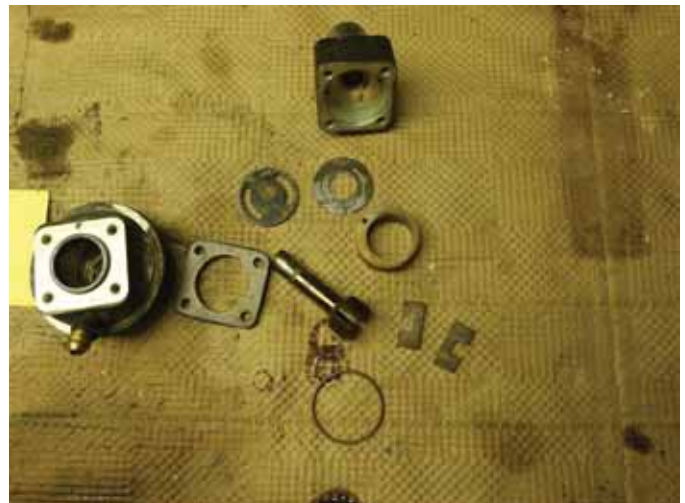
#### Fuel Pump

Condition: The fuel pump exhibited thermal damage and turned freely. The fuel pump drive was intact and undamaged. The fuel pump disassembled with no anomalies noted except thermal damage.

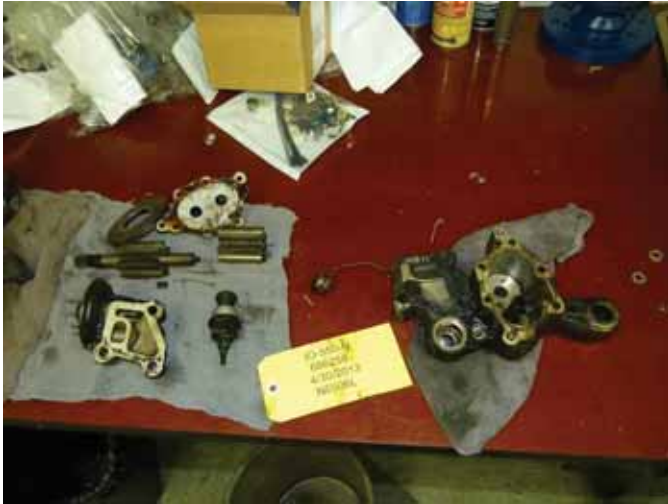
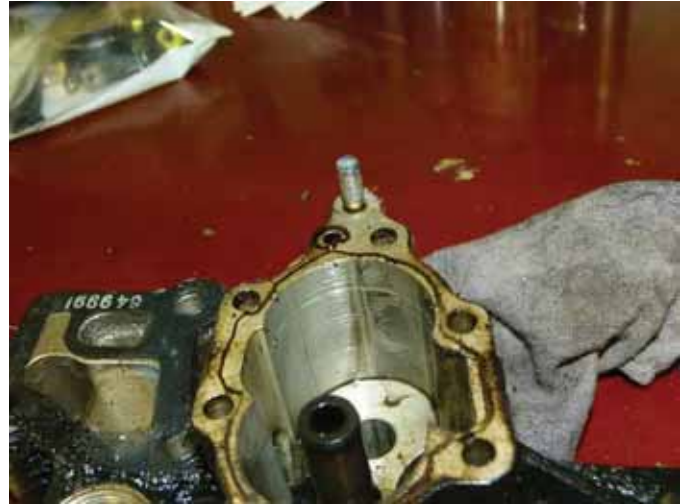
#### Oil Pump

Condition: The oil pump drive was intact. The oil pump cavity contained evidence of hard particle passage. The oil pump gear teeth exhibited normal operating signatures. The oil pressure relief valve and seat contained no obstructions and exhibited signatures of proper seating.

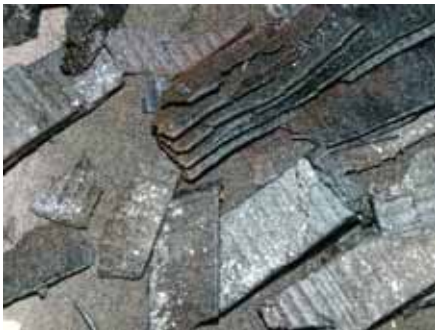
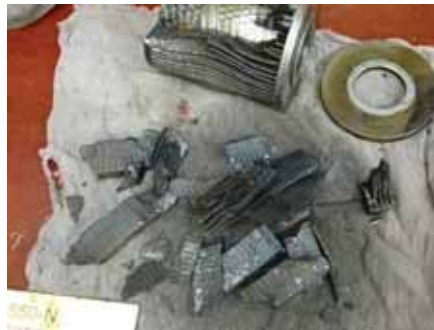
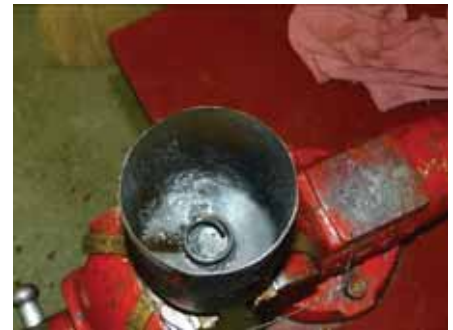
Condition: The oil filter housing was cut open using the Champion cutting tool and the filter element was cut from the canister to allow examination. The oil filter element was examined and contained flakes and slivers from the damaged internal engine components.

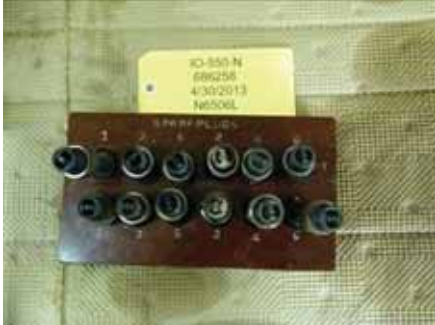
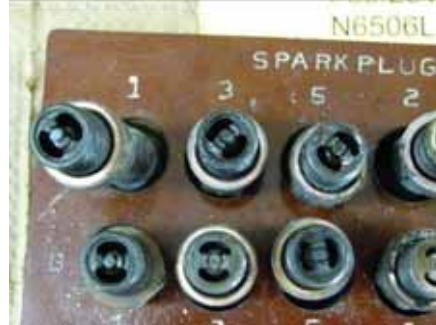
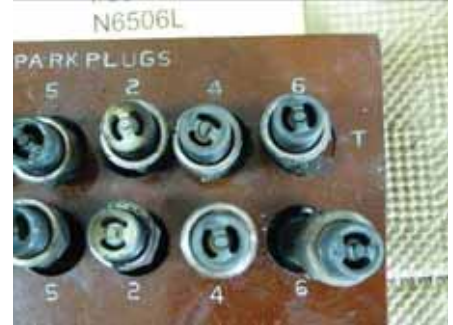
Condition: The top and bottom sparkplugs had normal wear signatures in accordance with the Champion aviation check-a-plug comparison chart.

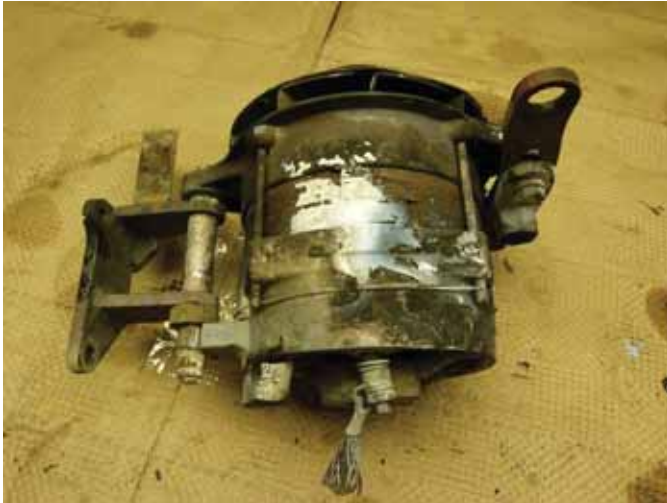
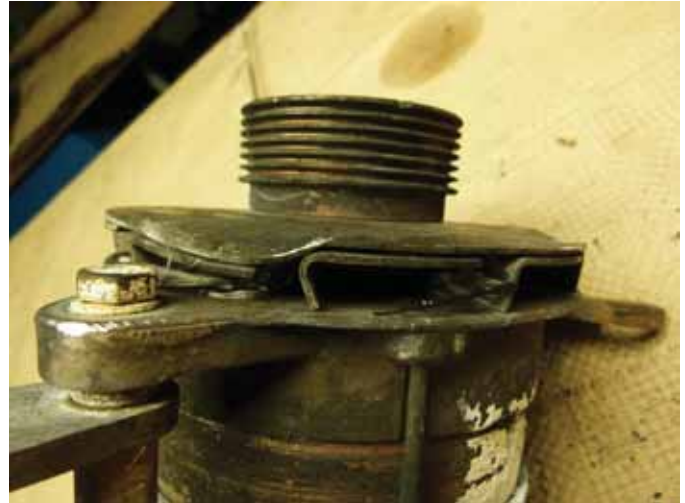
### Alternator

Condition: The alternator exhibited thermal and impact damage and the drive did not rotate.

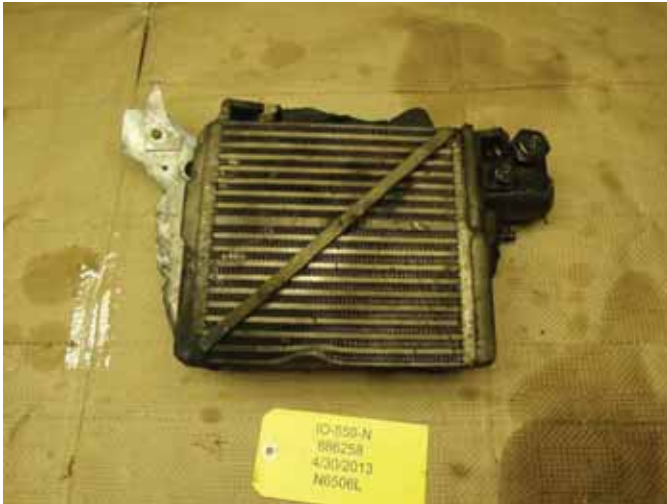
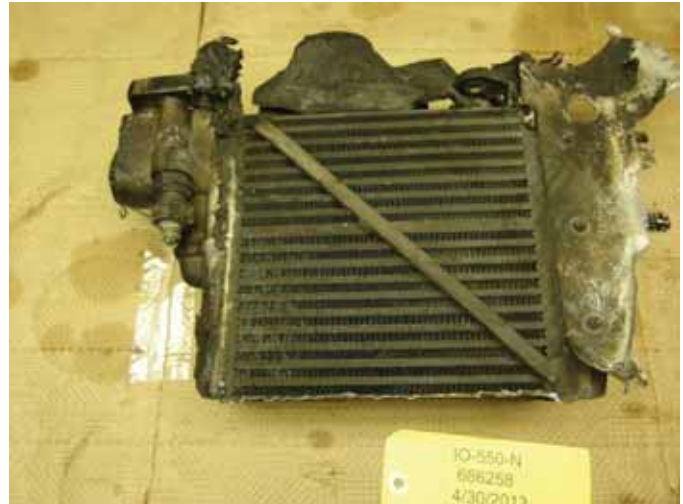
#### Oil Cooler

Condition: The oil cooler exhibited thermal and impact damage.

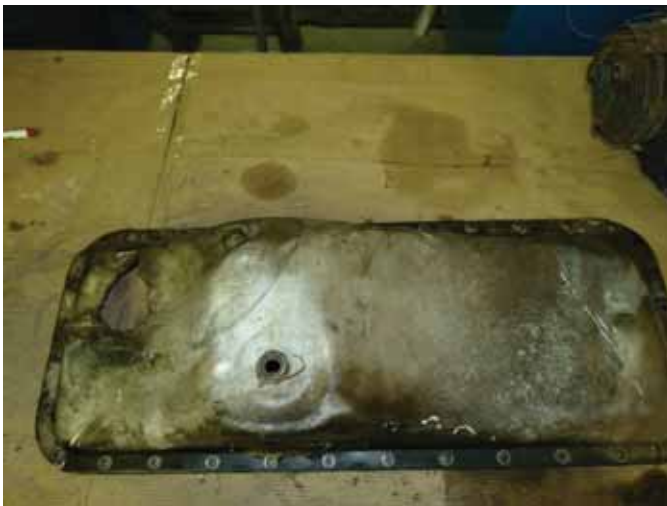
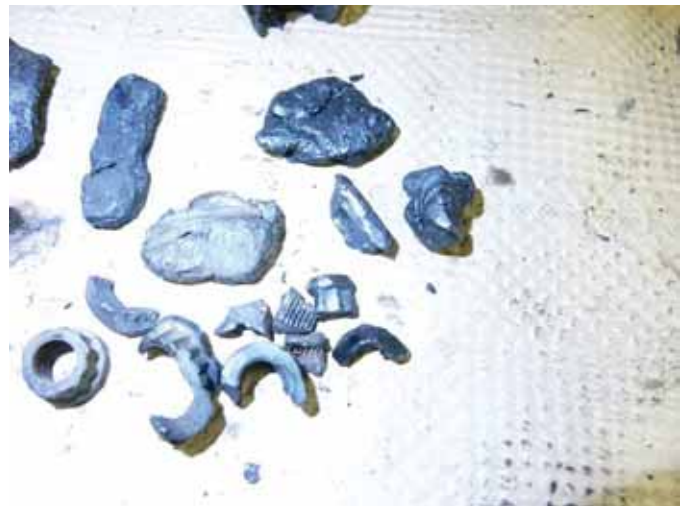
#### Oil Sump

Condition: The oil sump drain plug was safety wired. The oil sump exhibited impact and thermal damage. The oil sump contained metal and a residual amount of oil.

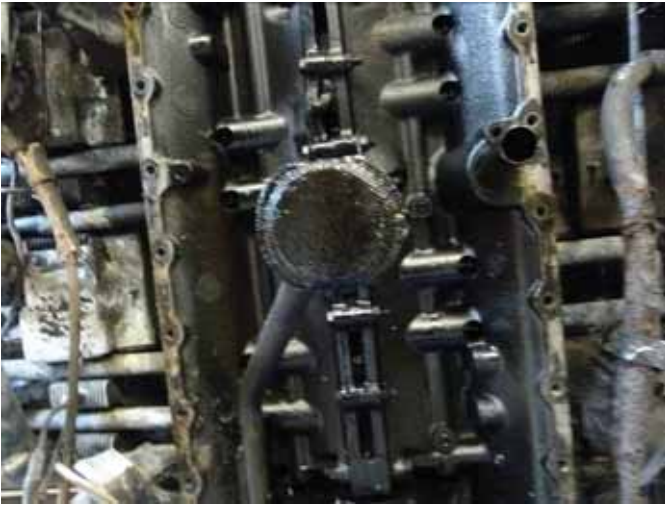
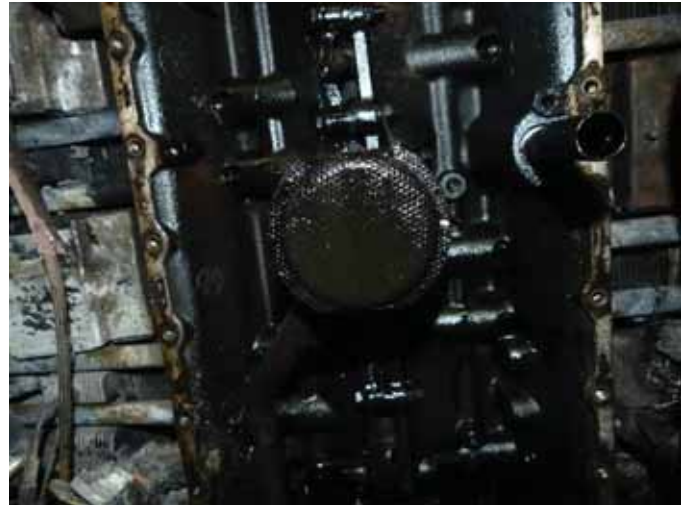
#### Oil Pick-up Tube & Screen

Condition: The oil pick-up tube was undamaged. The oil suction screen was unrestricted.

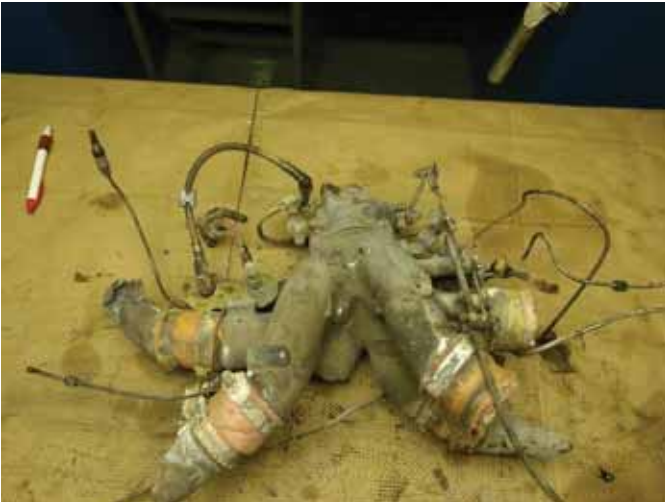
#### Induction System

Condition: The induction risers and exhibited impact and thermal damage.

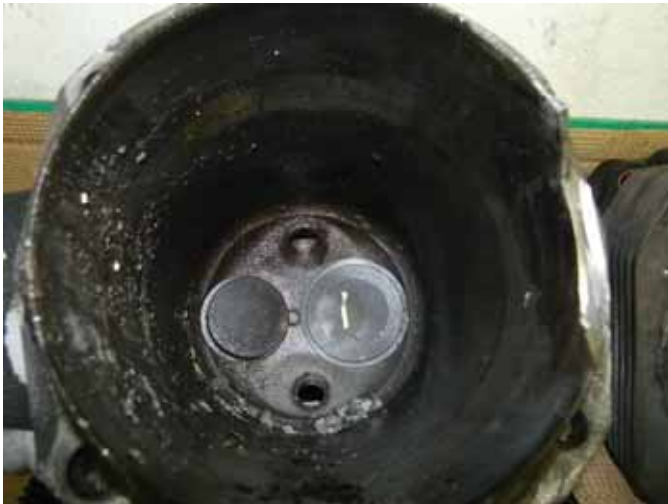
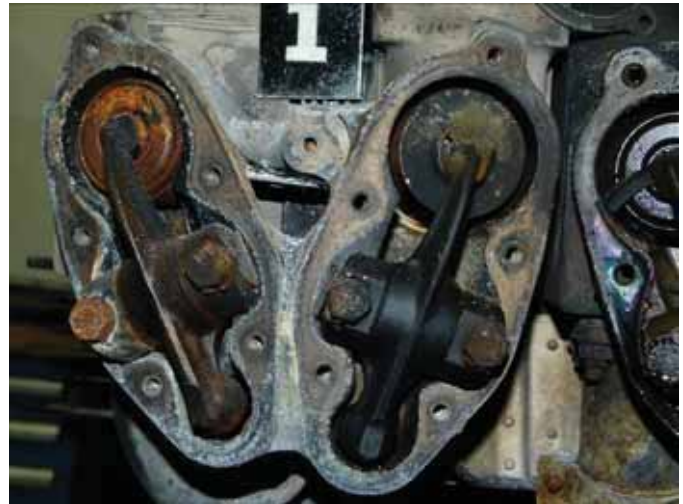
Cylinder #1    Part Number: 655465    Head Date: 8-10    Barrel Surface: Steel  
Serial #: AC10EB035    Work Order Numbers: None

Condition: The spot putty was not evident on the cylinder hold-down nuts. The cylinder combustion chamber had a normal amount of combustion deposits and the bore condition was free of scoring and undamaged. The cylinder skirt exhibited damage from the internal components of the engine. The intake and exhaust valve heads exhibited normal deposits and operating signatures. The rocker box area had an oil residue indicating lubrication to the overhead. The cylinder overhead components (valves, rocker arms, guides, springs, retainers and shafts) exhibited thermal damage.

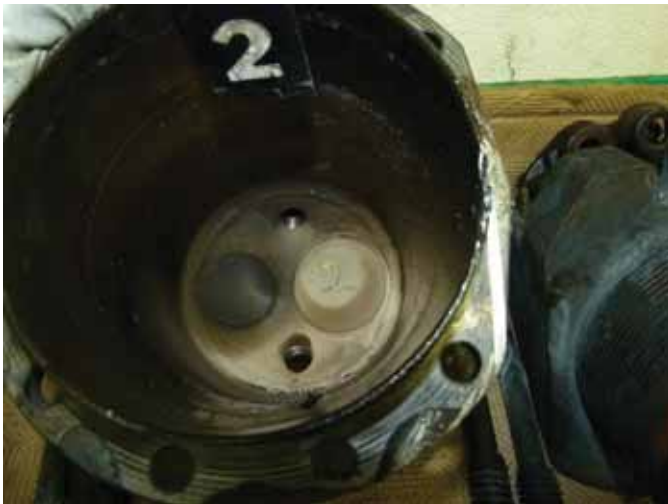
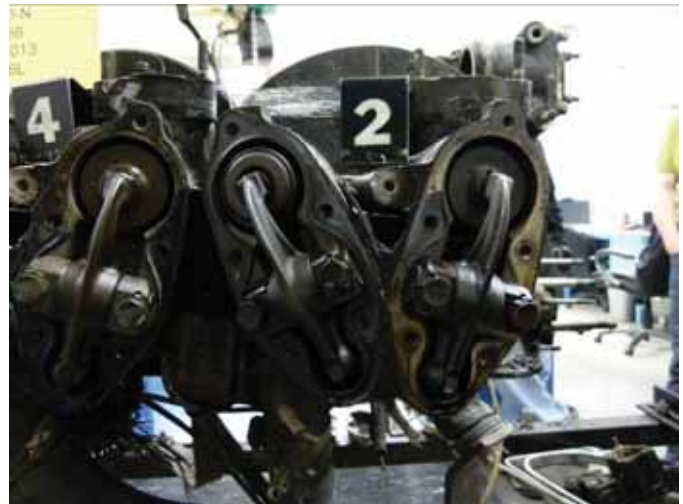
Cylinder #2    Part Number: 655465    Head Date: 11-08    Barrel Surface: Steel  
Serial #: AC08JC691    Work Order Numbers: None

Condition: The spot putty was not evident on the cylinder hold-down nuts. The cylinder combustion chamber had a normal amount of combustion deposits and the bore condition was free of scoring and undamaged. The cylinder skirt exhibited damage from the internal components of the engine. The intake and exhaust valve heads exhibited normal deposits and operating signatures. The rocker box area had an oil residue indicating lubrication to the overhead. The cylinder overhead components (valves, rocker arms, guides, springs, retainers and shafts) were lubricated and undamaged.

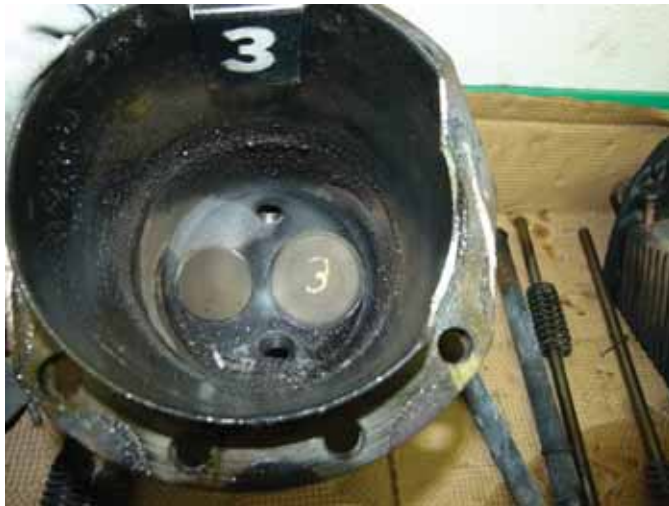
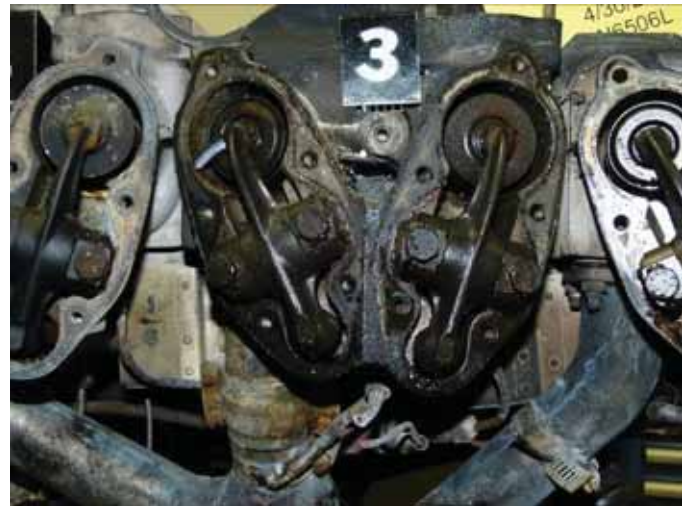
Cylinder #3      Part Number: 655465      Head Date: 3-02      Barrel Surface: Steel  
Serial #: U218      Work Order Numbers: None

Condition: The spot putty was not evident on the cylinder hold-down nuts. The cylinder combustion chamber had a normal amount of combustion deposits and the bore condition was free of scoring and undamaged. The cylinder skirt exhibited damage from the internal components of the engine. The intake and exhaust valve heads exhibited normal deposits and operating signatures. The rocker box area had an oil residue indicating lubrication to the overhead. The cylinder overhead components (valves, rocker arms, guides, springs, retainers and shafts) were lubricated and undamaged.

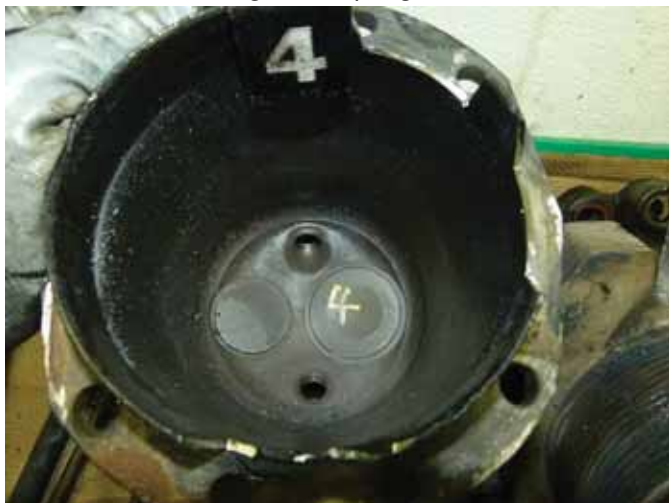
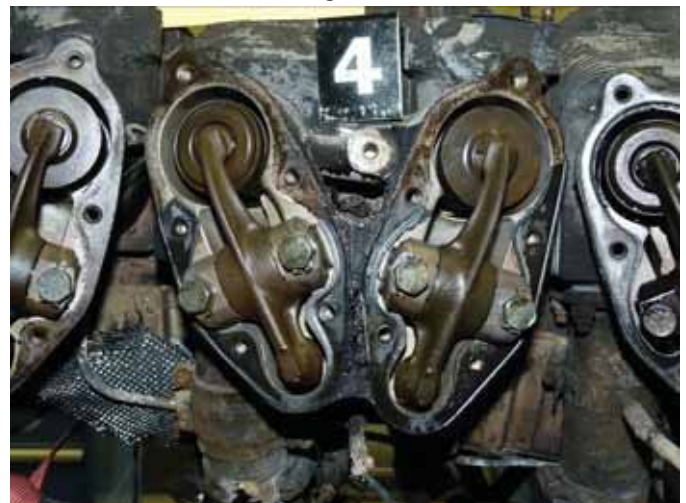
Cylinder #4      Part Number: 655465      Head Date: 3-02      Barrel Surface: Steel  
Serial #: T709      Work Order Numbers: None

Condition: The spot putty was not evident on the cylinder hold-down nuts. The cylinder combustion chamber had a normal amount of combustion deposits and the bore condition was free of scoring and undamaged. The cylinder skirt exhibited damage from the internal components of the engine. The intake and exhaust valve heads exhibited normal deposits and operating signatures. The rocker box area had an oil residue indicating lubrication to the overhead. The cylinder overhead components (valves, rocker arms, guides, springs, retainers and shafts) were lubricated and undamaged.

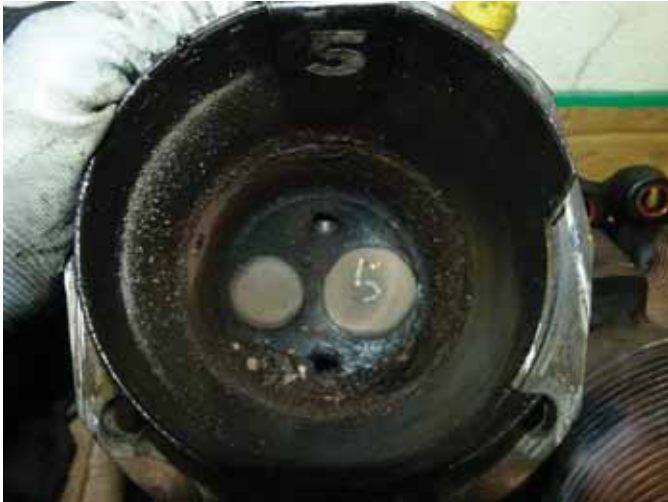
Cylinder #5    Part Number: 655465    Head Date: 8-10    Barrel Surface: Steel  
Serial #: EB024    Work Order Numbers: None

Condition: The spot putty was not evident on the cylinder hold-down nuts. The cylinder combustion chamber had a normal amount of combustion deposits and the bore condition was corroded and exhibited thermal damage. The cylinder skirt exhibited damage from the internal components of the engine. The intake and exhaust valve heads exhibited normal deposits and operating signatures. The rocker box area had an oil residue indicating lubrication to the overhead. The cylinder overhead components (valves, rocker arms, guides, springs, retainers and shafts) were lubricated and undamaged.

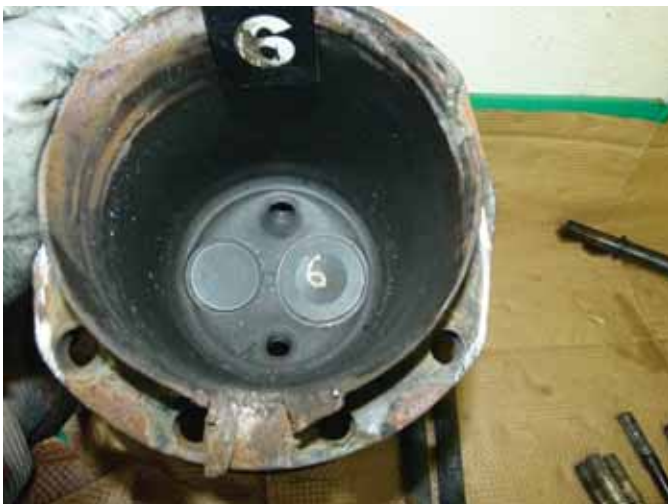
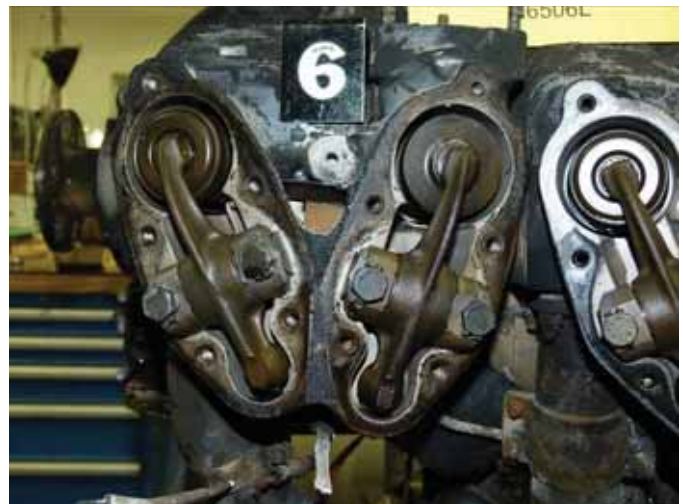
Cylinder #6    Part Number: 655465    Head Date: 3-02    Barrel Surface: Steel  
Serial #: T722    Work Order Numbers: None

Condition: The spot putty was not evident on the cylinder hold-down nuts. The cylinder combustion chamber had a normal amount of combustion deposits and the bore condition was free of scoring and undamaged. The cylinder skirt exhibited damage from the internal components of the engine. The intake and exhaust valve heads exhibited normal deposits and operating signatures. The rocker box area had an oil residue indicating lubrication to the overhead. The cylinder overhead components (valves, rocker arms, guides, springs, retainers and shafts) were lubricated and undamaged.

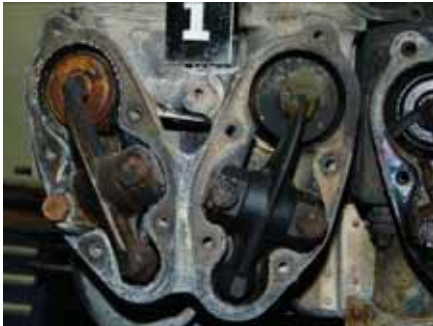
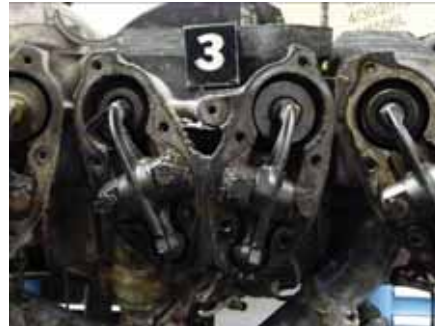
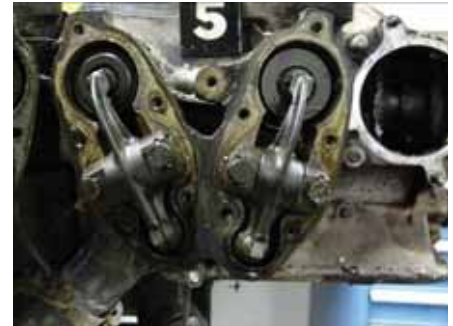
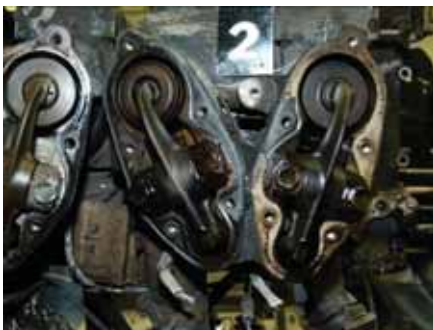
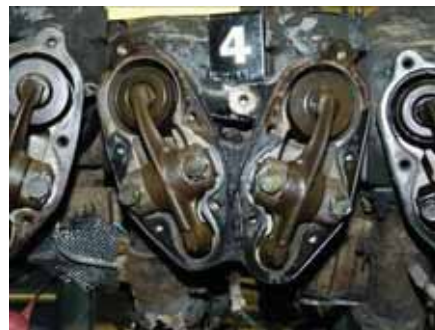
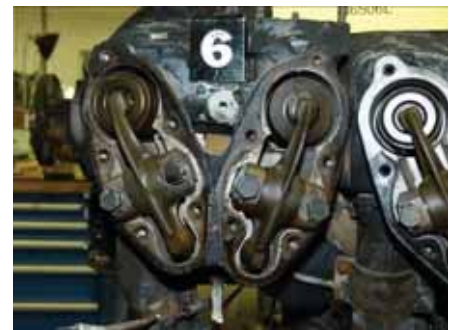
#### Rocker Arm and Shaft

Condition: The intake and exhaust rocker arms and shafts exhibited normal operating signatures and signs of thermal damage from the post-crash fire.

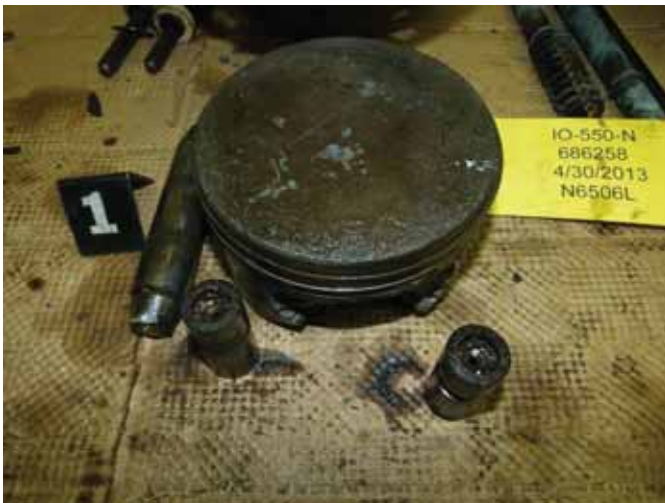
#### #1 Piston, Rings and Pin

Condition: The piston head exhibited a normal amount of combustion deposits and the piston skirt was impact damaged by the internal components of the engine. The piston pin and plug assembly was intact and exhibited damage.

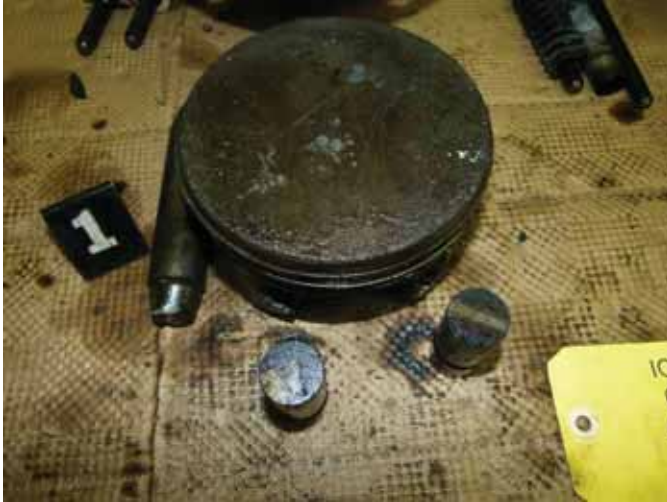
#2 Piston, Rings and Pin      Piston Part Number:    654857

Condition:    The piston head exhibited a normal amount of combustion deposits and the piston skirt was impact damaged by the internal components of the engine. The piston pin and plug assembly was intact and undamaged.

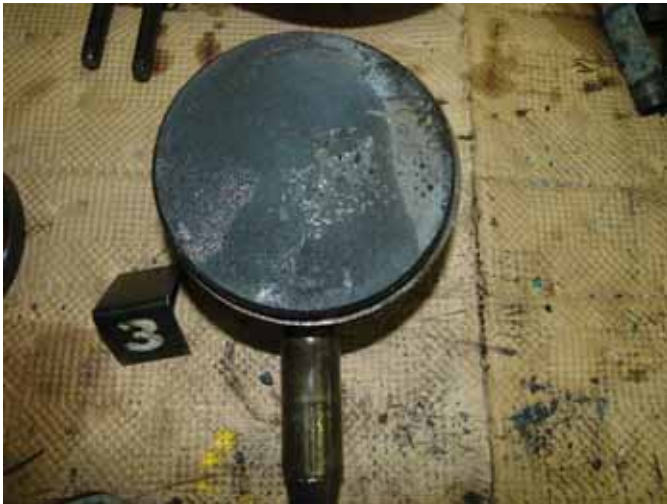
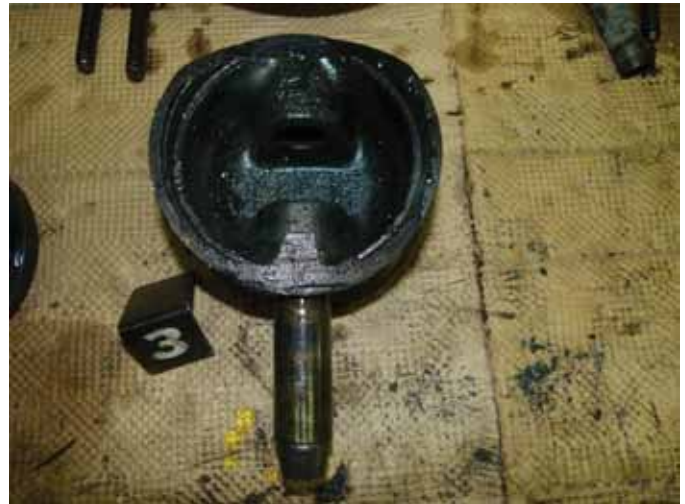
#3 Piston, Rings and Pin      Piston Part Number:    654857

Condition:    The piston head exhibited a normal amount of combustion deposits and the piston skirt was intact and undamaged. The piston pin and plug assembly was intact and undamaged.

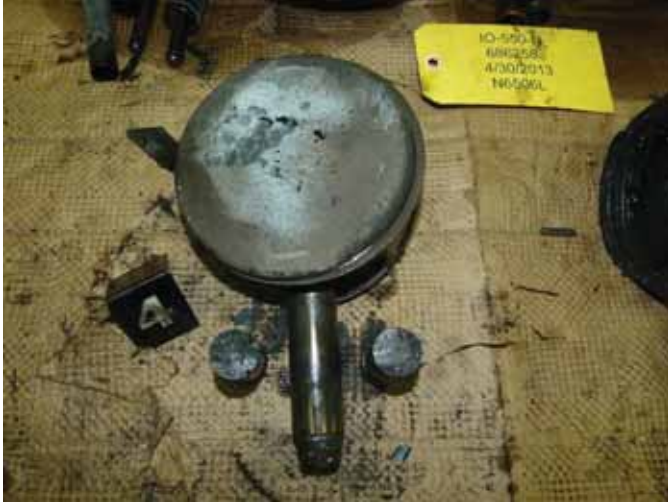
#4 Piston, Rings and Pin      Piston Part Number:    654857

Condition:    The piston head exhibited a normal amount of combustion deposits and the piston skirt was impact damaged by the internal components of the engine. The piston had dark soot indicating post-crash fire damage. The piston pin and plug assembly was intact and undamaged.

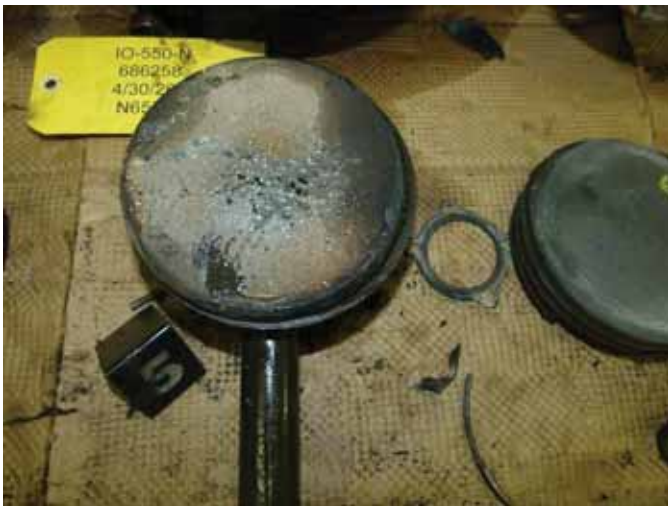
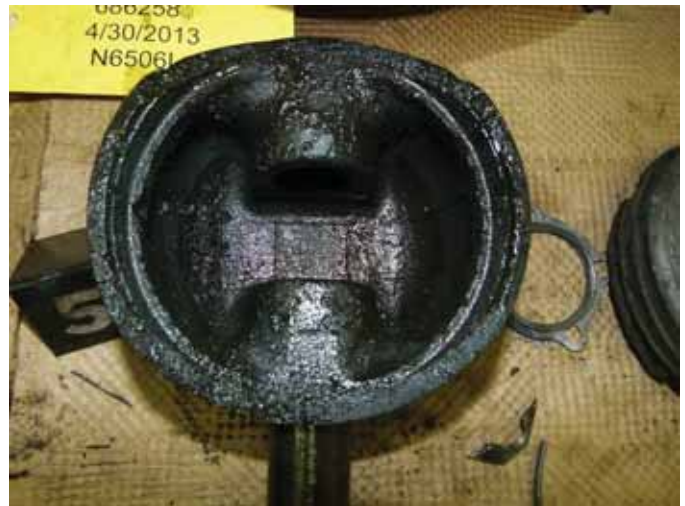
#5 Piston, Rings and Pin      Piston Part Number:    654857

Condition:    The piston head exhibited a normal amount of combustion deposits and the piston skirt was undamaged. The piston had dark soot indicating post-crash fire damage. The piston pin and plug assembly was intact and undamaged.

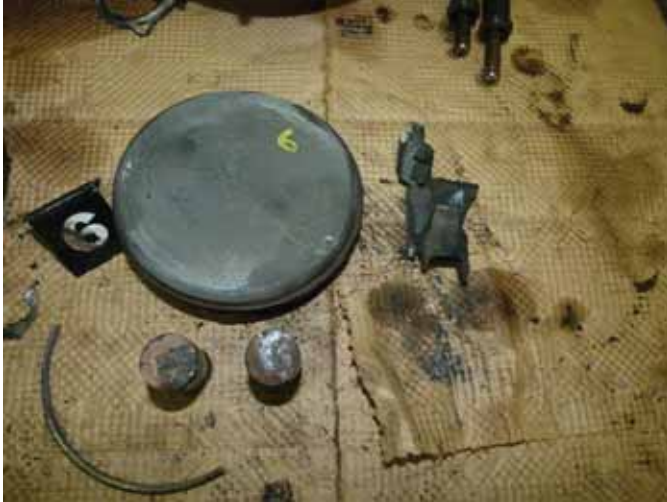
#6 Piston, Rings and Pin      Piston Part Number:    654857

Condition:    The piston head exhibited a normal amount of combustion deposits and the piston skirt exhibited impact damage with the internal components of the engine. The piston was fractured below the piston pin and portions found in the oil sump contents.

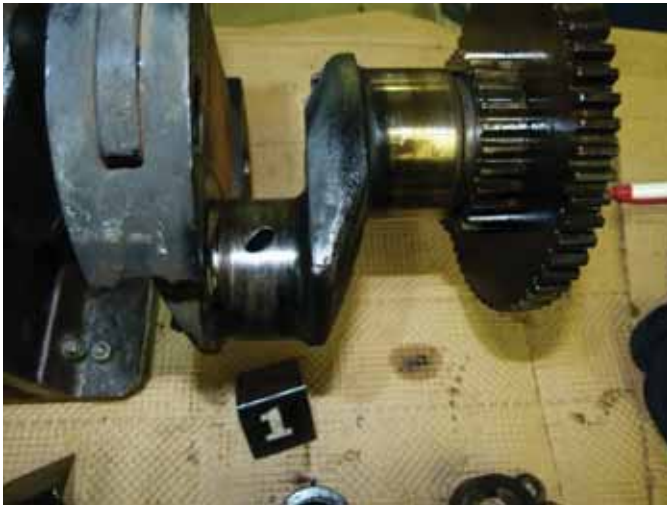
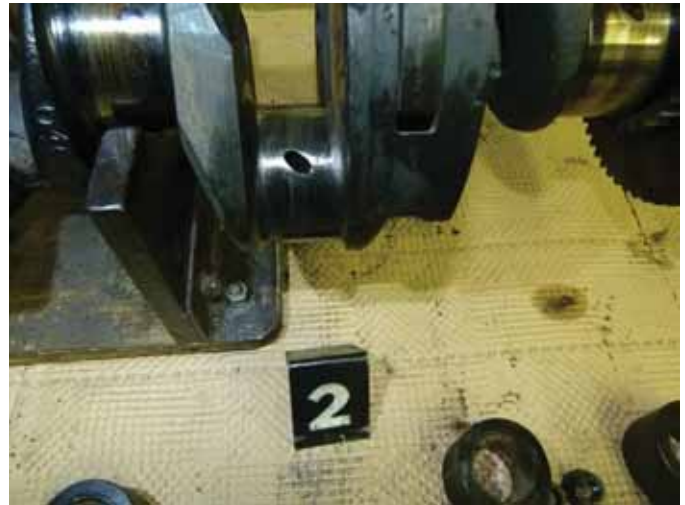
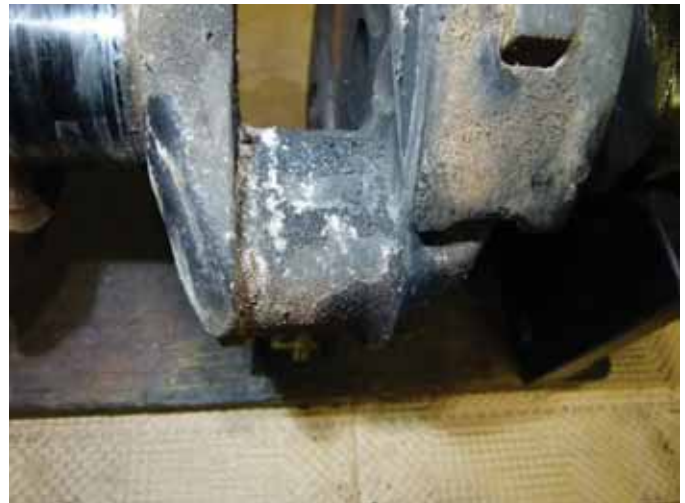
Crankshaft      Forging number: 649878      Serial number: N02BA500      Heat code: KAAN

Condition: The crankshaft and counterweight assembly exhibited lubrication distress, thermal damage, and mechanical damage concentrated at the number three, four, five and six connecting rod journals. The crankshaft cluster gear was intact and exhibited normal operating signatures. The gear bolts were tight and safety wired and the gear teeth were undamaged. The crankshaft main bearing journals were intact, undamaged and exhibited thermal damage signatures. The front and rear set of counterweight assemblies were intact and exhibited thermal damage from the post-crash fire. All of the counterweight pins, plates and snap-rings were intact. The number four connecting rod journal exhibited thermal distress and scoring from lack of sufficient lubrication. The number five connecting rod journal exhibited signs of lubrication distress, thermal discoloration, mechanical damage and displacement of the journal material. The number six connecting rod journal exhibited signs of lubrication distress, thermal discoloration, mechanical damage and displacement of the journal material. Excluding the displacement of journal material on number five and six, the oil transfer passages were open and unrestricted. Alternator drive face gear teeth were intact and undamaged. The oil transfer collar was intact and undamaged. The oil transfer plug was tight and in position.

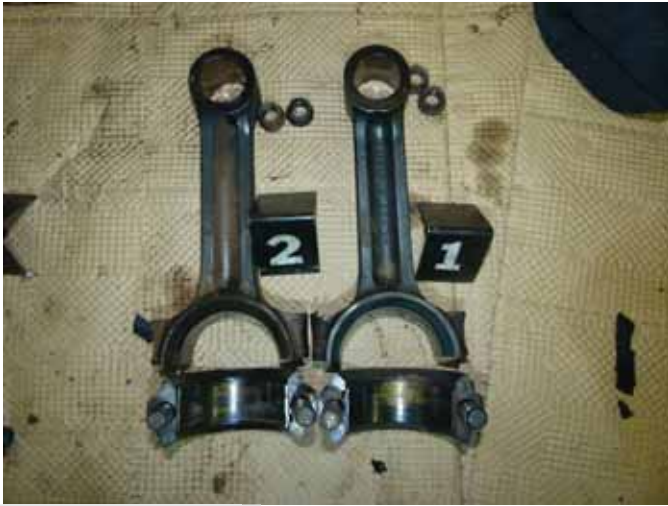
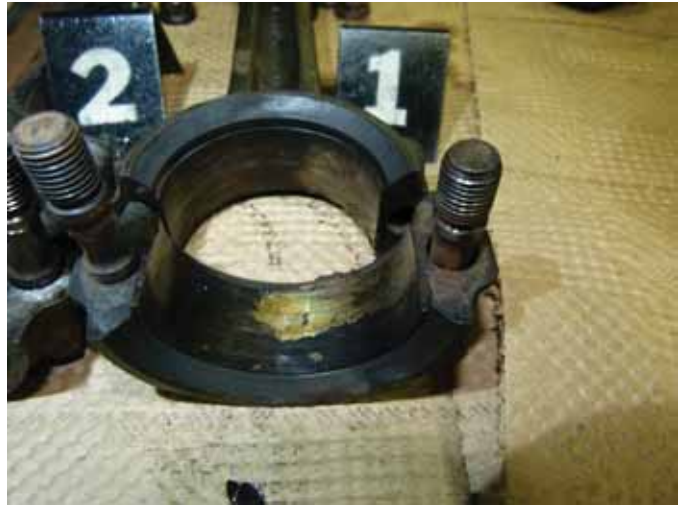
#1 Connecting Rod    Part #: 655911    Forging #: 646126F    Serial #: AE02CA368

Condition:    The connecting rod assembly was intact and exhibited thermal discoloration. The connecting rod nuts and bolts were intact.

#1 Connecting Rod Bearings    Part #:    642398    Date Code:    Not Reported

Condition:    The connecting rod bearing exhibited lubrication distress and thermal smearing of the surface babbit, exposing the copper layer.

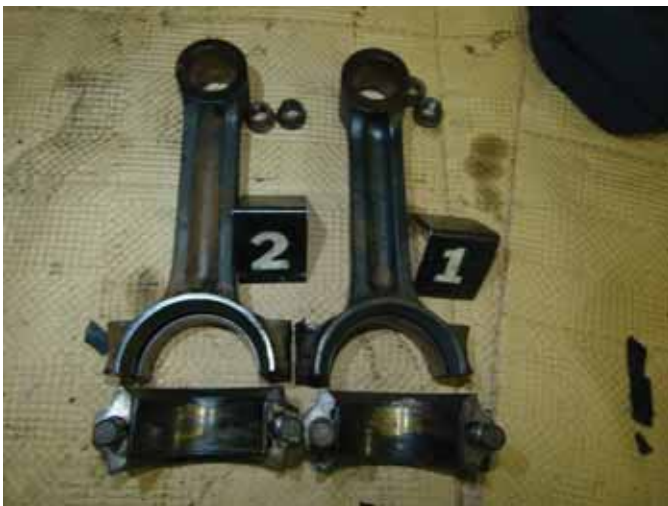
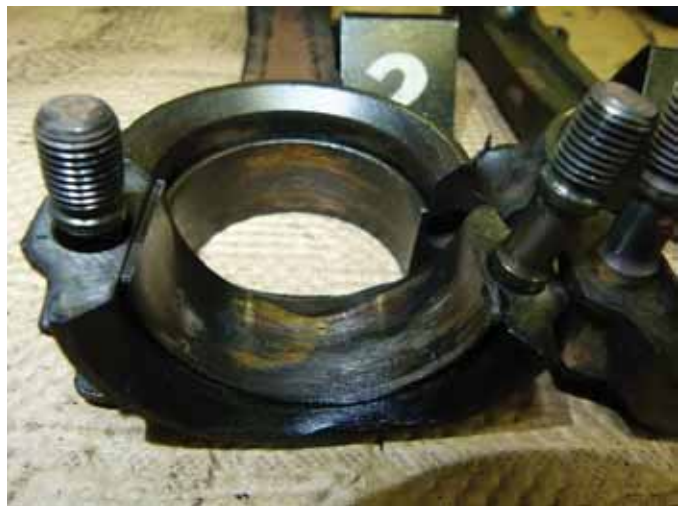
#2 Connecting Rod    Part #: 655911    Forging #: 646126F    Serial #: AE02CA386

Condition:    The connecting rod assembly was intact and exhibited thermal discoloration. The connecting rod nuts and bolts were intact.

#2 Connecting Rod Bearings    Part #:    642398    Date Code:    Not Reported

Condition:    The connecting rod bearing exhibited lubrication distress and thermal smearing of the surface babbit, exposing the copper layer.

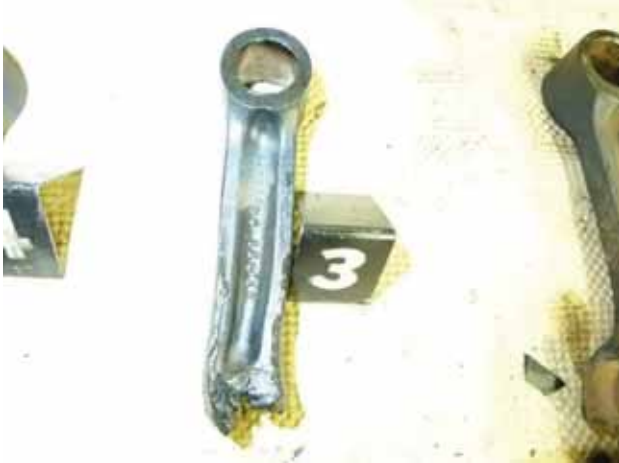
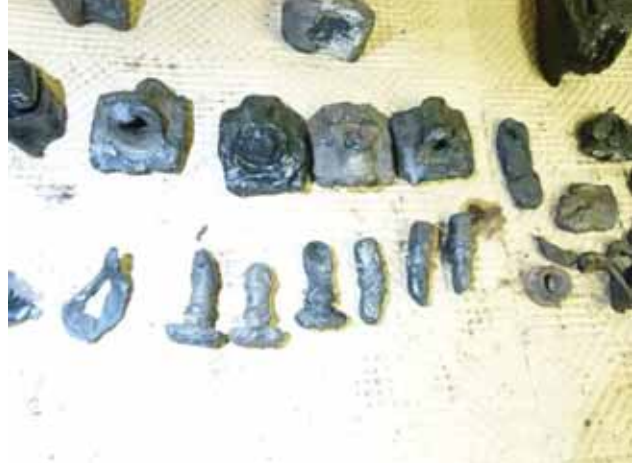
#3 Connecting Rod Bearings      Part #: *illegible*      Date Code: *illegible*

Condition:      The connecting rod exhibited extreme thermal and mechanical damage and was fractured through at the base of the I-beam, separating of both sections of bearing supports. Fragments of connecting rod cap exhibited thermal and mechanical damage. Fragments of connecting rod bolts and nuts were fractured through and exhibited mechanical damage and overload signatures.

Condition:      Only fragments and the connecting rod bearing remained. These fragments of the bearing exhibited lubrication and thermal distress and were found in the oil sump.
