**Continental Motors, Inc.**

## **ENGINE EXAMINATION REPORT**

ENGINE MODEL: IO550N

REGISTRATION: N6506L

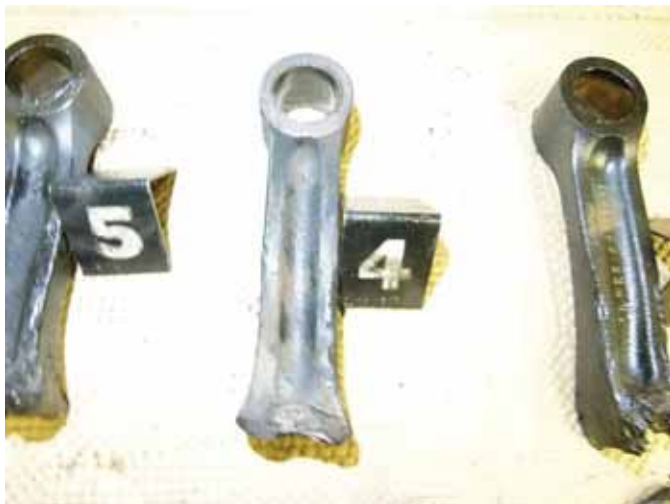
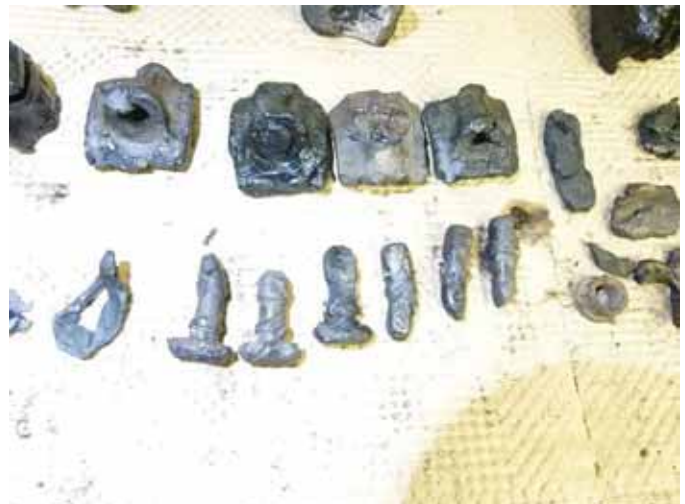
#3 Connecting Rod      Part #: 655911      Forging #: 646126F      Serial #: AE02CA376

Condition:      The connecting rod exhibited extreme thermal and mechanical damage and was fractured through at the base of the I-beam, separating of both sections of bearing supports. Fragments of connecting rod cap exhibited thermal and mechanical damage. Fragments of connecting rod bolts and nuts were fractured through and exhibited mechanical damage and overload signatures.

#3 Connecting Rod Bearings      Part #: *illegible*      Date Code: *illegible*

Condition:      Only fragments and the connecting rod bearing remained. These fragments of the bearing exhibited lubrication and thermal distress and were found in the oil sump.

#4 Connecting Rod      Part #: 655911      Forging #:      Serial #: AE02CA446

Condition:      The connecting rod exhibited extreme thermal and mechanical damage and was fractured through at the base of the I-beam, separating of both sections of bearing supports. Fragments of connecting rod cap exhibited thermal and mechanical damage. Fragments of connecting rod bolts and nuts were fractured through and exhibited mechanical damage and overload signatures. Fragments from the oil sump could not be matched with their location in the engine.

#4 Connecting Rod Bearings      Part #: *illegible*      Date Code: *illegible*

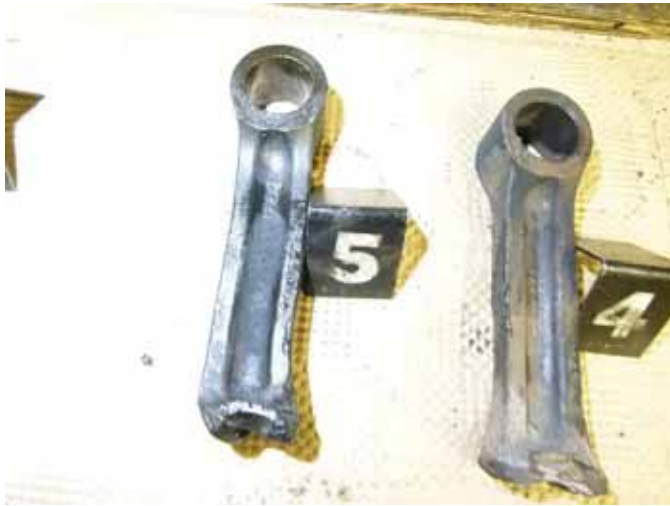
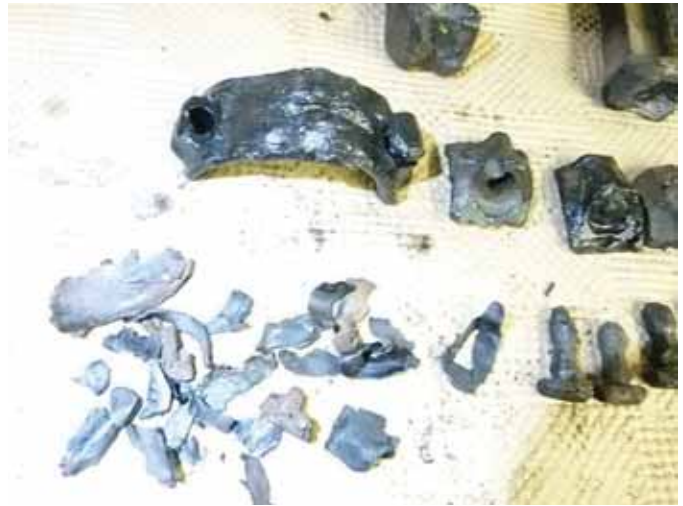
#5 Connecting Rod      Part #: 655911      Forging #:      Serial #: AE02CA413

Condition:      The connecting rod exhibited extreme thermal and mechanical damage and was fractured through at the base of the I-beam, separating of both sections of bearing supports. Fragments of connecting rod cap exhibited thermal and mechanical damage. Fragments of connecting rod bolts and nuts were fractured through and exhibited mechanical damage and overload signatures.

#5 Connecting Rod Bearings      Part #: *illegible*      Date Code: *illegible*

Condition:      Only fragments and the connecting rod bearing remained. These fragments of the bearing exhibited lubrication and thermal distress and were found in the oil sump. Fragments from the oil sump could not be matched with their location in the engine.

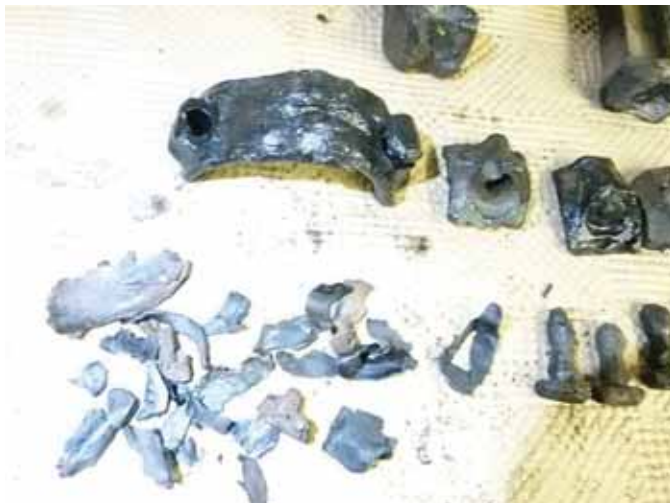
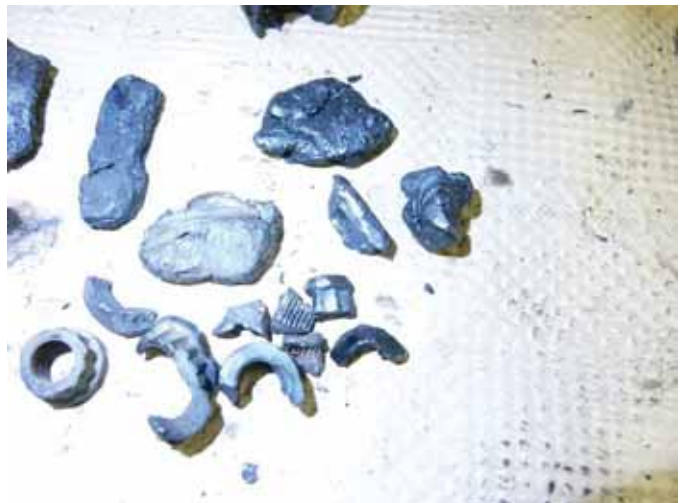
#6 Connecting Rod      Part #: 655911      Forging #: 646126F      Serial #: Missing

Condition:      The number six connecting rod was not returned with this exhibit.

#6 Connecting Rod Bearings      Part #: *illegible*      Date Code: *illegible*

Condition:      Only fragments and the connecting rod bearing remained. These fragments of the bearing exhibited lubrication and thermal distress and were found in the oil sump. Fragments from the oil sump could not be matched with their location in the engine.

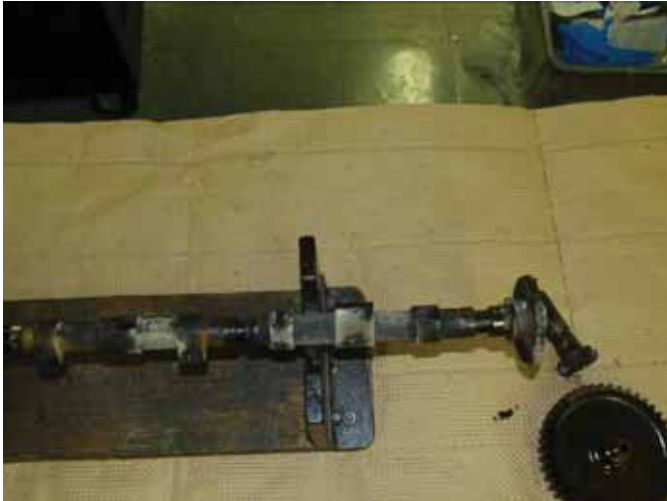
Condition: The camshaft lobes exhibited normal operating signatures. The camshaft had thermal damage from the post impact fire. The gear teeth were intact and undamaged. The gear bolts were tight and safety wire was present.

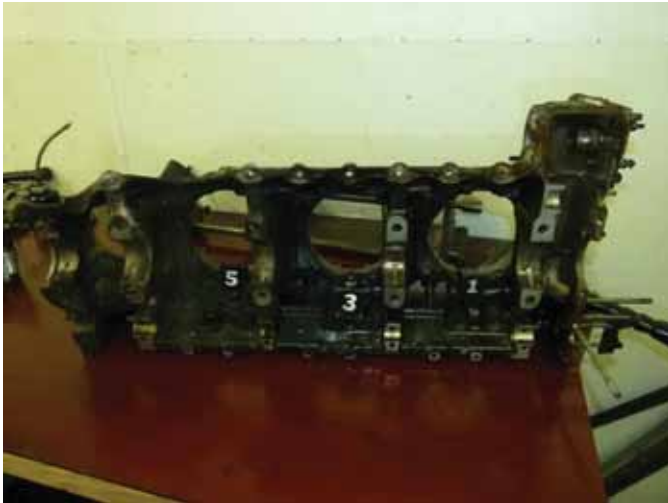
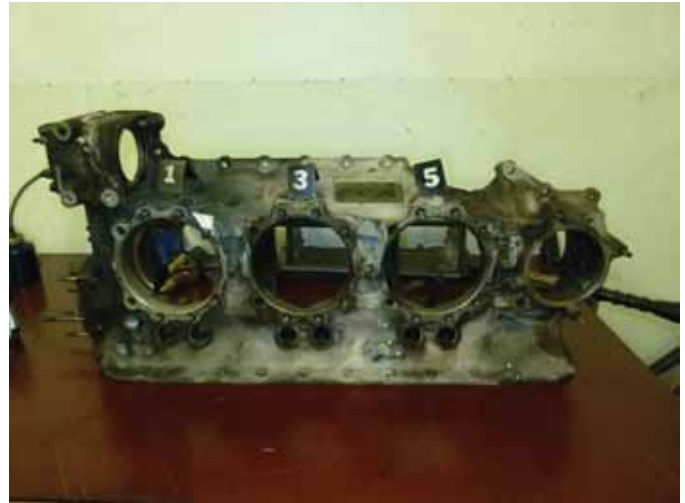
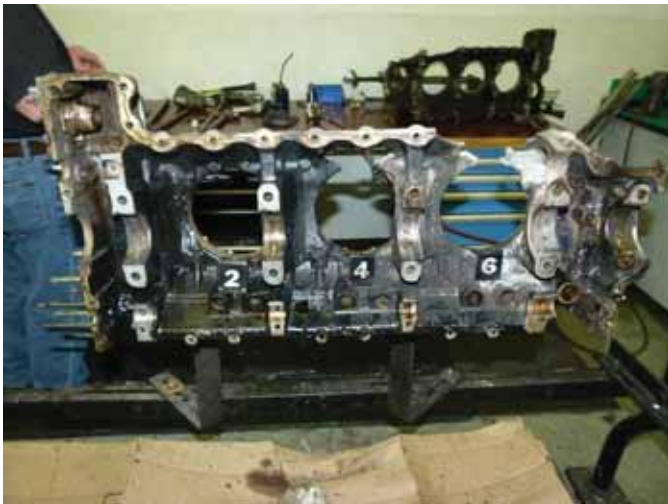
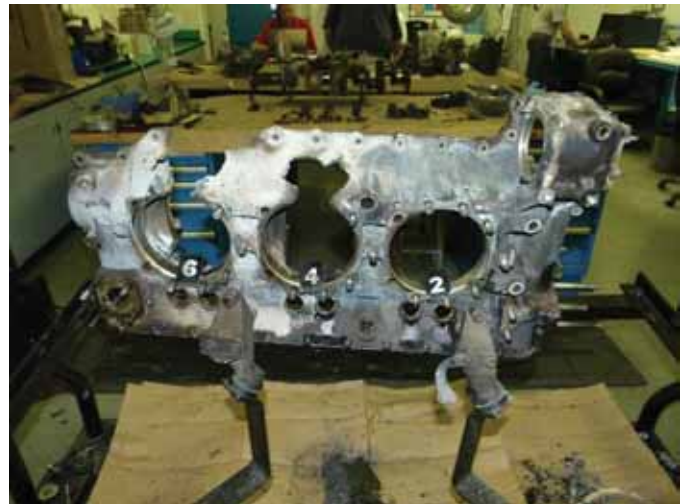
Crankcase Casting Number 1-3-5 Side: 653921 2-4-6 Side: 653920 Serial number: R02BA311

Condition: The crankcase exhibited exterior damage concentrated at the number four, five and six cylinder bays. The remaining cylinder bays were intact and exhibited mechanical damage. The main bearing support mating surfaces were intact and exhibited no signs of fretting or bearing tang lock-slot elongation. The main bearing support diameters were intact and exhibited no signs of bearing movement or rotation. The oil galleys and passages in the left and right crankcase halves were intact, clear and unrestricted.

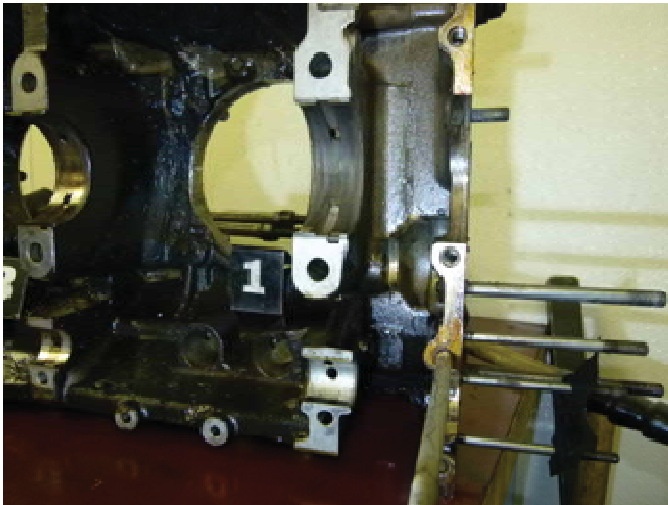
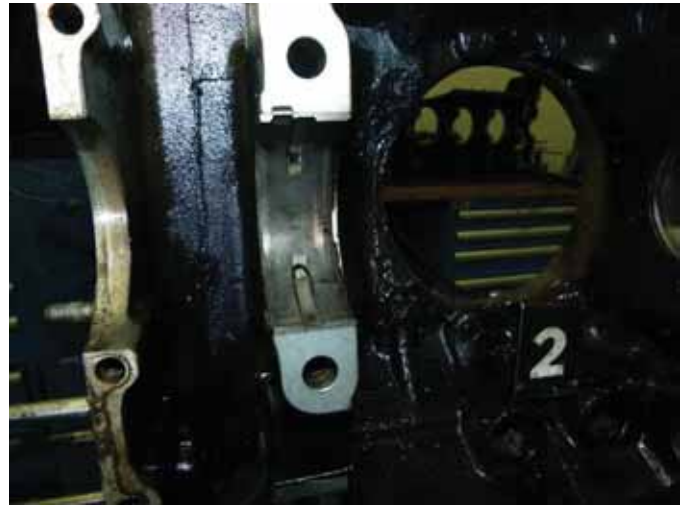
#1 Main Bearings      Part #: 634503

Condition      The #1 (rear) bearings exhibited contamination imbedded in the surface layer. The bearings exhibited lubrication distress and thermal smearing of the surface babbitt.

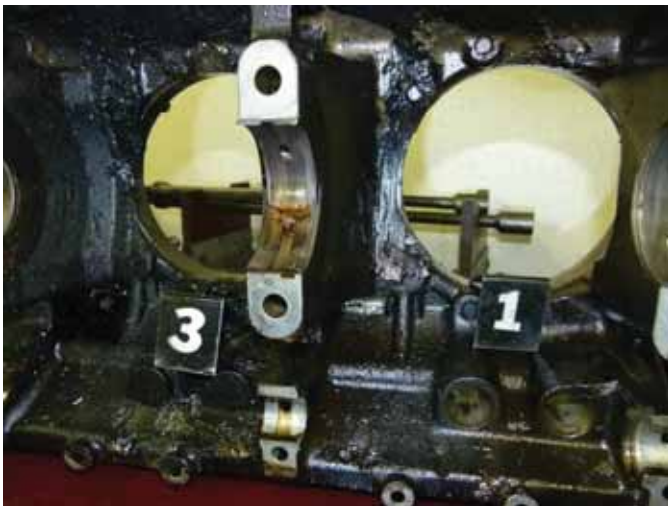
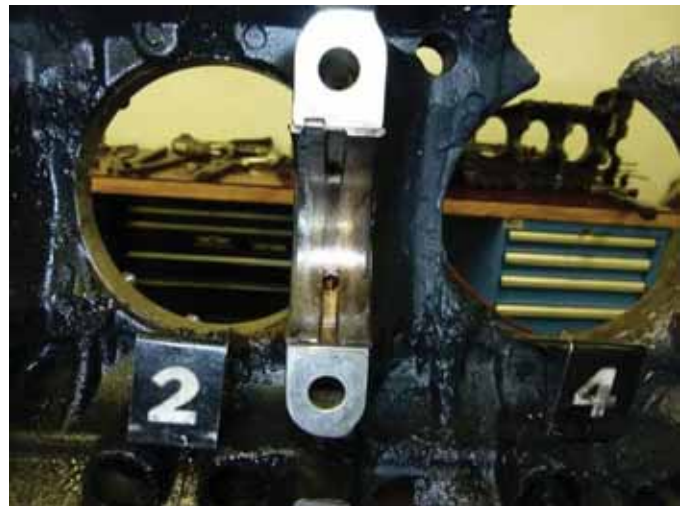
#2 Main Bearings      Part #: 634503

Condition      The #2 (intermediate) bearings exhibited contamination imbedded in the surface layer. The bearings exhibited lubrication distress and thermal smearing of the surface babbitt.

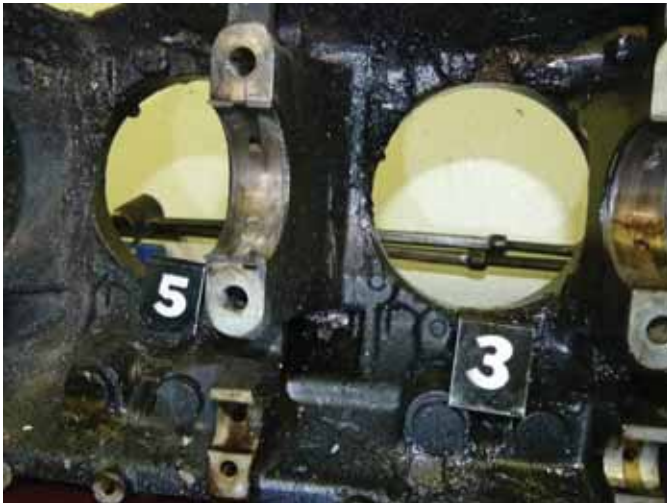
Condition      The #3 (intermediate) bearings exhibited contamination imbedded in the surface layer. The bearings exhibited lubrication distress and thermal smearing of the surface babbit.

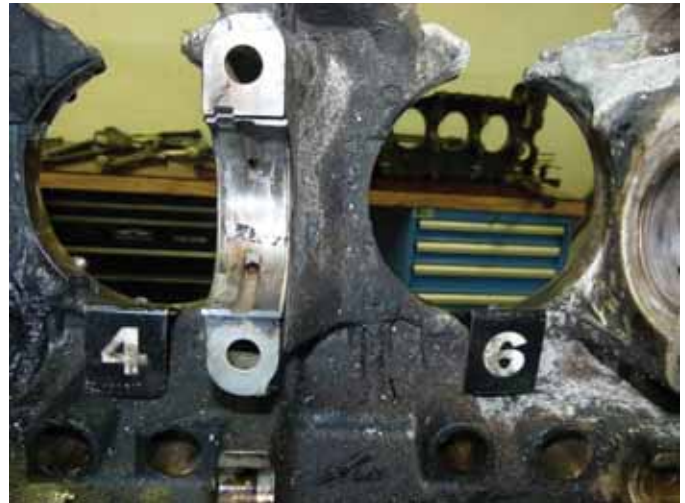
#3 Main Bearings      Part #: 634503

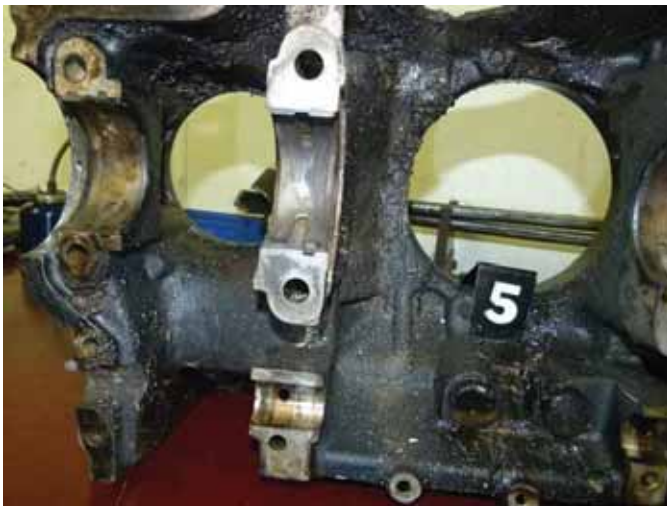
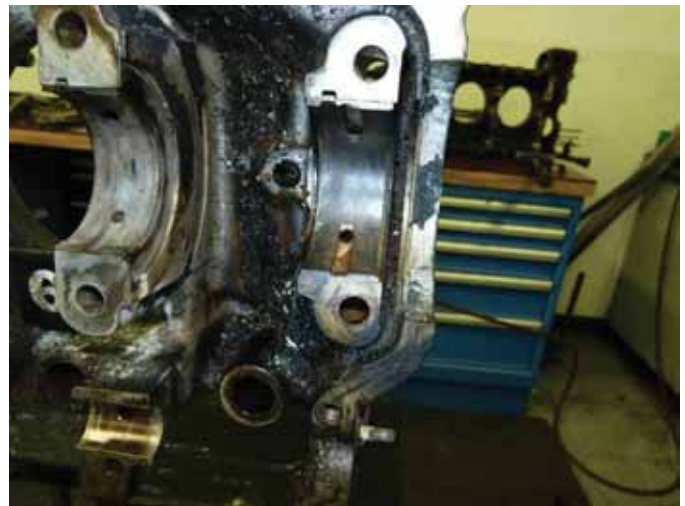
#4 Main Bearings      Part #: 653547

Condition      The #4 (front) bearings exhibited contamination imbedded in the surface layer. The bearings exhibited lubrication distress and thermal smearing of the surface babbit.

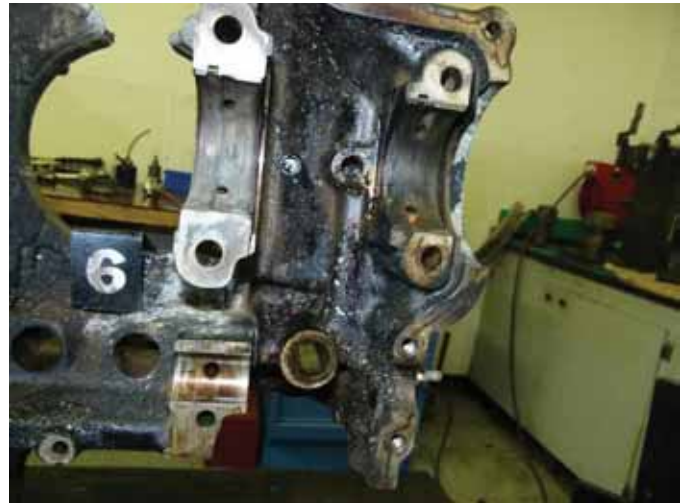
#5 Main Bearings      Part #: 653547

Condition      The #5 (front) bearings exhibited contamination imbedded in the surface layer. The bearings exhibited lubrication distress and thermal smearing of the surface Babbitt.

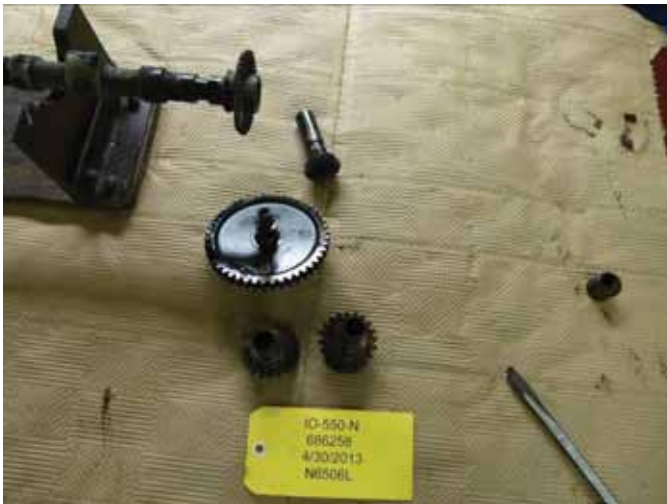
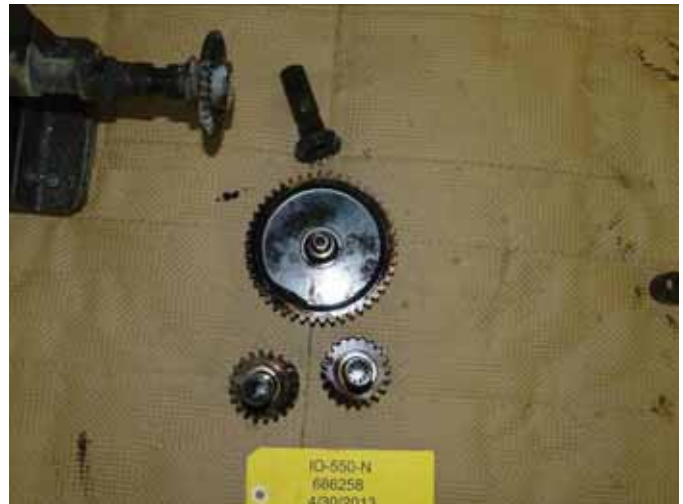
Accessory Gears

Condition: Continuity was confirmed visually. The teeth were undamaged and exhibited normal operating signatures.

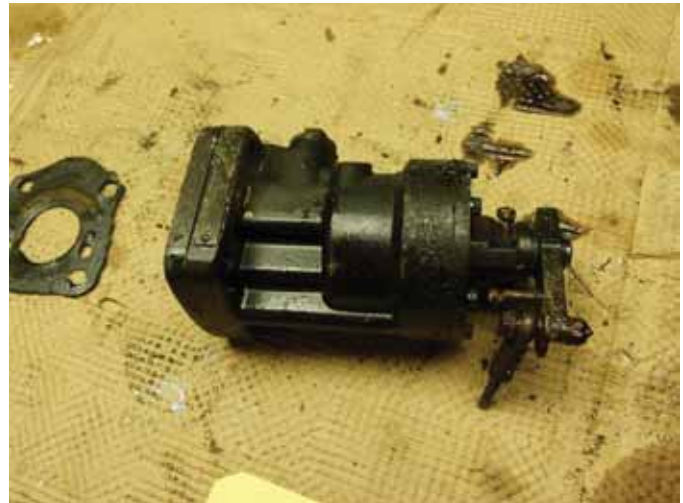
Propeller Governor    Part number: Illegible

Condition:    The propeller governor could be rotated by hand, was intact and exhibited thermal damage. The propeller governor gasket was removed and the oil screen was free of obstruction.
