**NATIONAL TRANSPORTATION SAFETY BOARD**

**Global Positioning System (GPS) Device**

**Specialist's Factual Report**

Location: Senoia, Georgia  
Date: August 9, 2014  
Aircraft: Cessna 150C  
Registration: N7968Z  
Operator: Private  
NTSB Number: ERA14FA377

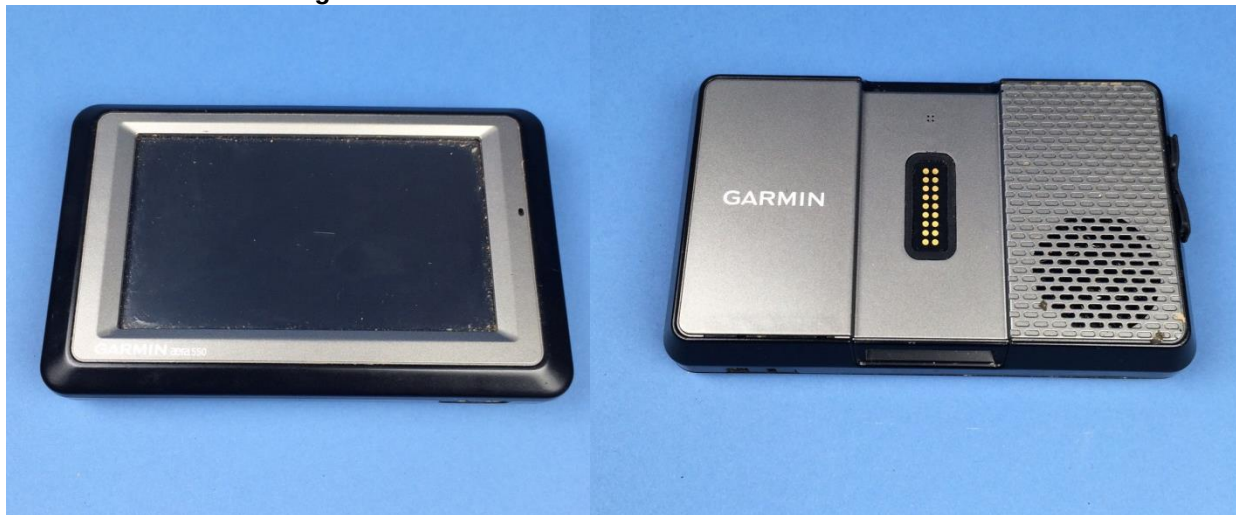
Upon arrival at the Vehicle Recorder Laboratory, an exterior examination revealed that the unit had sustained no significant damage. The unit was powered up using the device's battery and tracklog data downloaded normally to a PC running Garmin MapSource communicating with the unit via the built-in USB port. Figure 1 shows the condition of the unit shortly after it arrived in the laboratory.

**Figure 1. The front and back of the Garmin Aera 550.**

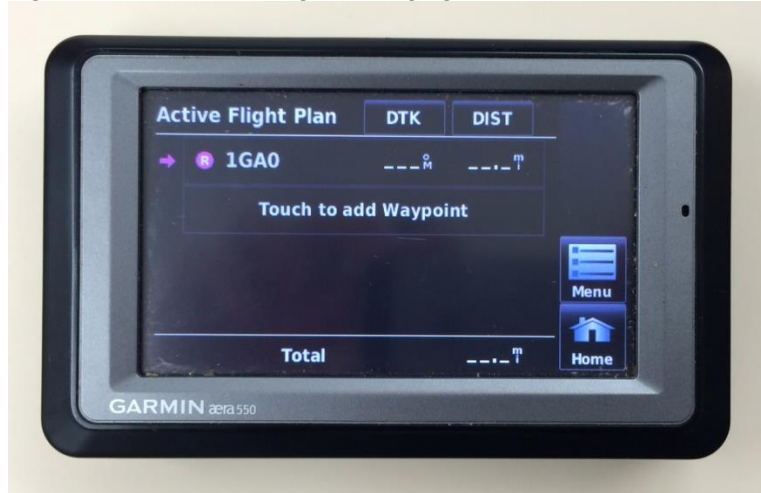
The unit functioned normally and the device's various pages were displayed in the laboratory. Upon startup, the device indicated that the "Americas Aviation Data 1102, US SafeTaxi 11S1 and US Onstacles 11B1" databases had all expired March 10, 2011. The active flight plan page showed that the user had programmed in a direct-to waypoint for Eagle Neck Airport (1GA0), Shellman Bluff, Georgia. The time at which this waypoint was entered by the user could not be determined. Figure 2 shows the Active Flight Plan screen in which the waypoint is shown.

Figure 2. The Active Flight Plan page of the Garmin Aera 550.

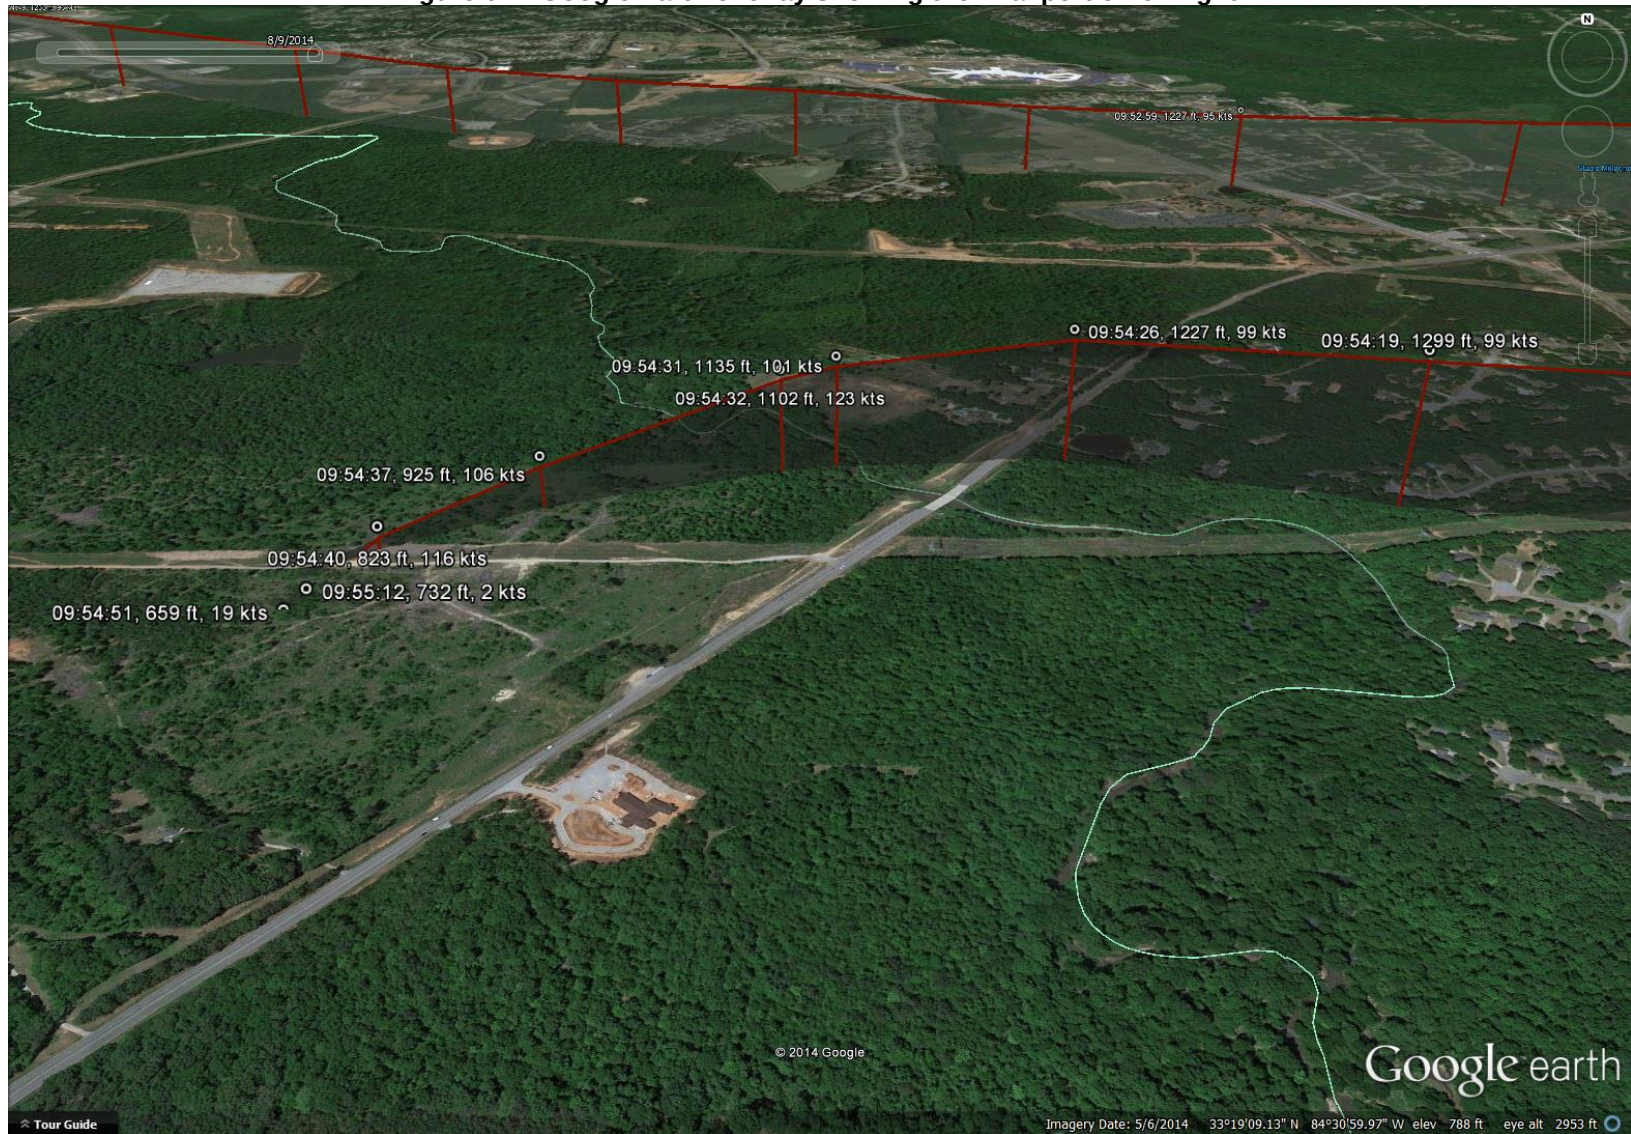
Figure 6 is a Google Earth overlay which shows the aircraft's final portion of flight and subsequent impact with terrain.

Figure 6. A Google Earth overlay showing the final portion of flight.

The session on August 9<sup>th</sup>, 2014 showed that data recording began in the ramp area of Atlanta Regional Airport-Falcon Field (FFC), Senoia, Georgia at 09:39:52 UTC. At 09:48:24, data shows the aircraft on takeoff roll departing Runway 31. The aircraft made a left turnout after departure and climbed to 1,191 feet. When turning downwind toward the southeast, the aircraft lost altitude briefly. The aircraft climbed and continued on a southeasterly heading where its altitude was shown between approximately 1,100 and 1,800 feet. Around 09:53:28, the aircraft began a right turn from 1,368 feet toward a westerly heading. Finally, at 09:54:26 at an altitude of 1,227 feet and a derived groundspeed of 99 knots, the aircraft began a slight left descending left turn toward the impact location. During this time, the data showed a maximum recorded groundspeed of 123 knots. At 09:54:40, the aircraft was shown with an altitude of 823 feet and a groundspeed of 116 knots in the immediate vicinity of a high tension power line area approximately 3.25 NM southeast of the departure airport. At 09:54:51 UTC, data showed the aircraft's altitude had been degraded to a value roughly matching the topographic region. At this time, the aircraft's altitude had been reduced to 659 feet and derived groundspeed was shown as 19 knots. The last recorded data point was taken at 09:55:12 in the immediate vicinity of the wreckage location and recorded the aircraft at a derived groundspeed of 2 knots. This last recorded groundspeed value may be unreliable due to the device's sampling rate and the way it derives the groundspeed parameter using averaging.
