## **NATIONAL TRANSPORTATION SAFETY BOARD**

### **Meteorology Factual Report**

**ERA15FA088**

Location: near Kuttawa, Kentucky  
Date: January 2, 2015  
Time: About 1755 central standard time (2355 UTC<sup>1</sup>)  
Airplane: Piper Seneca PA-34; registration N81291

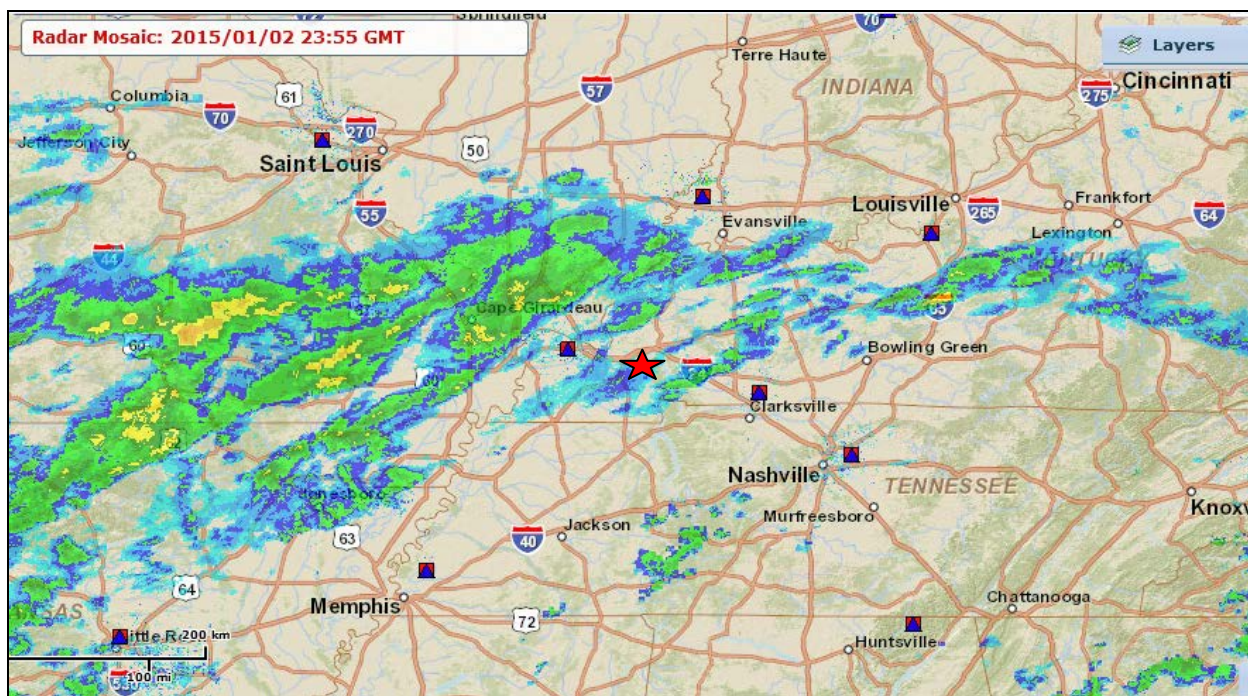
Figure 3 - NWS National radar mosaic for 1755 CST (2355Z)

The NOAA National Climatic Data Center (NCDC) National radar mosaic for 1755 CST (2355Z) is included as figure 3. The image depicted a band of echoes associated with rain showers extended over western Kentucky into southern Missouri and Illinois, and into northern Arkansas. The image depicted very light intensity echoes in the vicinity of the accident site, and rain showers between the accident site and the destination airport.

The closest NWS weather radar will be further documented in section 5.0 of this report, to further identify if any significant weather echoes were identified along the flight track and accident site.
