# NATIONAL TRANSPORTATION SAFETY BOARD

## Global Positioning System Device

### Specialist's Factual Report

Location: Mulberry, Tennessee  
Date: May 3, 2015  
Aircraft: Cessna 182P  
Registration: N6579M  
Operator: Private  
NTSB Number: ERA15FA204

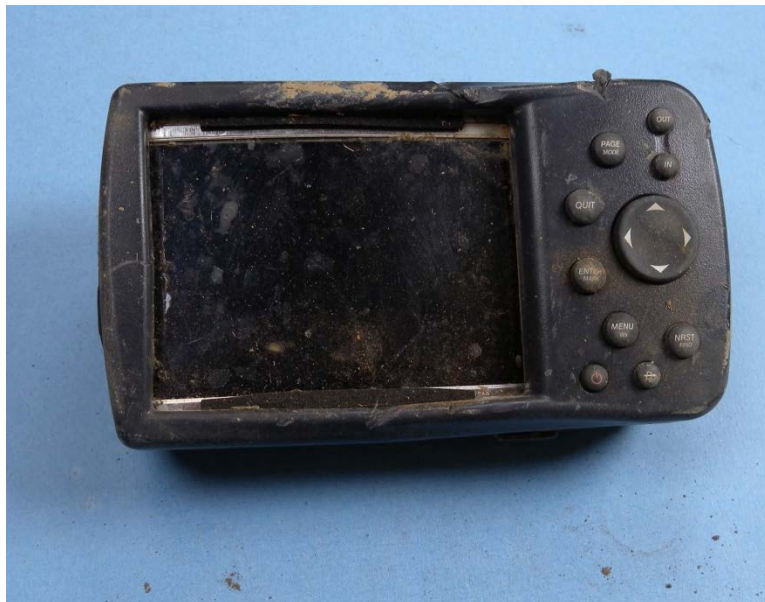
**Figure 1. Front of Garmin GPSMAP 396**

Upon arrival at the Vehicle Recorder Laboratory, an exterior examination revealed that the unit had sustained moderate damage. The device was covered with a coating of an unknown grey powdered substance. The glass protecting the screen on the front was broken. Figure 1 and 2 show the front and back of the device as received at the Vehicle Recorder Laboratory.
