**NATIONAL TRANSPORTATION SAFETY BOARD**  
Vehicle Recorder Division  
Washington, D.C. 20594

## **GPS and Personal Electronic Devices**

**Specialist's Factual Report  
by Joe Gregor**

Location: Saltville, Virginia  
Date: May 18, 2015  
Aircraft: Beech 95-B55  
Registration: N5816S  
Operator: Private  
NTSB Number: ERA15FA215

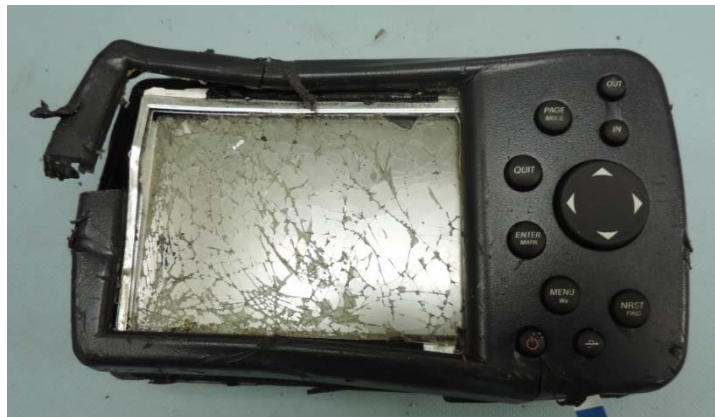
**Figure 1.** External view of the Garmin GPSMAP 495

Upon arrival at the Vehicle Recorder Division, an exterior examination revealed the unit had sustained substantial impact damage. The integrated circuit that contained stored track log data was cracked and unreadable.

No data was recovered from the GPSMAP 496.

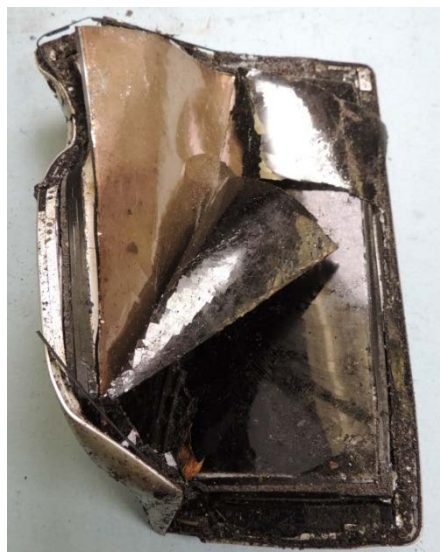
**Figure 2.** External view of the Apple iPad 3

Upon arrival at the Vehicle Recorder Laboratory, an exterior examination revealed the unit had sustained catastrophic impact damage. An internal inspection revealed that the internal circuitry was damaged beyond repair.

No data was recovered from the iPad 3.

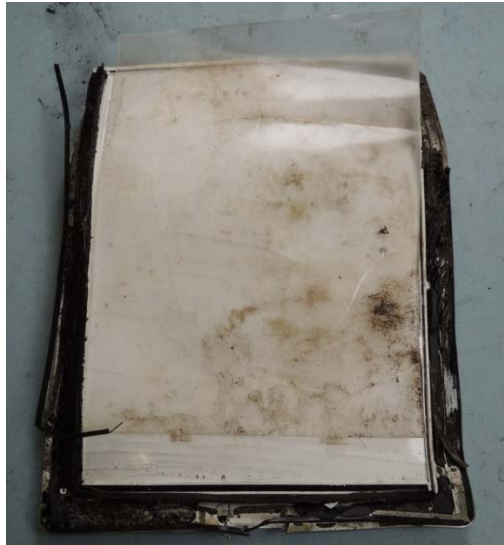
**Figure 4.** External view of the Apple iPad 2

Upon arrival at the Vehicle Recorder Laboratory, an exterior examination revealed the unit had sustained substantial impact damage. An internal inspection revealed that the internal circuitry was damaged beyond repair.

No data was recovered from the iPad 2.

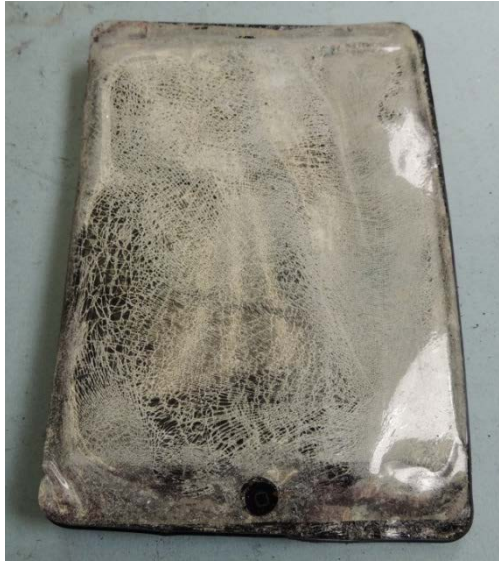
**Figure 4.** External view of the Apple iPad Mini

Upon arrival at the Vehicle Recorder Laboratory, an exterior examination revealed the unit had sustained substantial impact damage. An internal inspection revealed that the internal circuitry was damaged beyond repair.

No data was recovered from the iPad Mini.
