## SCENE EXAMINATION REPORT

CSSS JOB NO. 1286

Plane Crash

HOM 607-09, 215CR0329533

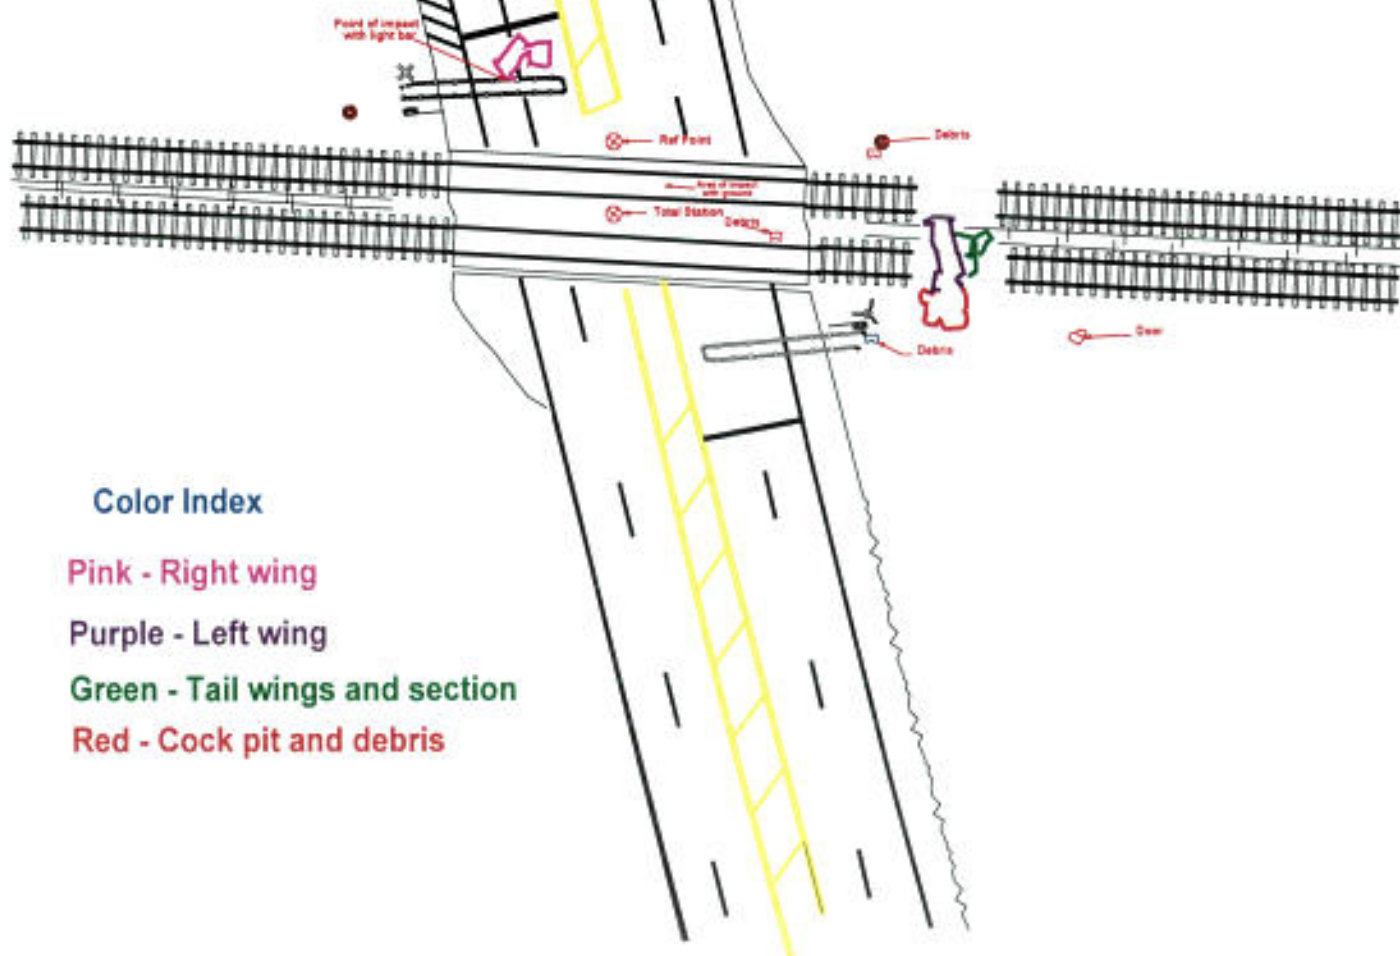
\* NOTE - LIRR light bar - 20' 9" above pavement when aircraft came into contact. See photos, video and discription for further details of crash

### Color Index

Pink - Right wing

Purple - Left wing

Green - Tail wings and section

Red - Cock pit and debris
