**NATIONAL TRANSPORTATION SAFETY BOARD**

## **Global Positioning System Device**

### **Specialist's Factual Report**

Location: Reynolds, Georgia  
Date: March 15, 2015  
Aircraft: KOLB MK-II  
Registration: N193Y  
Operator: Private  
NTSB Number: ERA15LA156

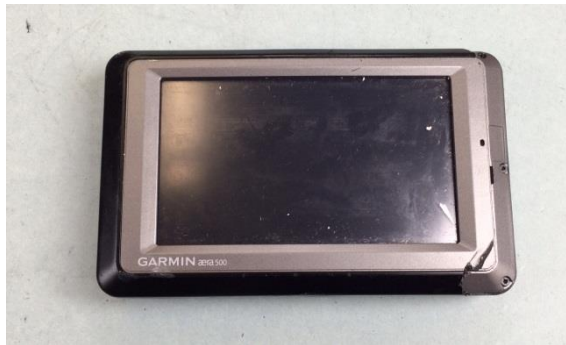
**Figure 1.** Front of Garmin Aera 500.

The device arrived with light damage around the unit's black frame but was in working condition. The device was connected to a PC via a USB cable and was downloaded normally using the manufacturer's recommended procedure and software.

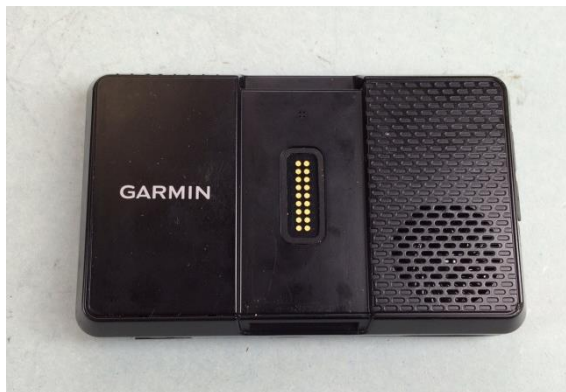
**Figure 2.** Back of Garmin Aera 500.

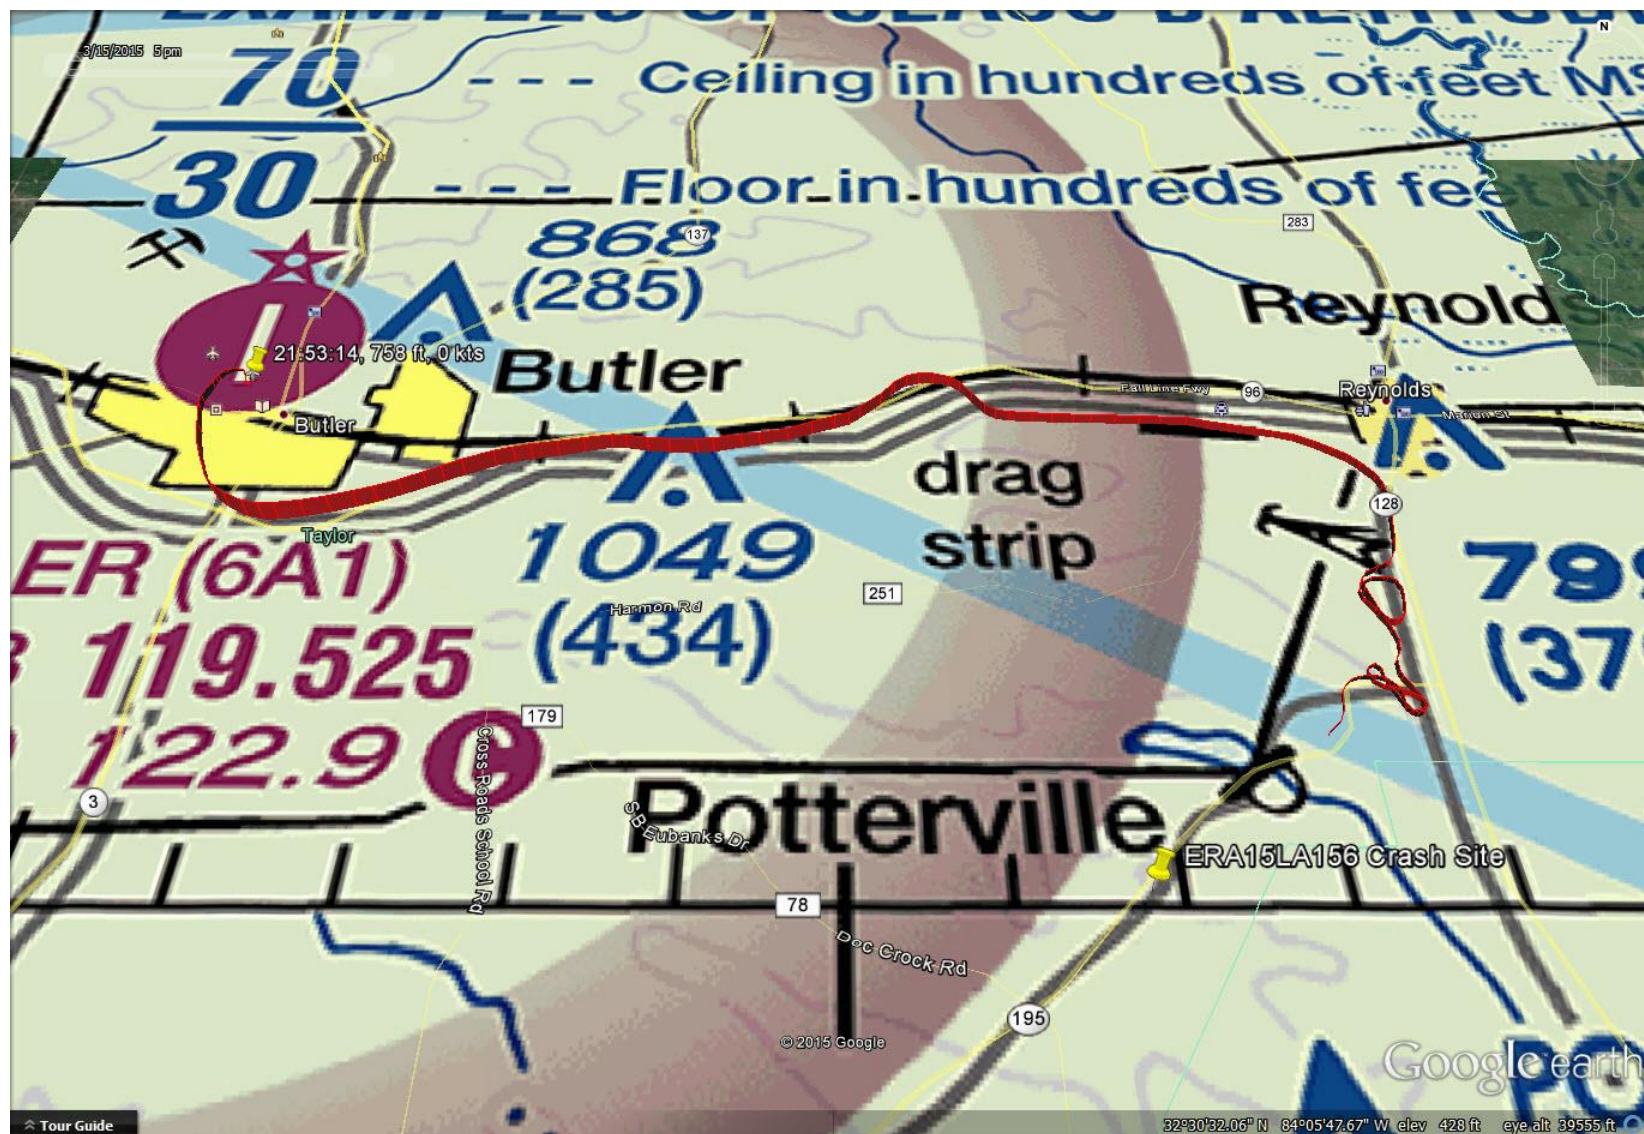
Figure 7 is a graphical overlay generated using Google Earth showing the recorded tracklogs for the accident flight overlaid on the Atlanta Sectional chart. A pin is shown placed at recorded coordinates for the aircraft wreckage site provided by the Investigator-In-Charge.

Figure 7. Google Earth overlay showing the entire recorded tracklog for the accident flight overlaid on the Atlanta Sectional Chart.
