# NATIONAL TRANSPORTATION SAFETY BOARD

MATERIALS LABORATORY FACTUAL REPORT

Report No. 16-030

Place : Charlotte Vermont  
Date : August 7, 2015  
Vehicle : Zenith STOL CH 750  
NTSB No. : ERA15LA381  
Investigator : Brian Rayner

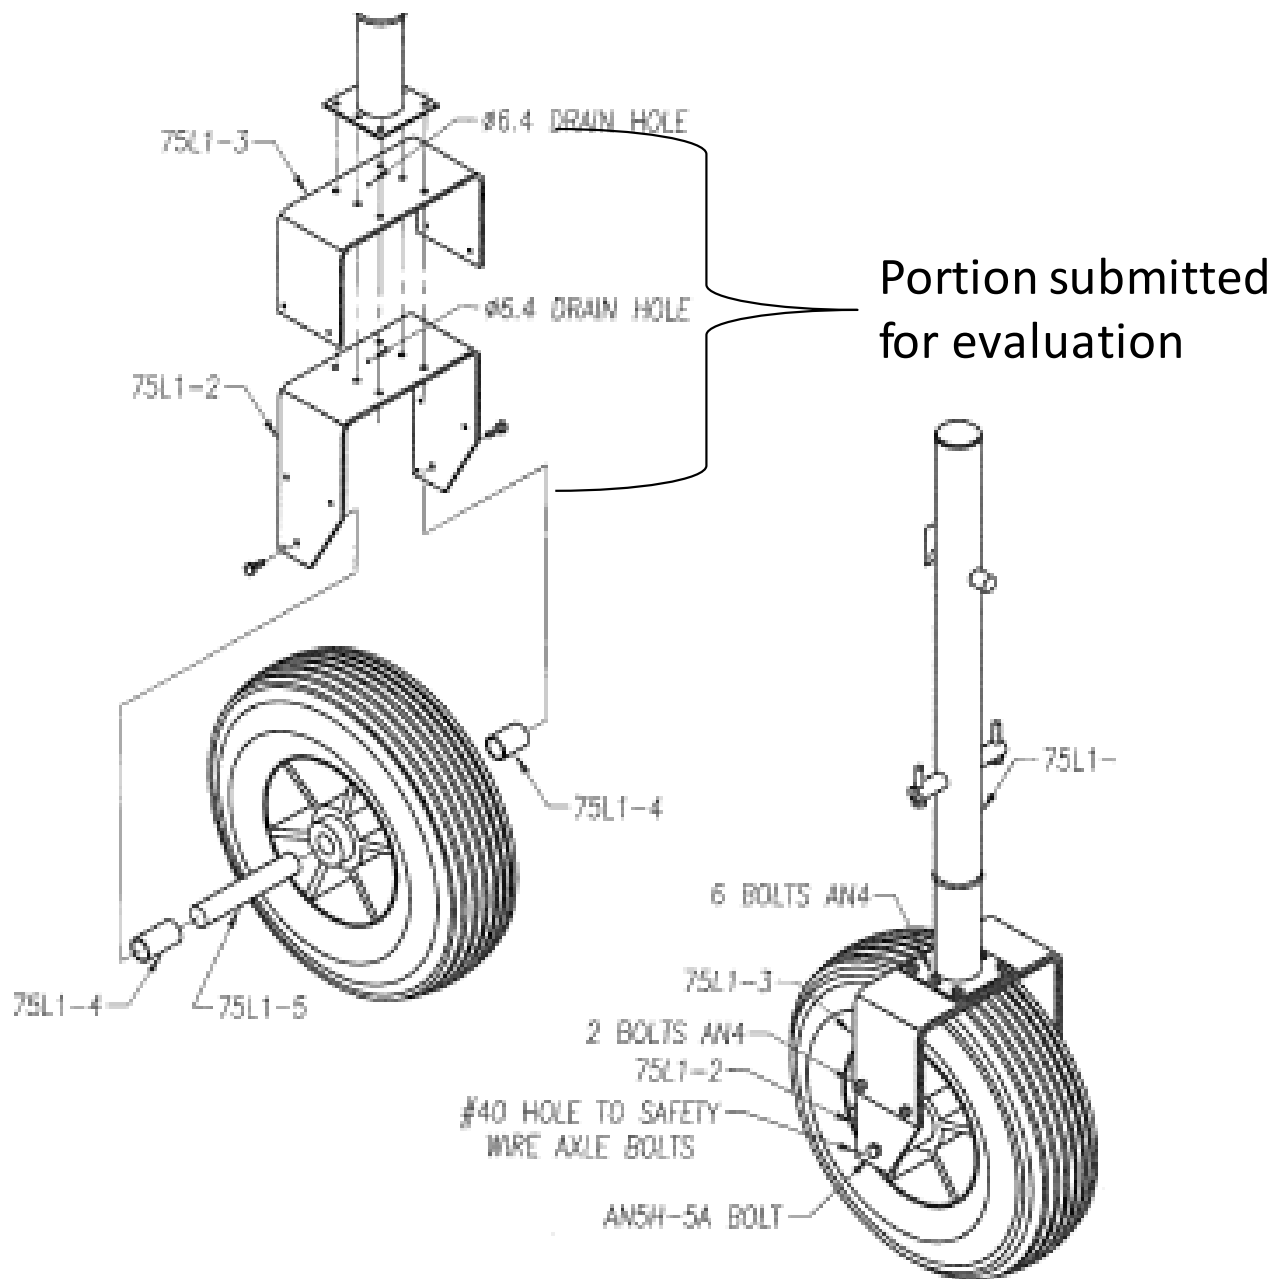
Figure 1 Isometric engineering drawings of the nose landing gear assembly.

An engineering drawing of the nose landing gear is shown in Figure 1, with the submitted fork and doubler identified. Figures 2 and 4 show the as-received fork with the doubler attached. Visual examination revealed bending deformation of the fork tangs and the top portion of the fork. The approximate angles of deformation are shown in Figure 3. Based on the deformation pattern, a simple sketch showing the approximate kinematic deformation of the fork due to a side-oriented force is shown in Figure 5.

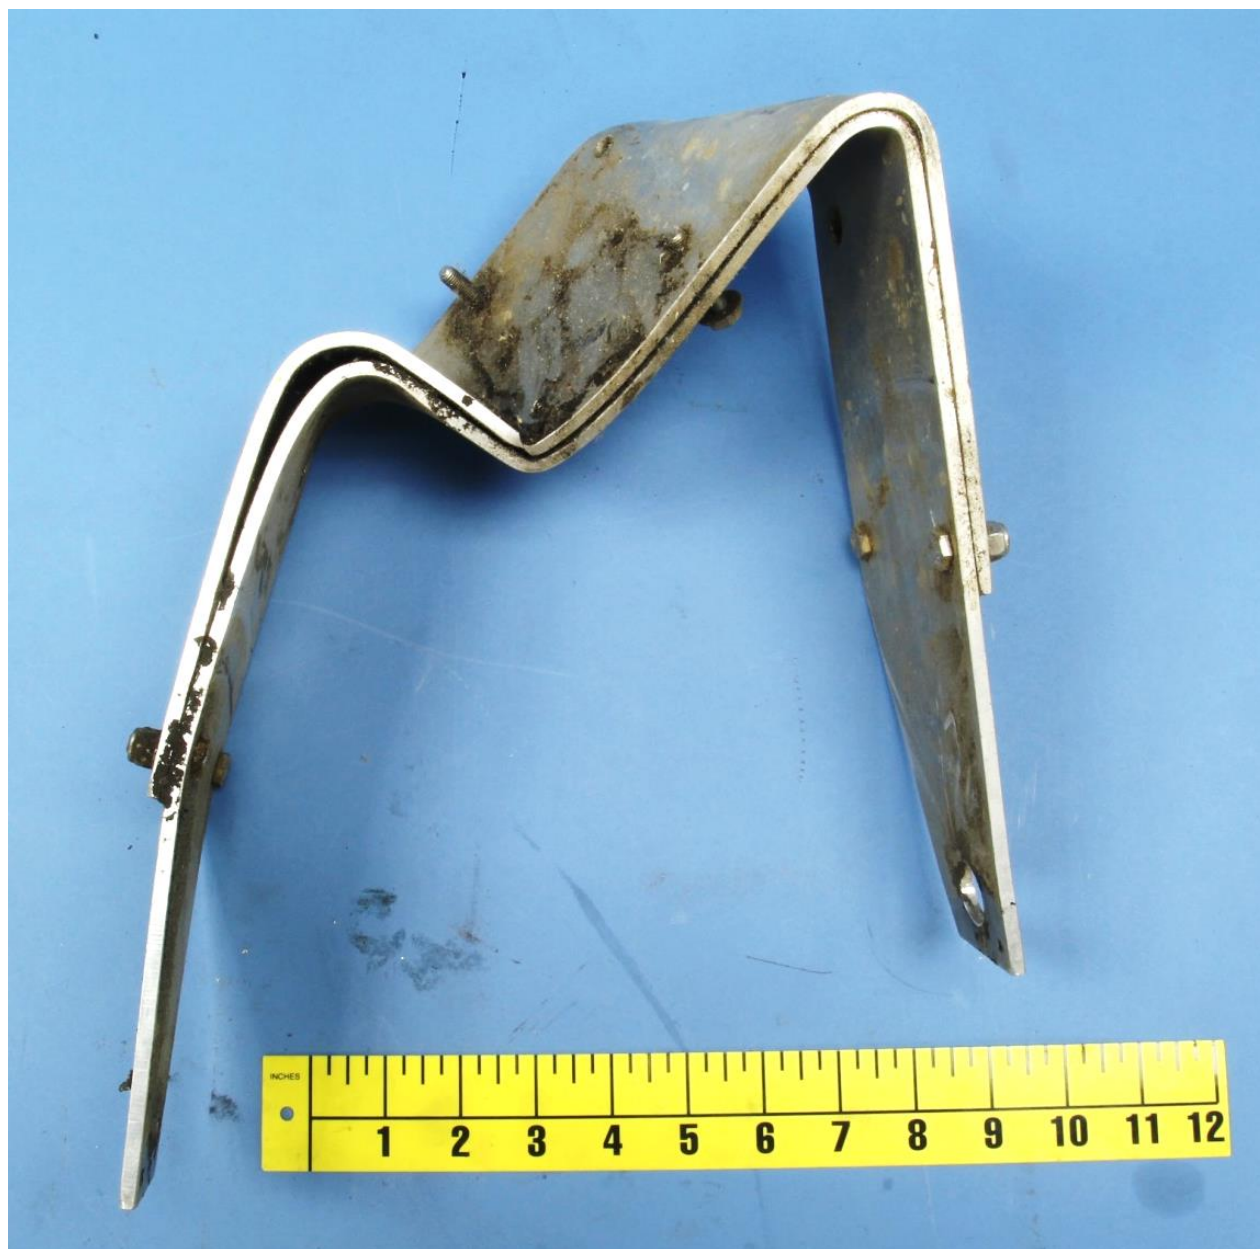
Figure 2 View of the as-received portion of nose landing gear fork and doubler.

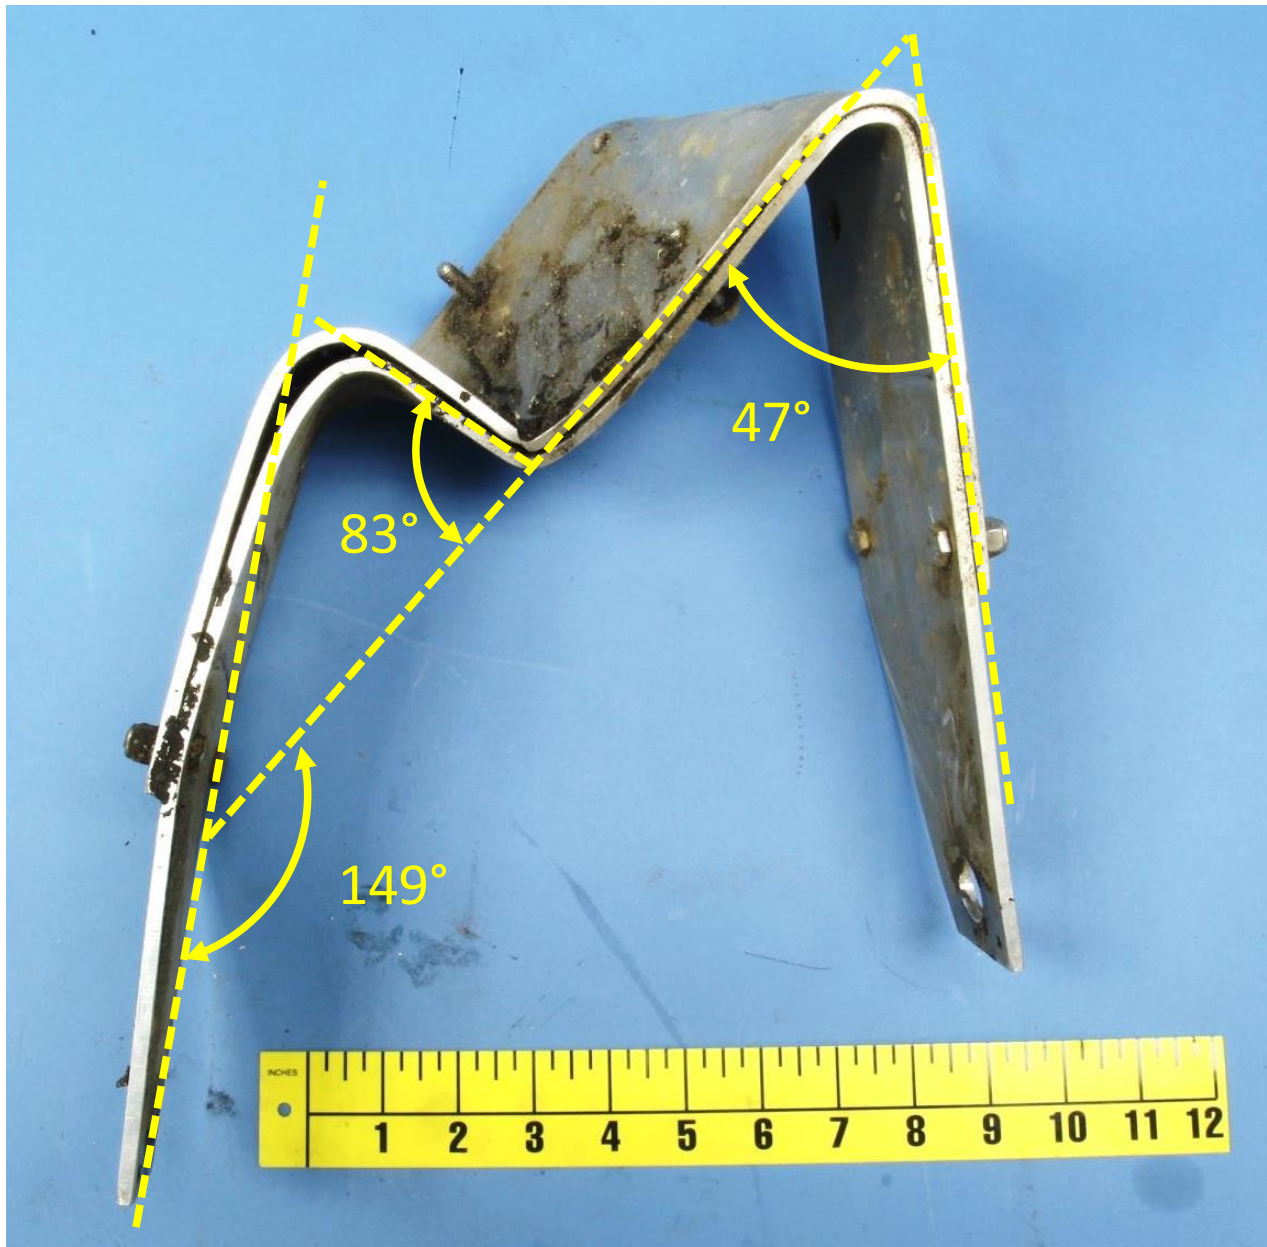
Figure 3 Same view as Figure 2 with the approximate angles of deformation indicated.

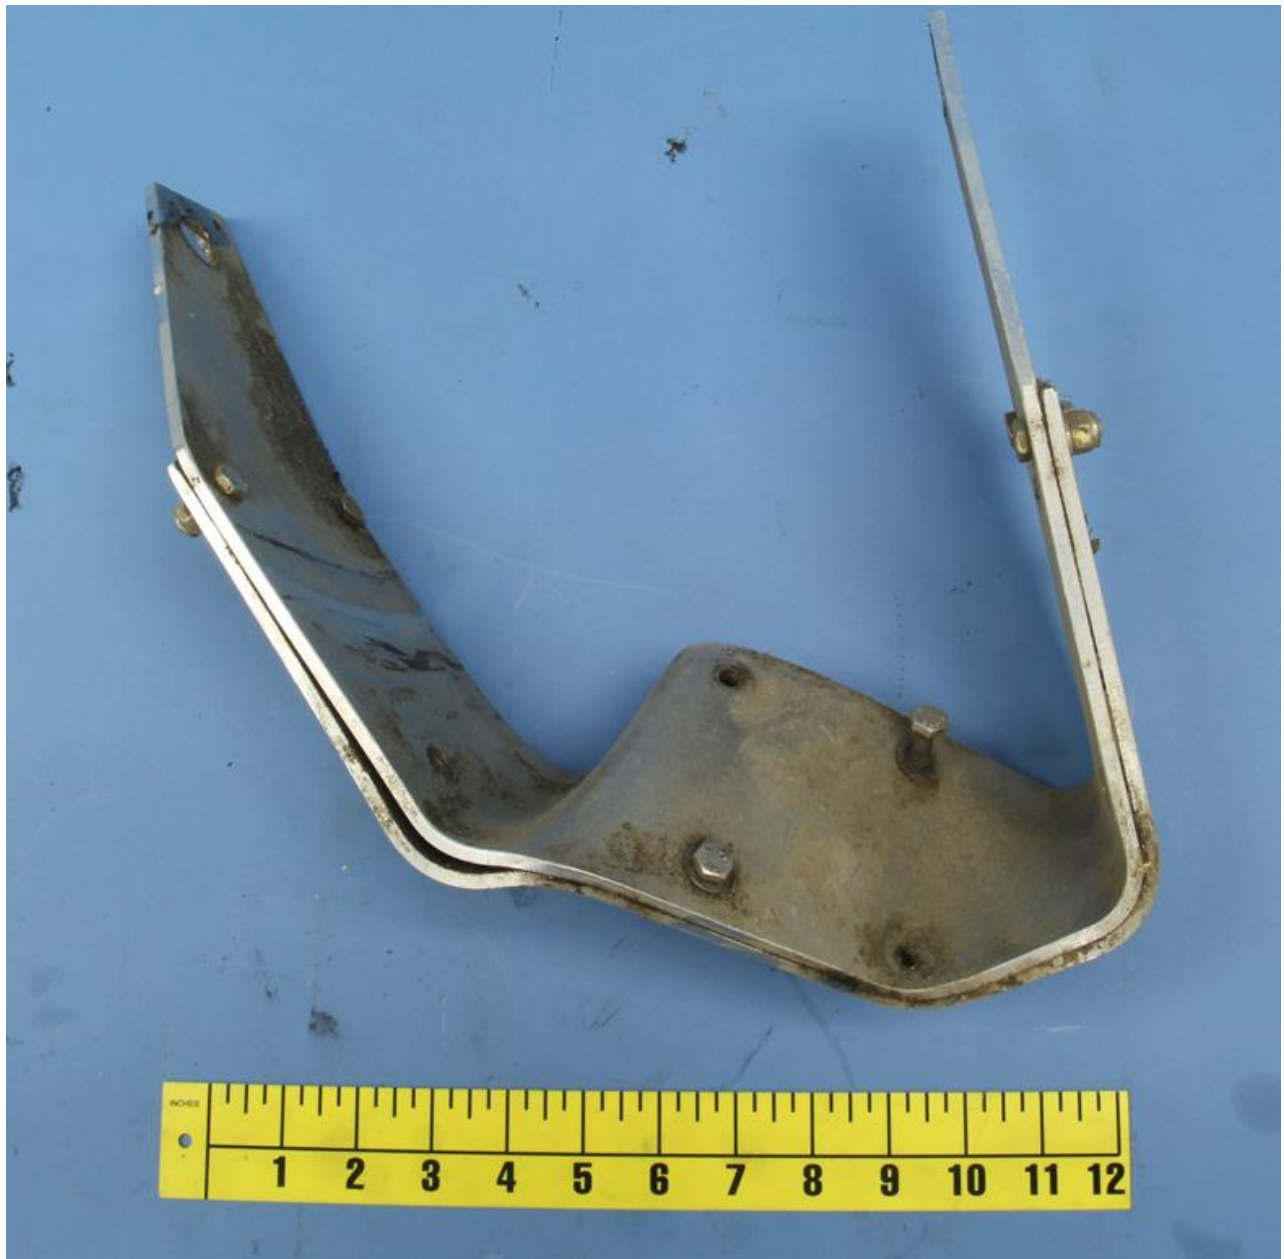
Figure 4 View showing the underside of the nose landing gear fork and doubler assembly.

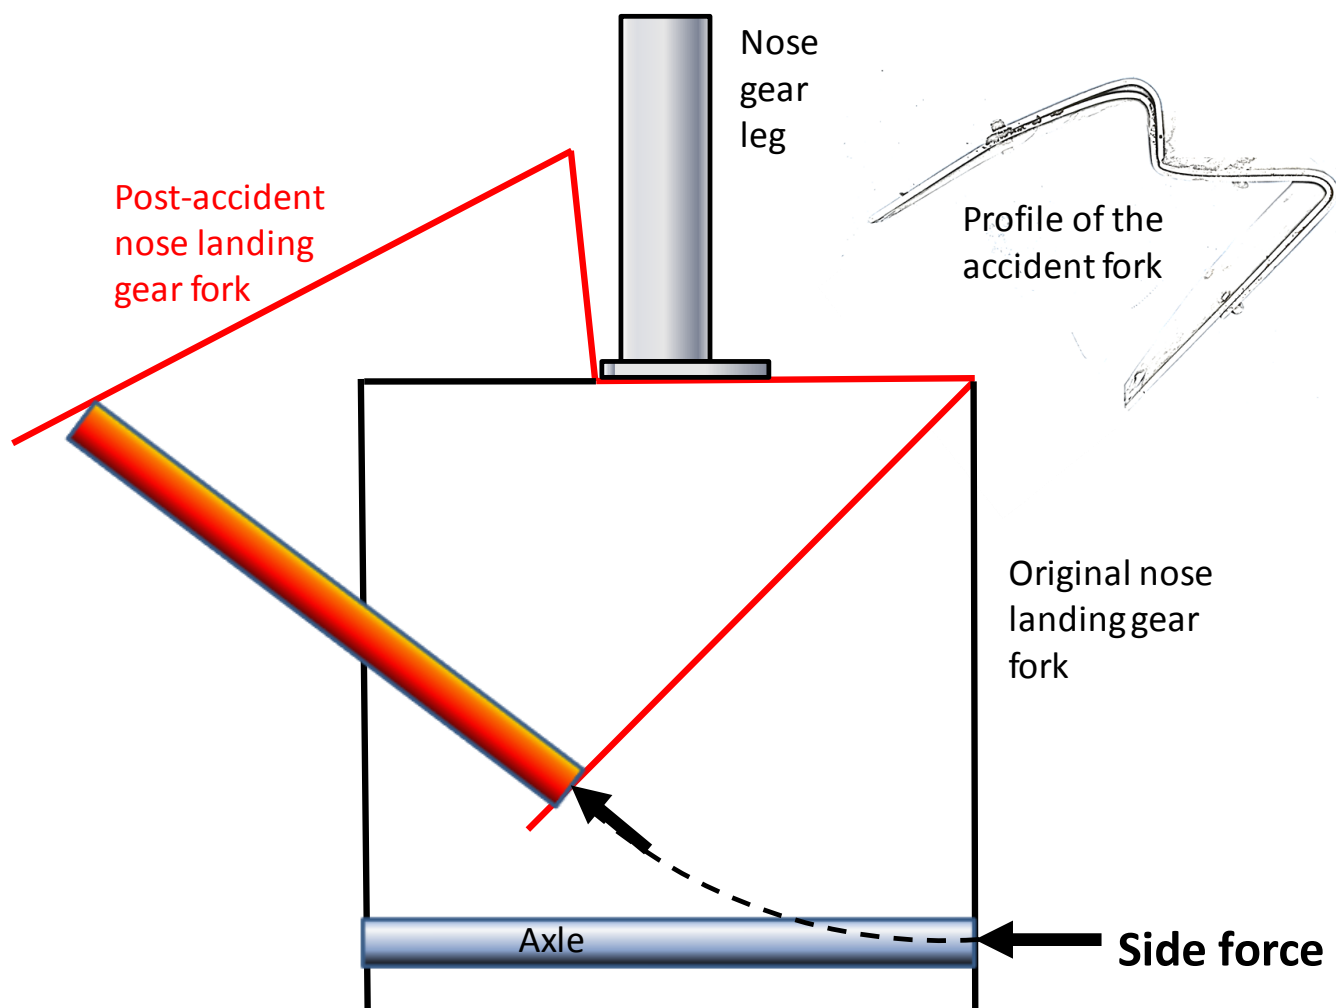
Figure 5 Schematic diagram showing the approximate kinematic deformation of the fork during the accident.
