## **NATIONAL TRANSPORTATION SAFETY BOARD**

### **Group Chairman's Factual Report**

# **METEOROLOGY**

**ERA16FA035**

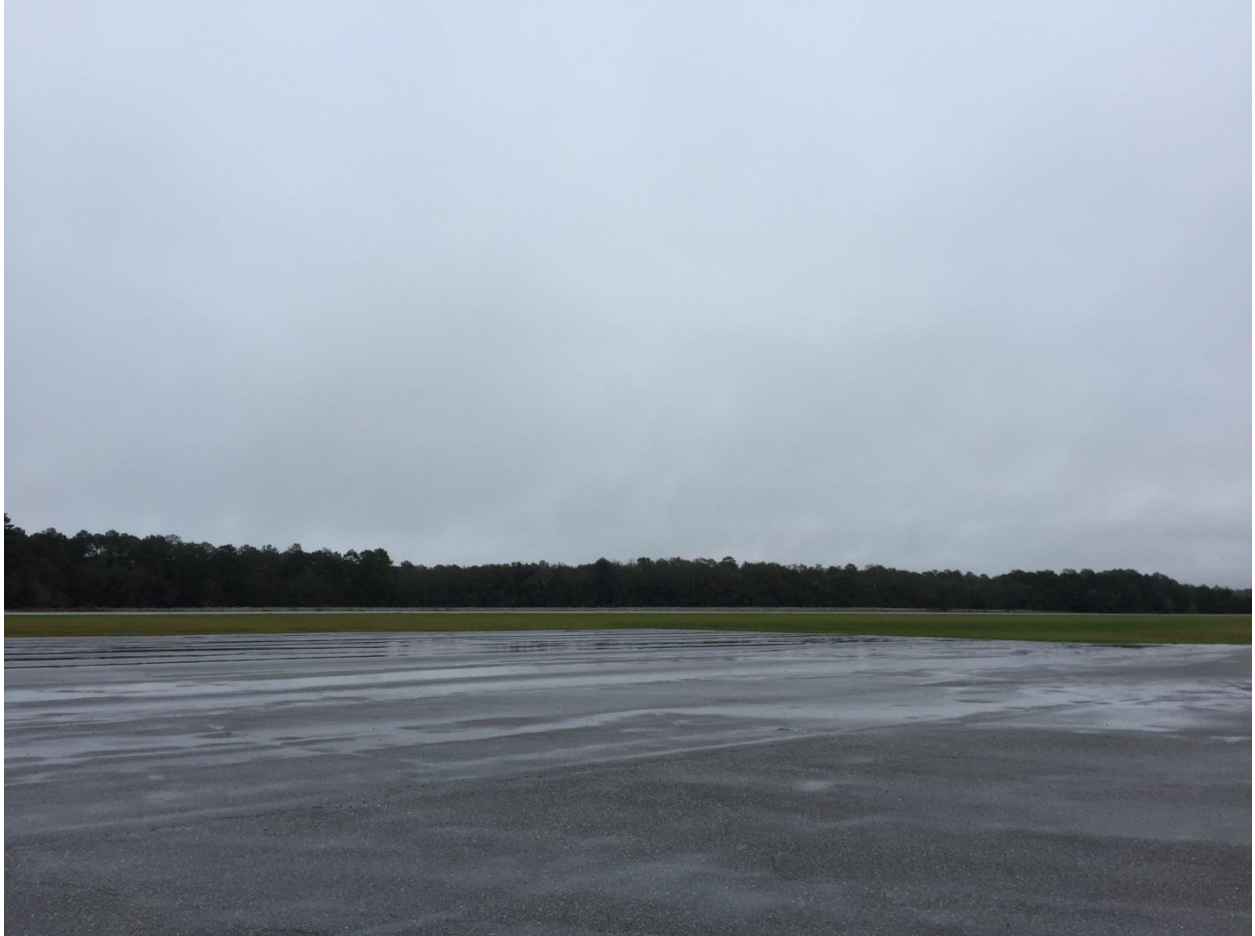
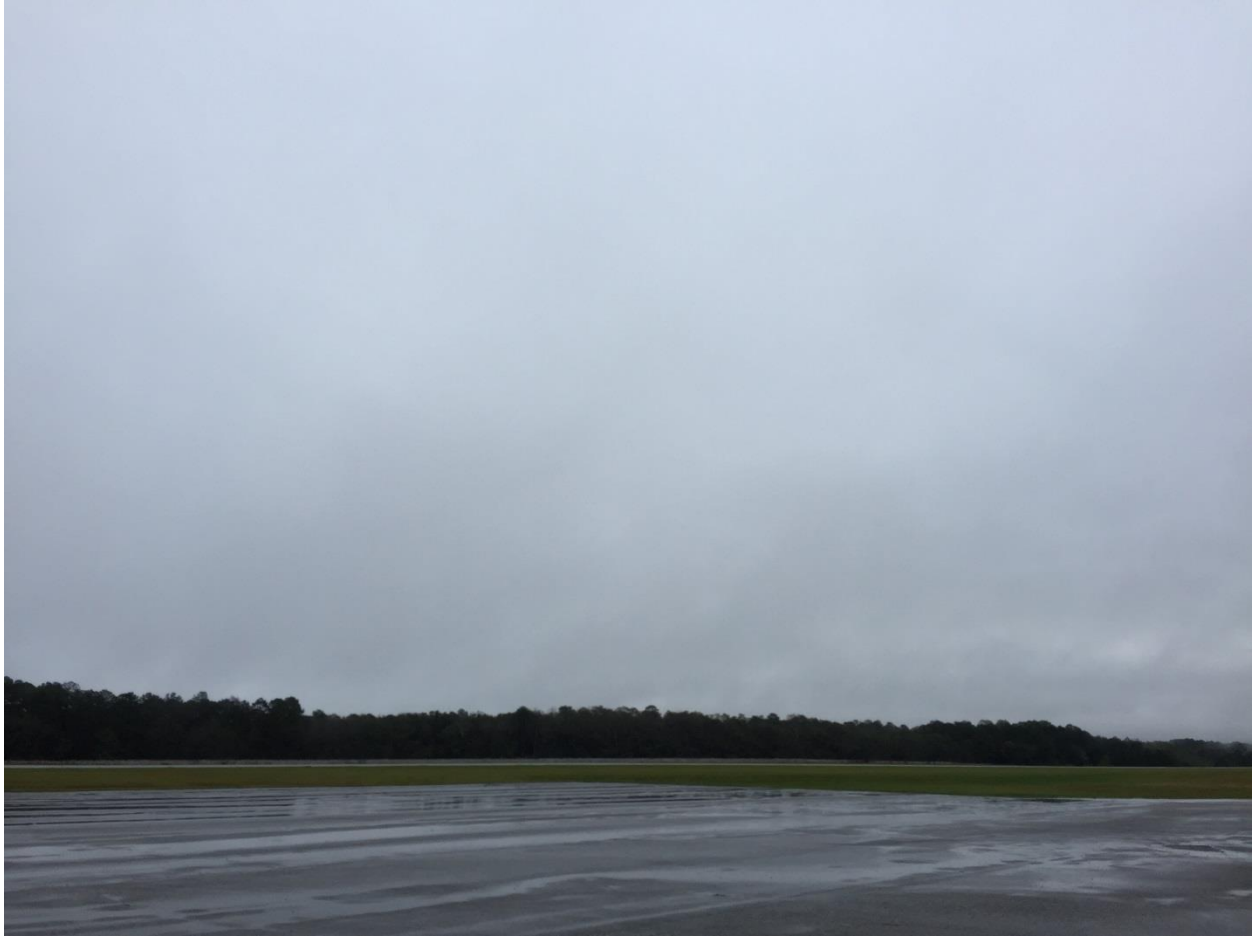
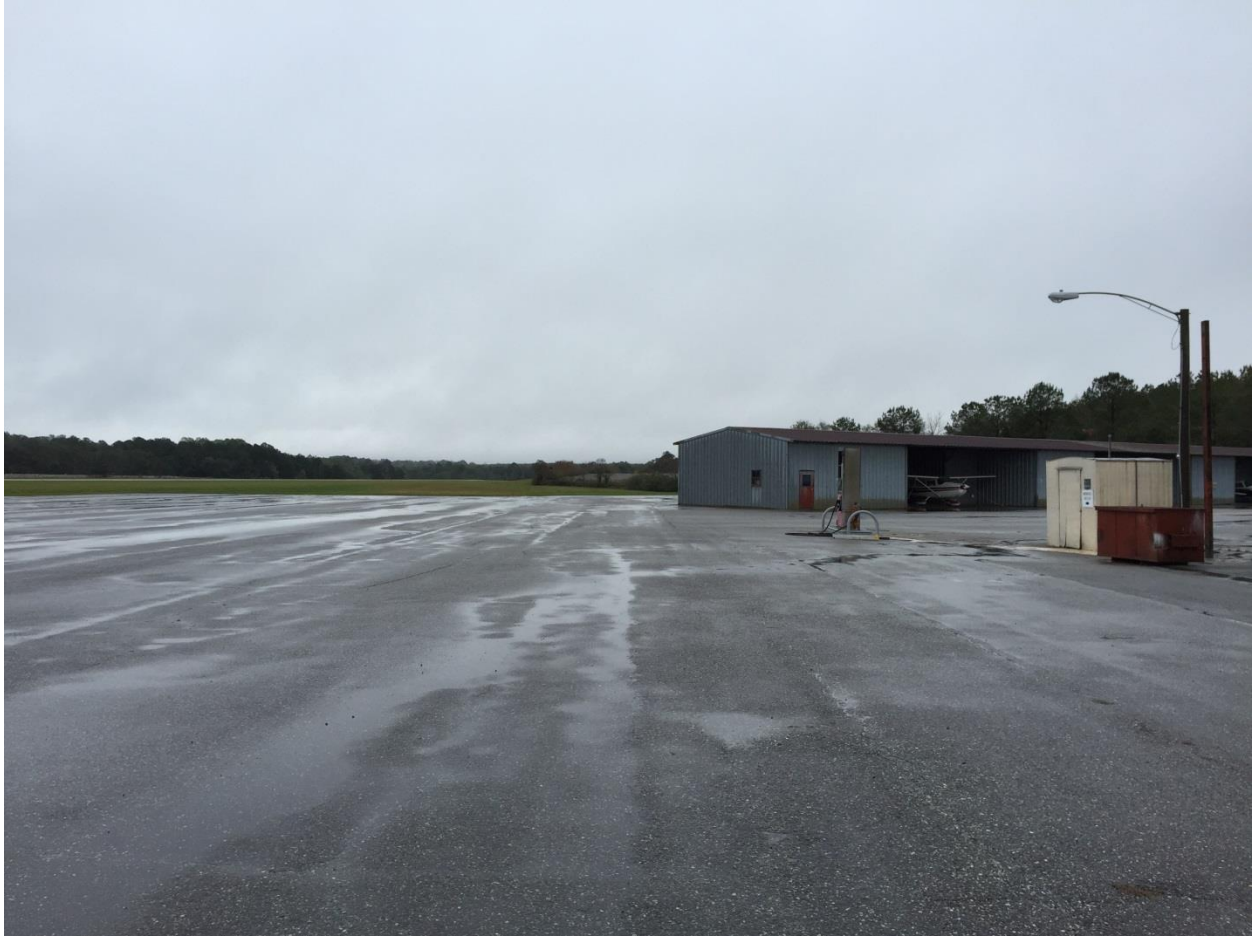
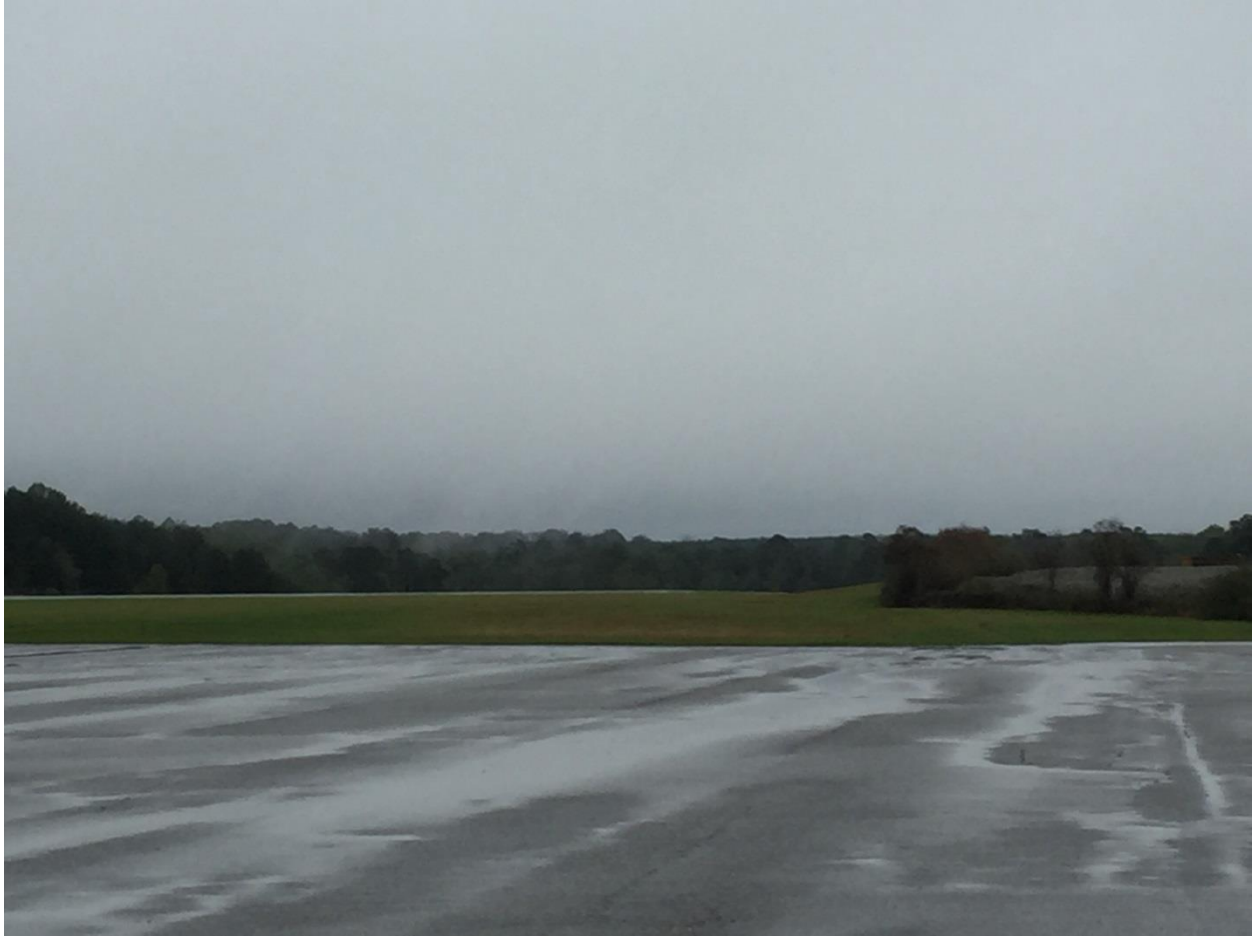
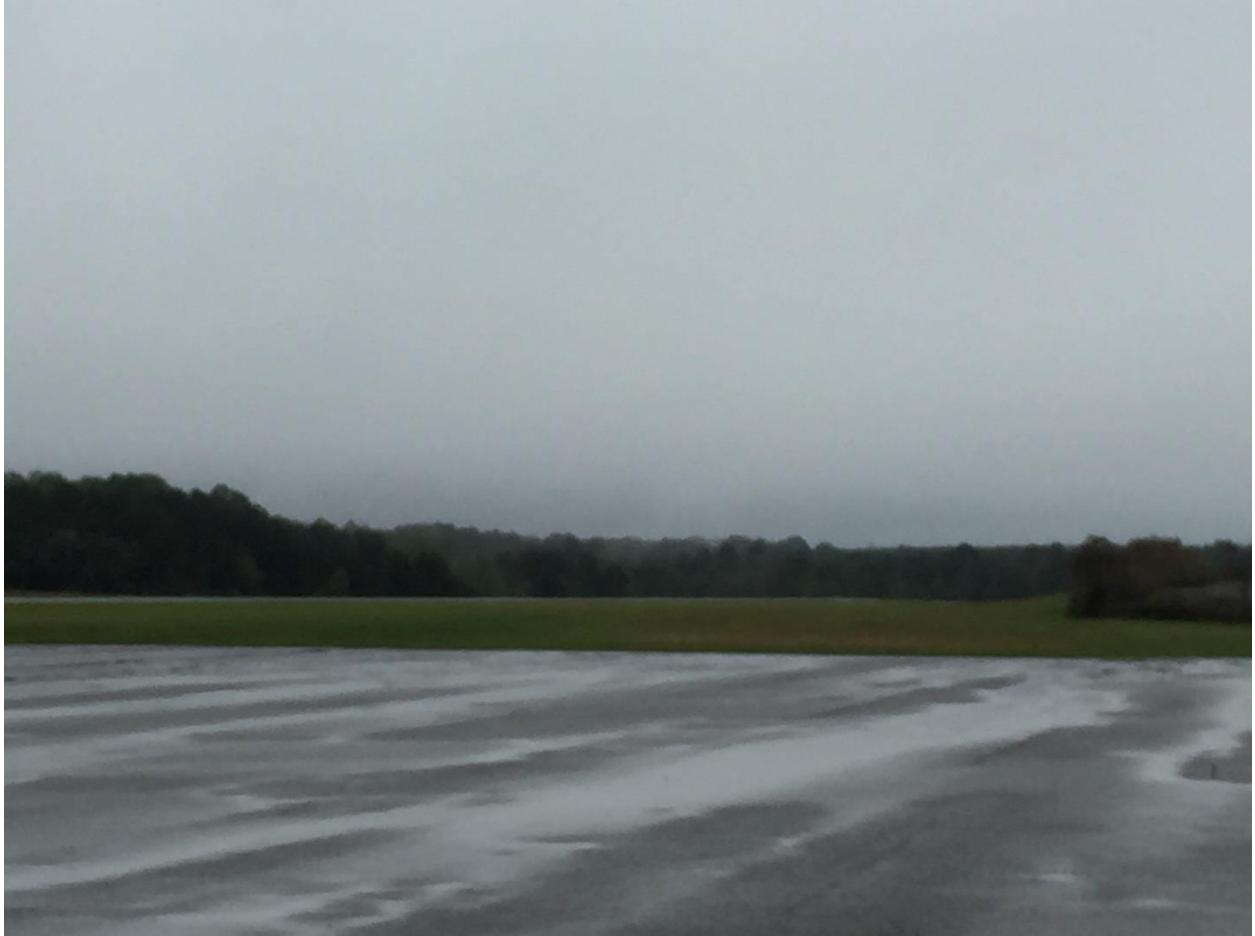
One of the persons' waiting to be picked up for the proposed return flight was at the destination airport, Cairo-Grady County Airport, before, at, and after the accident time. Figures 27 through 31 are images taken from the witness at Cairo-Grady County Airport between 0939 EST and 1001 EST. The images from 0939 to 1001 EST indicated low stratus and strato-cumulus clouds with rain having fallen at the airport recently. There are indications of mist in the trees on the southeastern end of the runway at 1001 EST (figures 30 and 31). Several other witnesses were located at Cairo-Grady County Airport around the accident time and they conveyed that the ceiling was overcast at 250 feet agl (attachment 2).

**Figure 27 – Witness image taken at 0939 EST from Cairo-Grady County Airport looking eastward**

**Figure 28 – Witness image taken at 0939 EST from Cairo-Grady County Airport looking east-southeastward**

**Figure 29 – Witness image taken at 0942 EST from Cairo-Grady County Airport looking southeastward**

**Figure 30 – Witness image taken at 1001 EST from Cairo-Grady County Airport looking southeastward**

**Figure 31 – Witness image taken at 1001 EST from Cairo-Grady County Airport looking east-southeastward**
