# Honeywell

Re: NTSB ID: ERA16FA043, N7FG, Beech A36TC; Honeywell examination

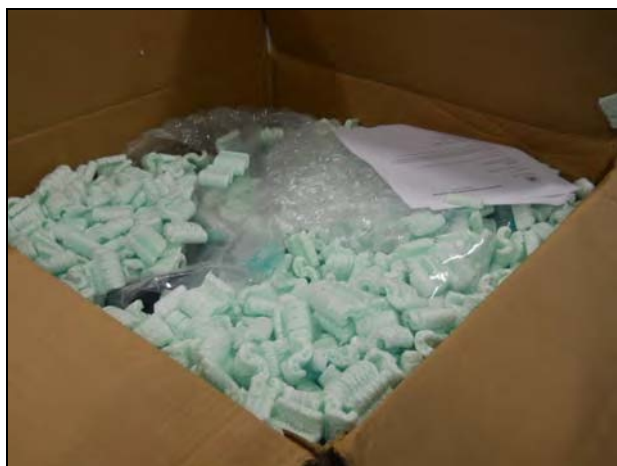
Items hand-carried by the FAA to Honeywell

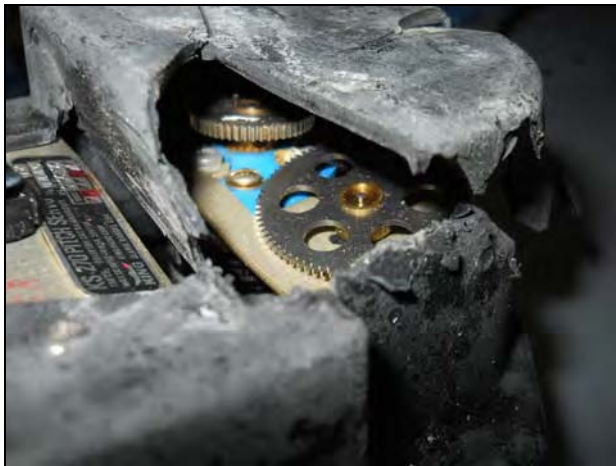
- The bracket that attaches the tach motor to the servo motor was bent, preventing gear engagement between the tach motor and servo motor. The bracket was straitened to allow gear engagement.

KS 270 Pitch Servo: internal damage – bracket bent, gears don't mesh

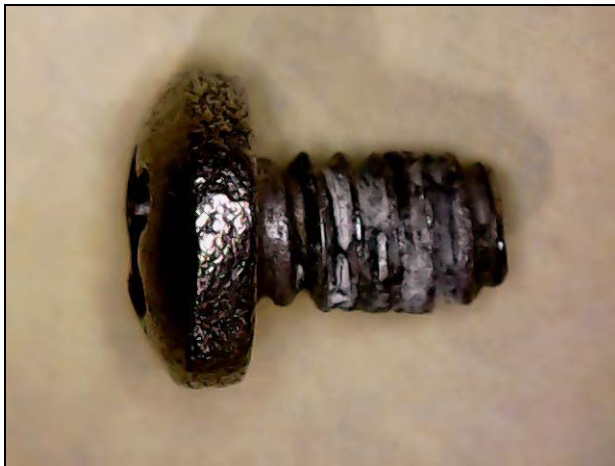
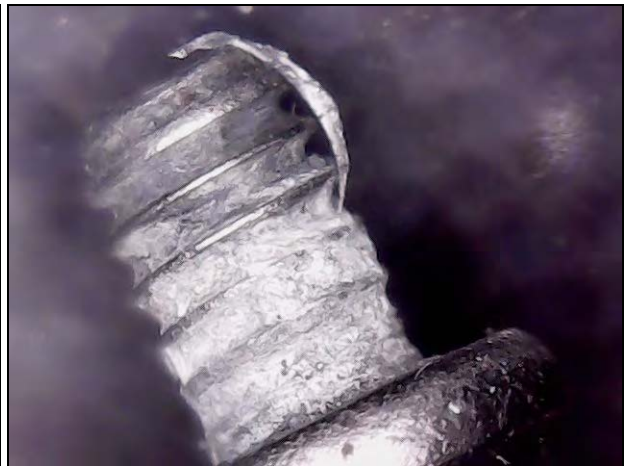
Screw securing circuit module assembly to the base plate assembly. Aluminum colored material located in the threads. The screw installs in the servo baseplate location shown in the following photo – notice damage or absence of threads.

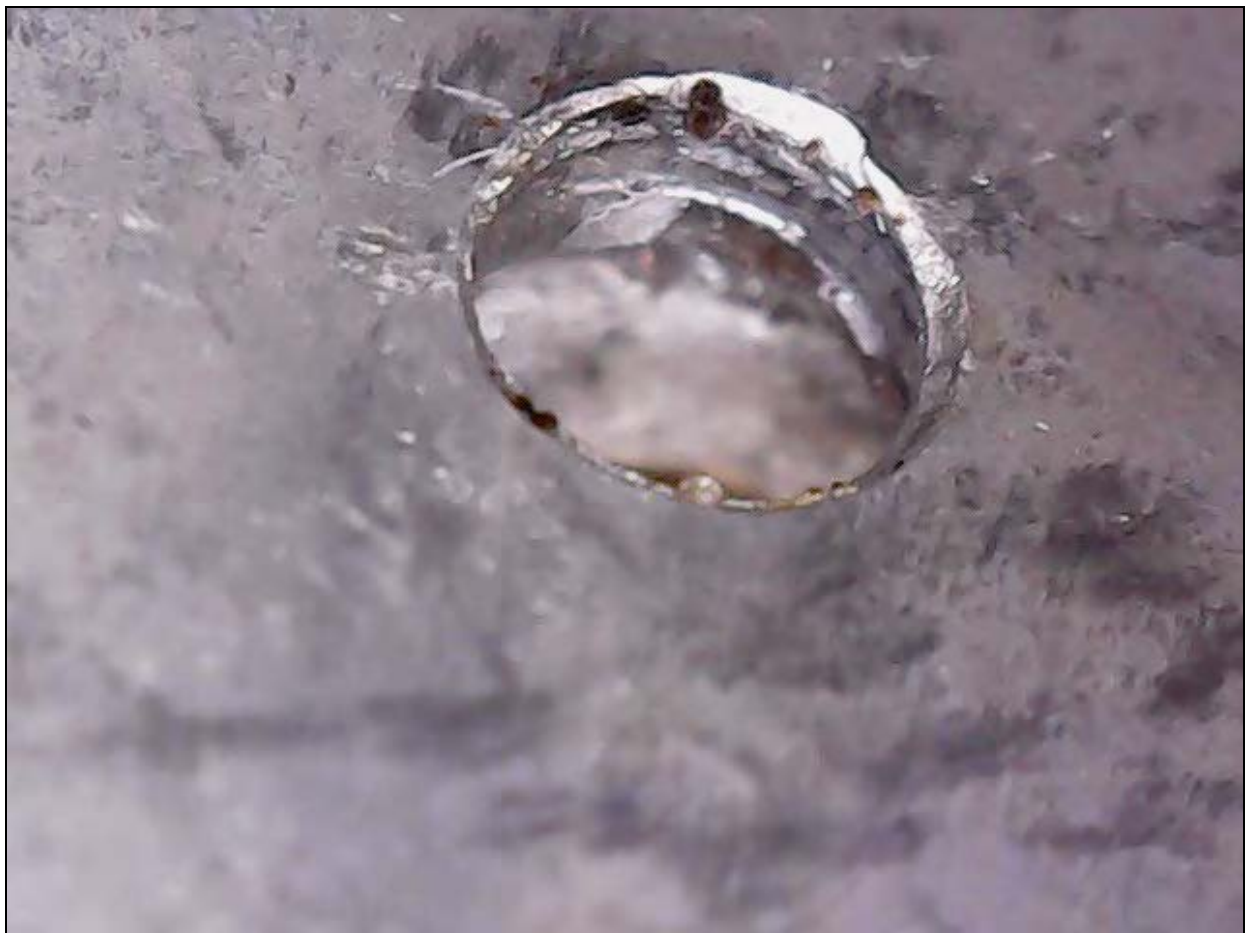
Screw hole in the servo baseplate – thread damage

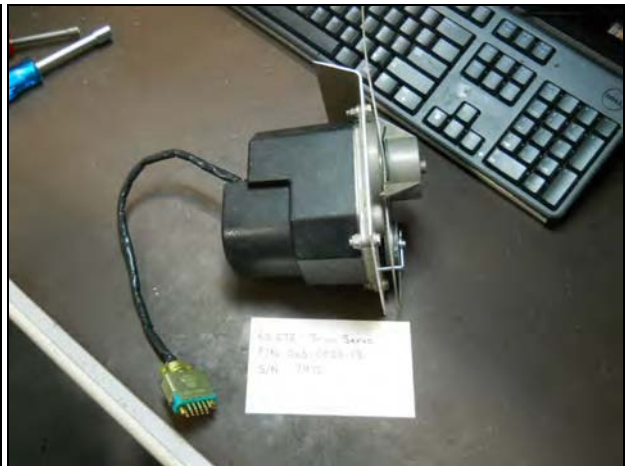
KS 272 Trim Servo received with associated mount and aircraft bracket

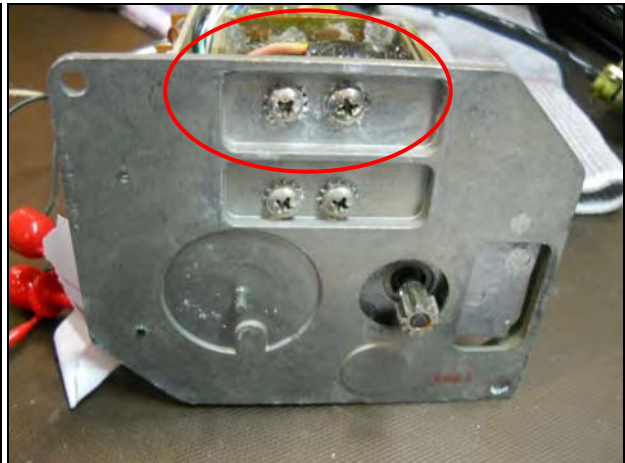
Rust/oxidation present

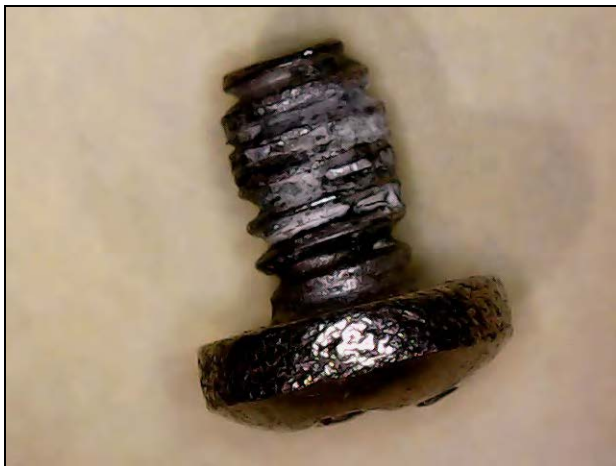
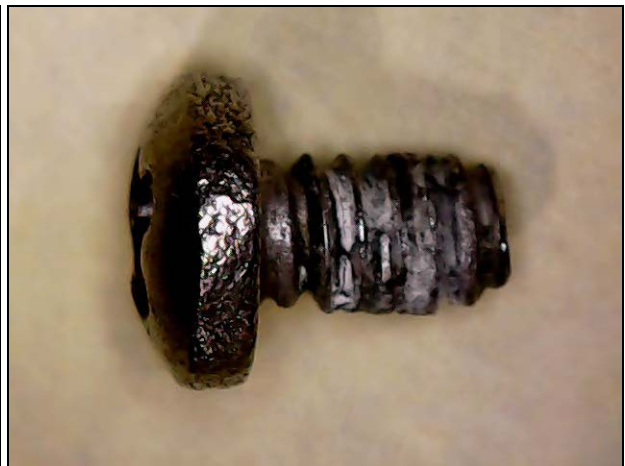
Screw securing circuit module assembly to the base plate assembly. Aluminum colored material in the threads.

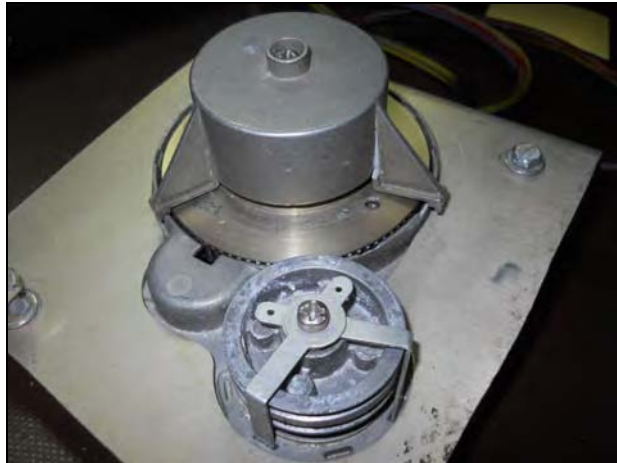
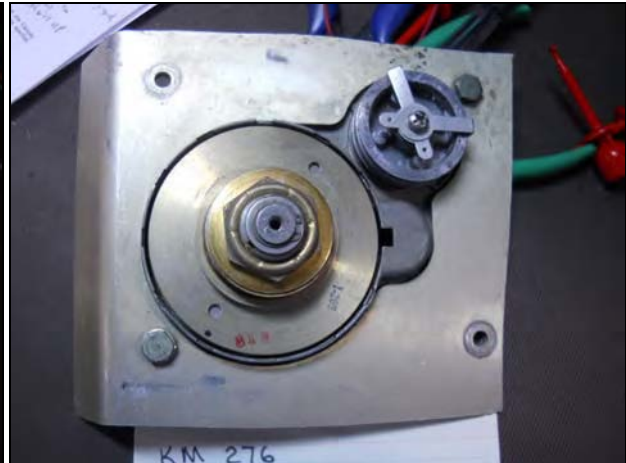
KM 276 Servo Mount attached to trim servo and aircraft bracket

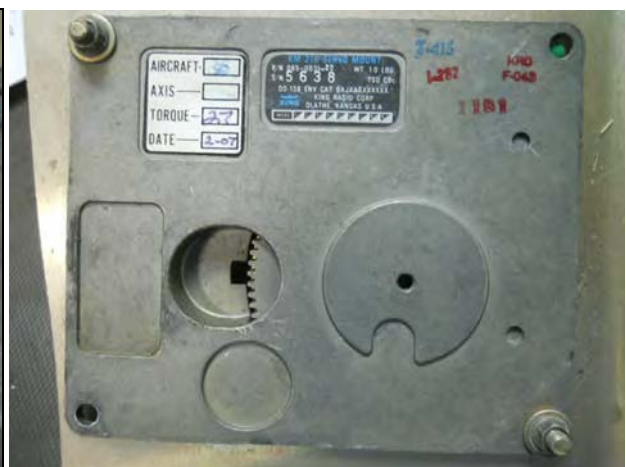
KM 276 Trim Servo Mount (back view)

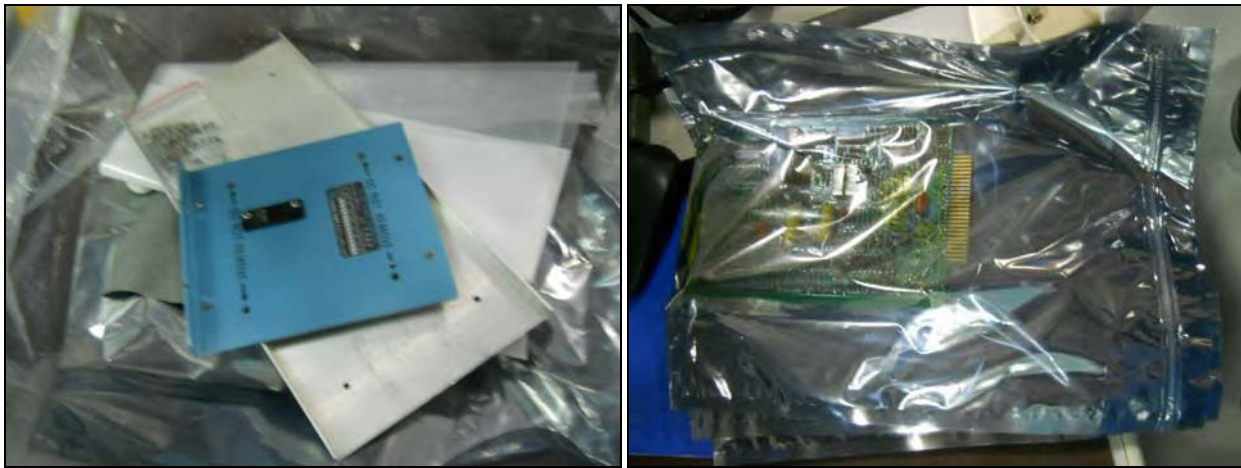
KC 295 Flight Computer as-received from the NTSB Lab – disassembled chassis on the left, circuit boards on the right

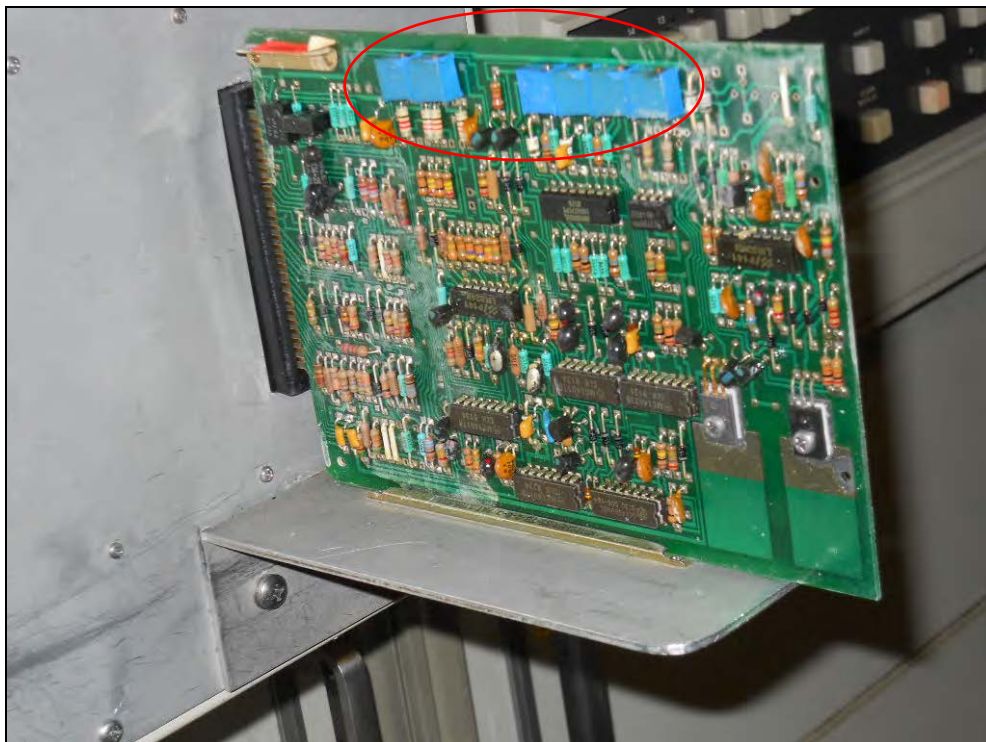
The six potentiometers were not adjusted during ATE testing to preserve post-accident condition

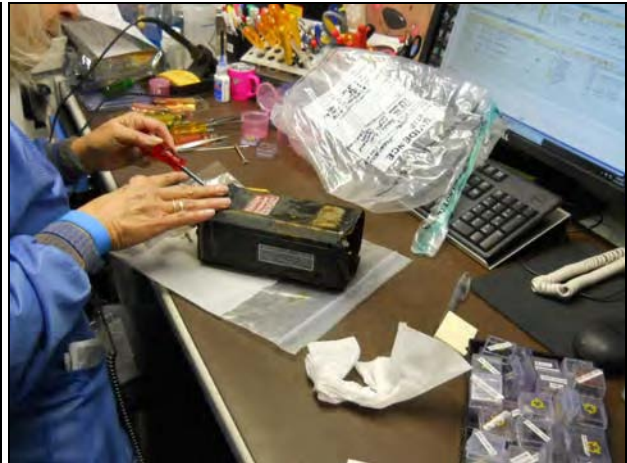
KI 256: disassembling for visual inspection

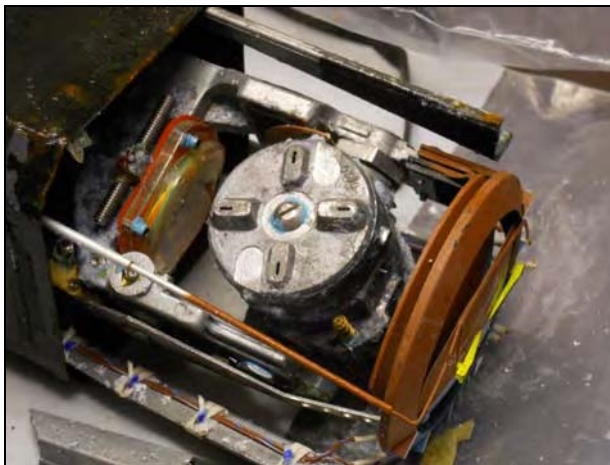
KI 256: removing the capsule and rotor assembly

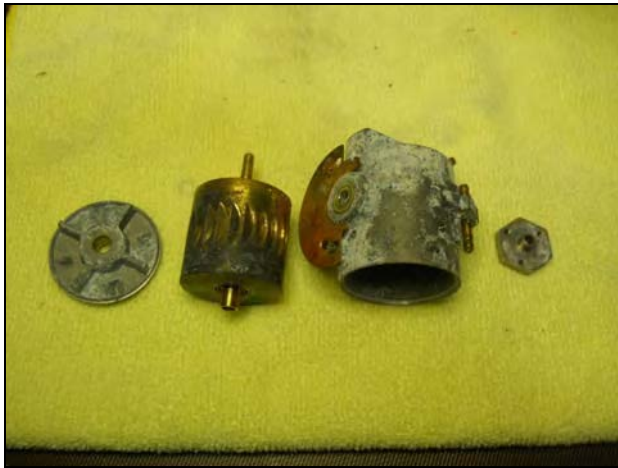
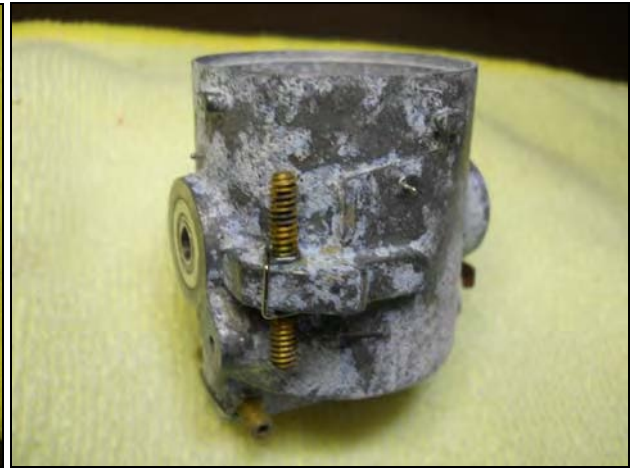
The KI 256 is impact damaged and cannot be functionally tested. The unit was disassembled and the gyro rotor and capsule assembly were visually inspected. Both rotor and capsule contain corrosion/oxidation. Rotor turns freely and exhibits minor roughness when spun. The rotor shaft endplay is slightly excessive. The bearings in the capsule are properly positioned and appear normal. The two fast erection vanes were dislodged from impact forces. No rotation scoring detected. No pre-impact anomalies observed.

KI 256: rotor and capsule corroded

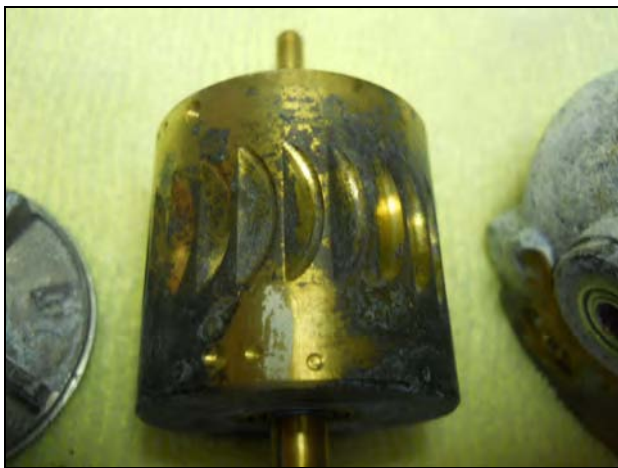
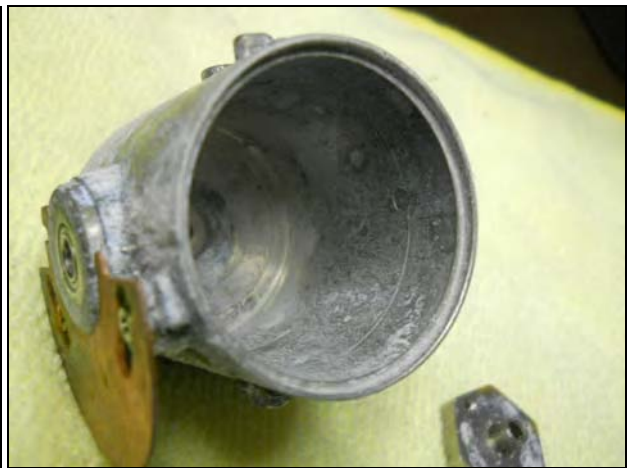
KI 256: no rotation scoring observed on the rotor or capsule

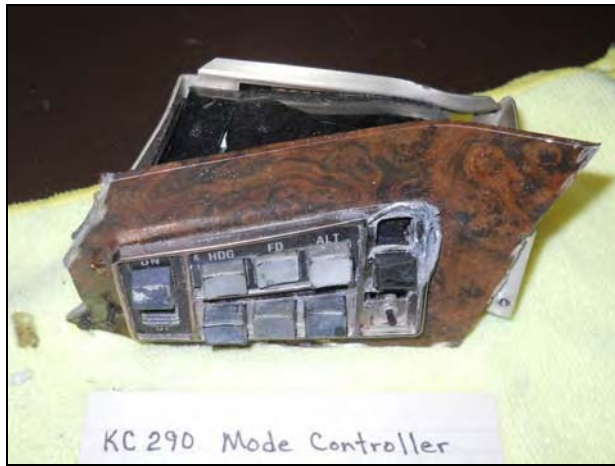
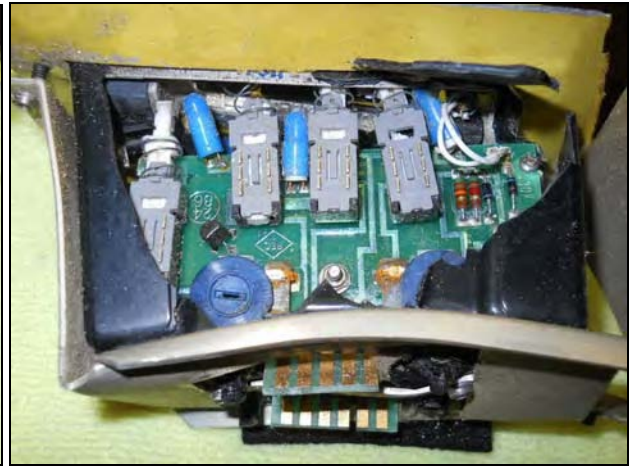
The KC 290 mode controller is impact damaged and cannot be functionally tested. Crushing and deformation present, loose and broken parts observed, case broken and blocking view of serial number (dataplate). Careful visual inspection found the Auto pilot “bat switch” is in the off position.

KC 290 Mode Controller is impact damaged which precludes functional testing

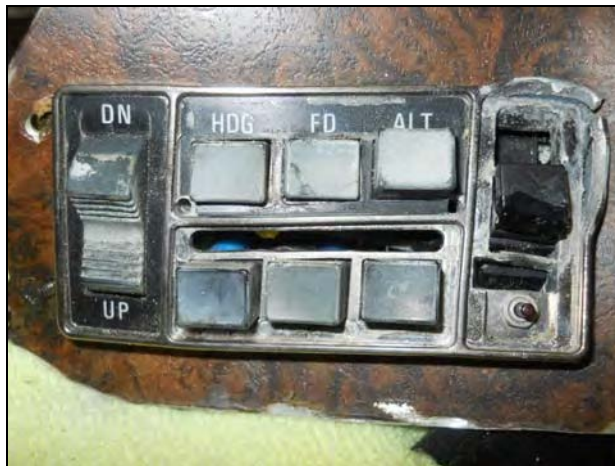
KC 290 accident unit

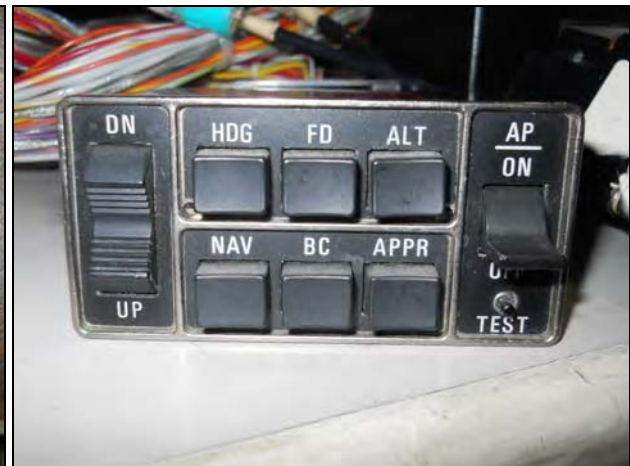
KC 290 exemplar unit
