# NATIONAL TRANSPORTATION SAFETY BOARD

### Specialist's Factual Report By Jane Foster

Location: Orlando, Florida  
Date: November 20, 2015  
Aircraft: Beech A36TC  
Registration: N7FG  
Operator: Private  
NTSB Number: ERA16FA043

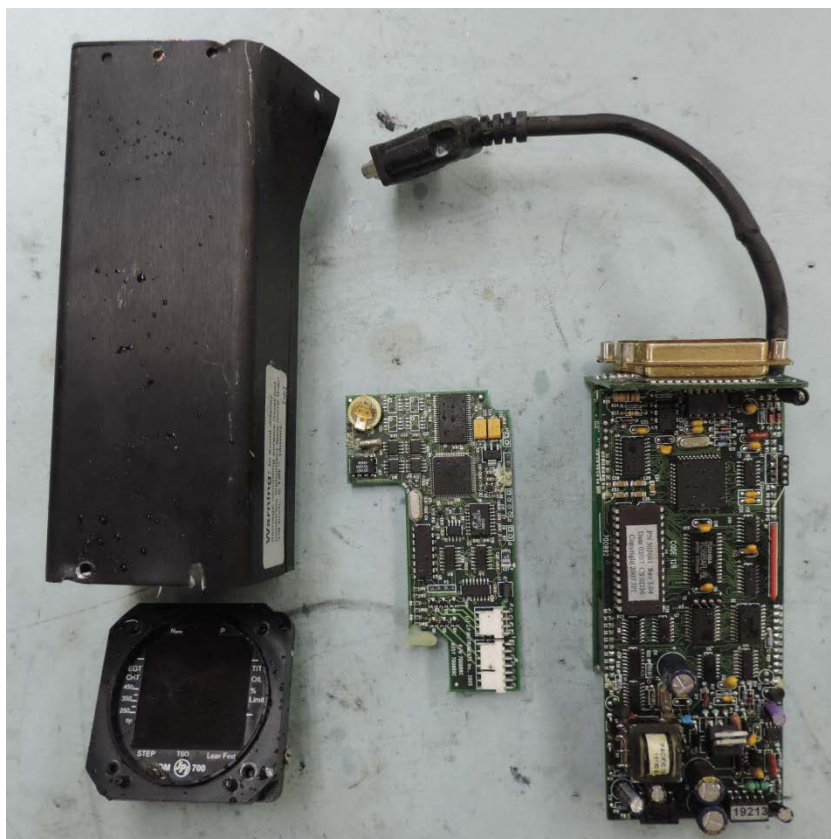
Upon arrival at the Vehicle Recorder Laboratory, it was determined that the JPI EDM-700, the Delorme inReach, and the SD card had water damage. An exterior examination revealed that the JPI EDM-700 had sustained moderate physical damage. Figure 1 shows the JPI EDM-700 as received. Figure 2 shows the front and back of the Delorme inReach as received. Figure 3 shows the SD card as received.

Figure 1. JPI EDM-700 after examination.

The device JPI EDM-700 was water damaged and physically damaged upon arrival to the laboratory. The circuit boards were removed, cleaned, and dried in a vacuum drying oven. The chips containing the unit's non-volatile memory (NVM) were identified and these chips were removed from the board. The chips were found to be in good condition after removal and data could be extracted. The chip read out normally using an adapter socket appropriate for the type and model of chip. The read out resulted in a binary file which was converted to engineering units using laboratory software. The binary readout and subsequent conversion produced files consistent with a normally operating JPI device. However, the data from the JPI EDM-700 could not be verified. The flight length (about 4 hours) was not consistent with information from other data sources pointing to about a 15 minute flight.

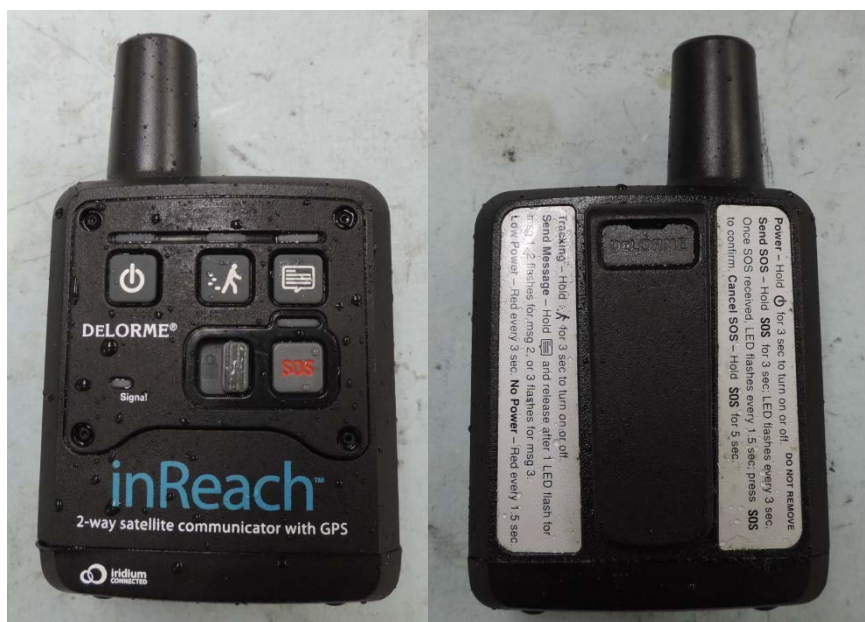
Figure 2. Delorme inReach as received.

The device was powered up normally and no data was stored on the device. A follow up with the manufacturer was conducted and data recording was not turned on during the month of the accident. No data was able to be recovered from the manufacturer's database.

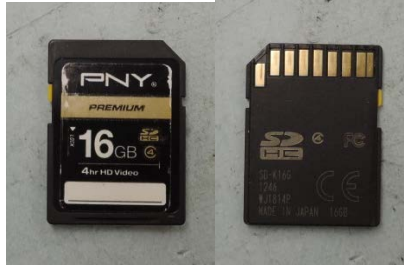
**Figure 3. SD Card as received.**

The SD card was read out normally and the contents were examined to find no accident related data. No pictures from the day of the flight or of the airplane were recorded.
