**NATIONAL TRANSPORTATION SAFETY BOARD**  
Vehicle Recorder Division  
Washington, D.C. 20594

## **Multiple Electronic Devices**

**Specialist's Factual Report  
by Sean Payne**

Location: Linesville, Pennsylvania  
Date: December 7, 2015  
Aircraft: Cubcrafters CCK-1865  
Registration: N541TC  
Operator: Private  
NTSB Number: ERA16FA063

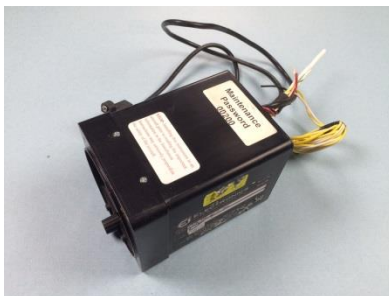
Upon arrival at the Vehicle Recorder Division, an exterior examination revealed the unit had not sustained any significant impact damage. Information was extracted by removing the device's internal microSD flash memory card and reading the device's contents in a forensic recovery program. The microSD card revealed a number of datafiles in .CSV format, one of which contained data captured during the accident flight. Figure 1 shows the device's condition upon arrival to the laboratory. Figure 2 shows the microSD card just prior to removal and read out.

**Figure 1. The device's condition upon arrival.**

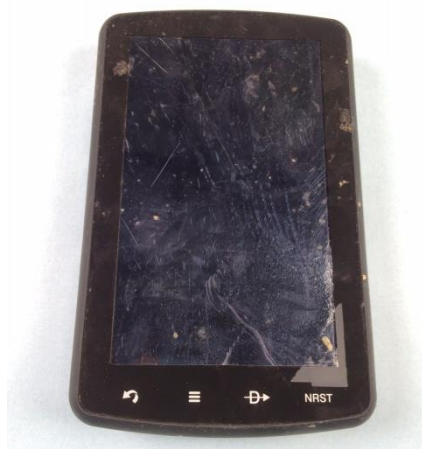
Upon arrival at the Vehicle Recorder Laboratory, an exterior examination revealed the unit had sustained some impact damage. The device's screen was no longer functioning. Power was applied to the device on the laboratory work bench and information was extracted using the manufacturer's software normally, without difficulty. Figure 5 shows the device's condition upon arrival to the laboratory.

Figure 5. The device's condition upon arrival.

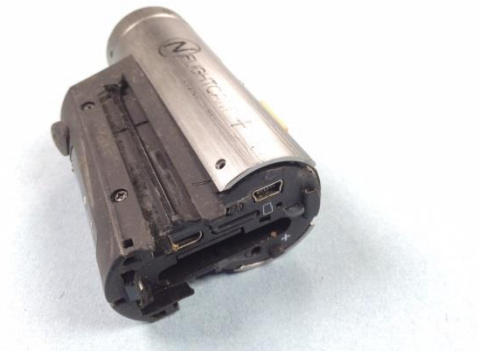
Upon arrival at the Vehicle Recorder Laboratory, an exterior examination revealed the unit had sustained significant impact damage. The device’s battery door was missing as well as the switch which turns the device on and off. The battery itself was also not present. The device’s microSD card was found seated in the device’s flash media slot. Upon further examination, the microSD card was found to have a crack running the width of the card. An examination of the edge of the card revealed the crack had penetrated through the card’s plastic casing. Figure 9 shows the device’s condition upon arrival to the laboratory. Figure 10 shows the device’s microSD card seated in the camera’s flash memory slot. Figure 11 shows the microSD card removed from the device under magnification. Figure 12 shows the underside of the microSD card under magnification.

**Figure 9. The device’s condition upon arrival.**

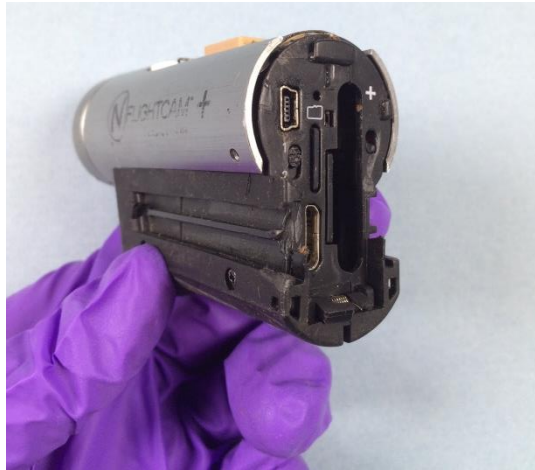
**Figure 10. The microSD card shown seated in the device's memory slot.**
