## MEMORANDUM FOR RECORD

**Subject:** ERA16FA097, N401PT, Lancair IV-P, 01/30/16, Albany, Georgia, Review of Security Video

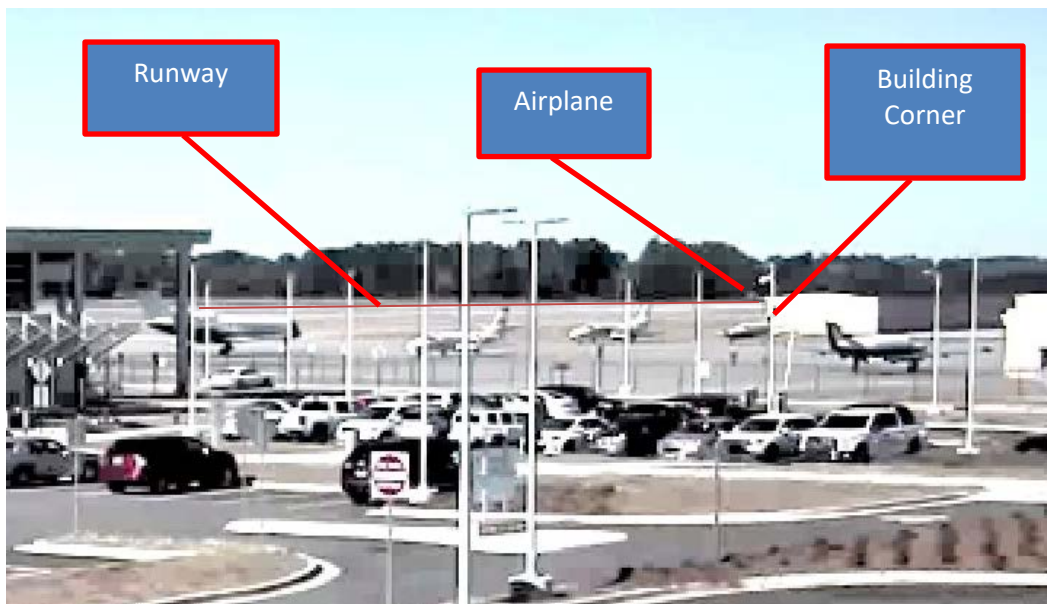
A review of airport security video revealed that during the takeoff roll (moving from the right to the left in this image), the airplane lifted off just as it passed the corner of a building in the foreground:

*Figure 1 Security Video Image – Enlarged*

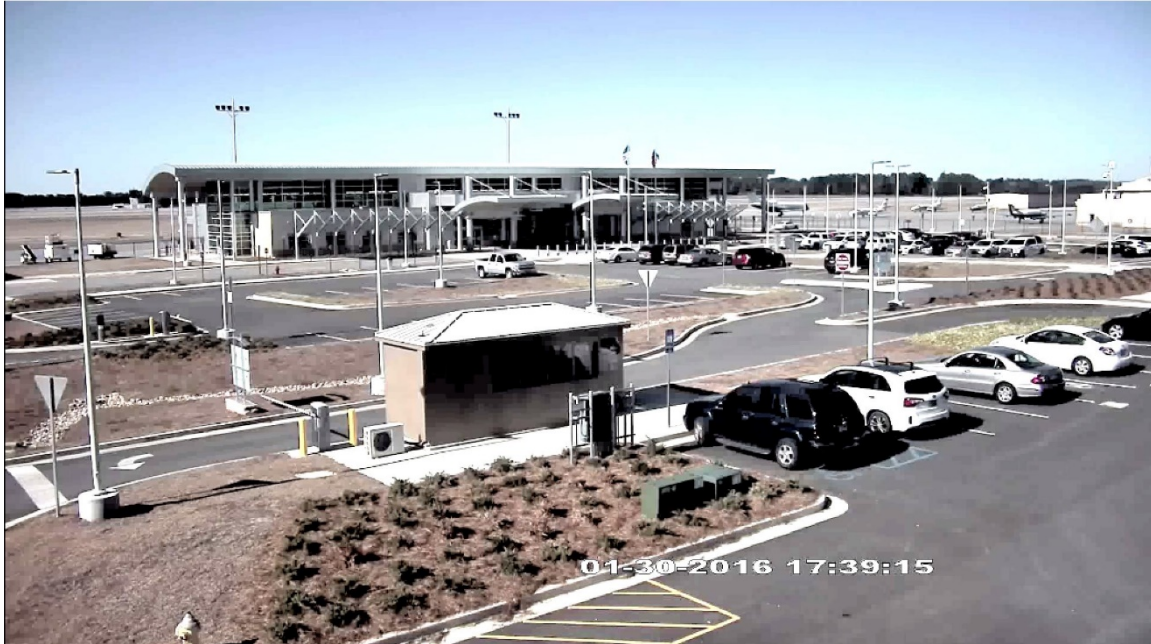
*Figure 2 Security Video Image – Full View*

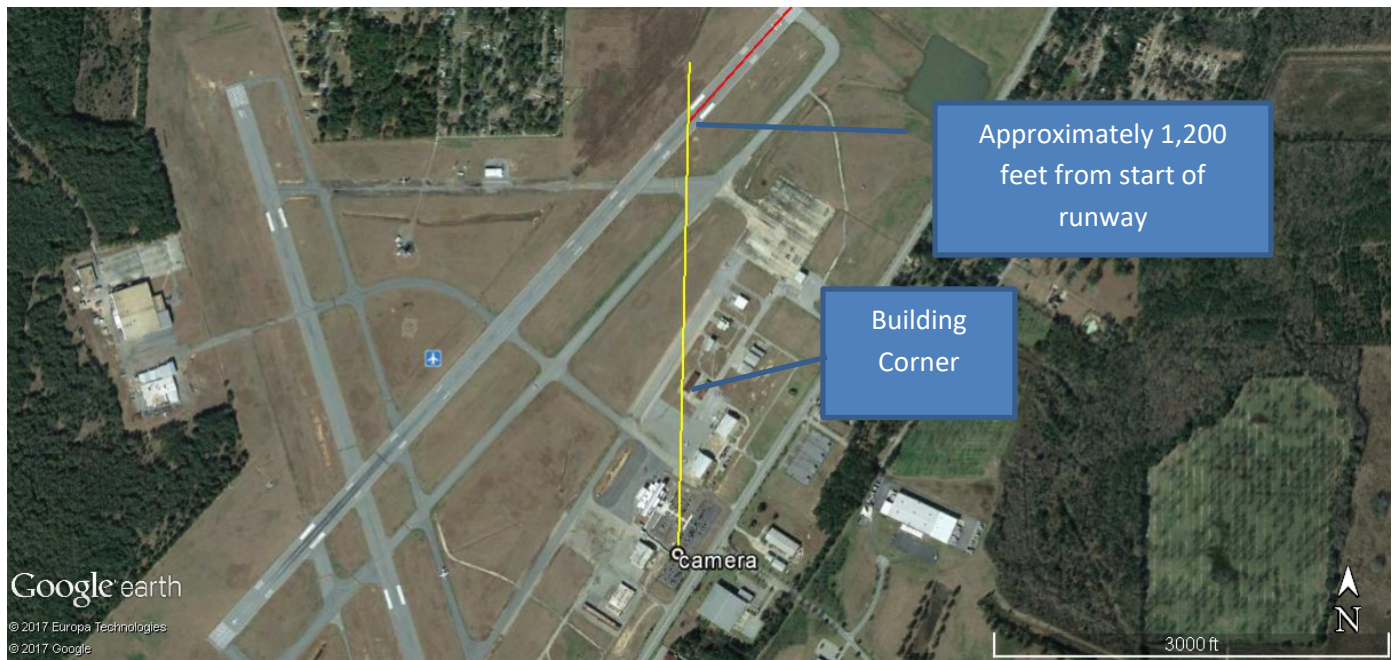
Using a geographical information system overhead image of the airport, a line of sight was constructed from the camera location through the building corner, and extended to the runway centerline. The line of sight intersected the runway about 1,200 feet from the start of the runway.

*Figure 3 - Overhead Image of Airport*
