**NATIONAL TRANSPORTATION SAFETY BOARD**

## **Global Positioning System Device**

### **Specialist's Factual Report**

Location: Albany, Georgia  
Date: January 30, 2016  
Aircraft: Lancair IV-P  
Registration: N401PT  
Operator: Private  
NTSB Number: ERA16FA097

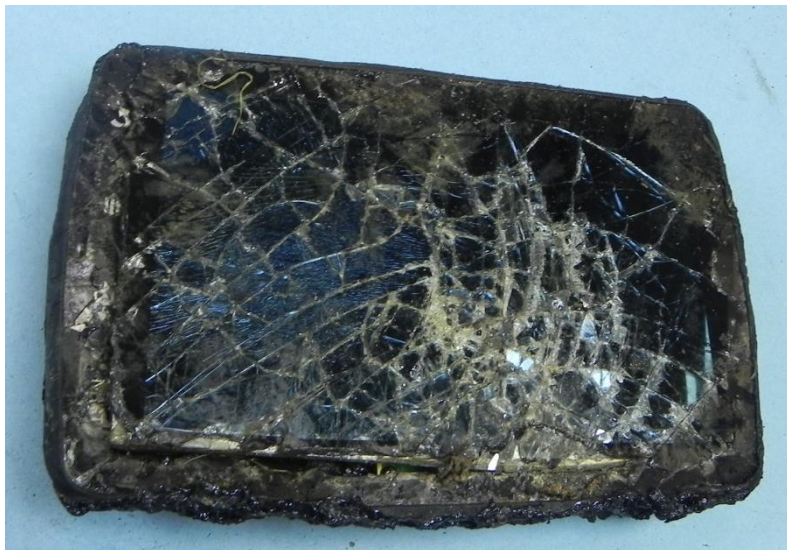
Upon arrival at the Vehicle Recorder Laboratory, an examination revealed the unit had sustained heavy fire and impact damage. The display screen was shattered and the casing was badly melted. The extent of the damage is shown in figures 1 and 2.

**Figure 1. Front of device as received.**

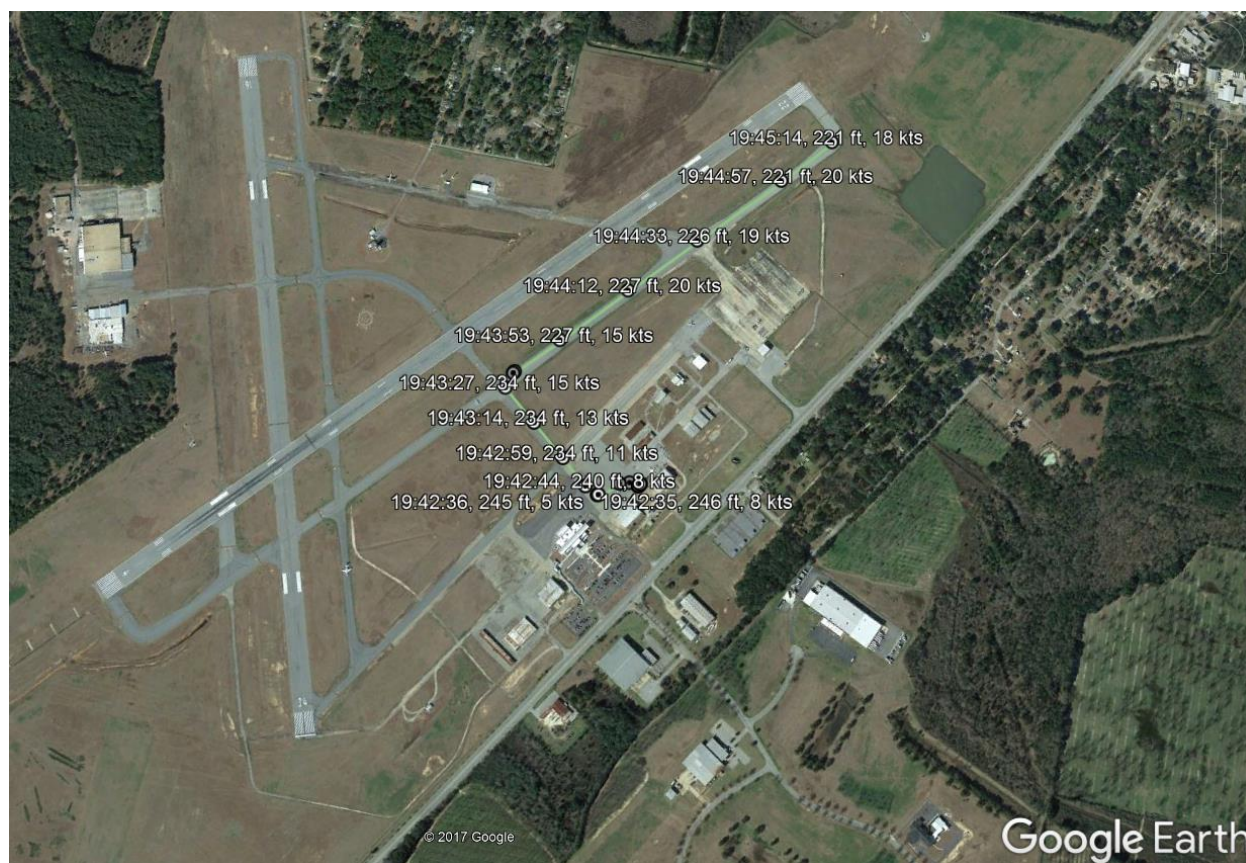
Figure 3 is a graphical overlay generated using Google Earth for the accident flight. The weather and lighting conditions in Google Earth are not necessarily the weather and lighting conditions present at the time of the recording.

The recorded flight shows the vehicle taxiing along the runway at ABY. The last recorded parameter was at 19:45:14 UTC on January 30, 2016, with a GPS altitude of 221 feet above Mean Sea Level (MSL) and a ground speed of 18 knots. Due to data buffering on the GPS unit, the data recording may have ended before the accident event.

**Figure 3. Google Earth image showing accident flight.**

Tabular data used to generate figure 3 are included as Attachment 1. This attachment is provided in electronic comma-delimited (.CSV) format.
