**NATIONAL TRANSPORTATION SAFETY BOARD**  
Vehicle Recorder Division  
Washington, D.C. 20594

## **Electronic Devices**

**Specialist's Factual Report  
by Jane Foster**

Location: Clermont, Florida  
Date: March 12, 2016  
Aircraft: Sheahen RV-8A  
Registration: N838RV  
Operator: Private  
NTSB Number: ERA16FA127

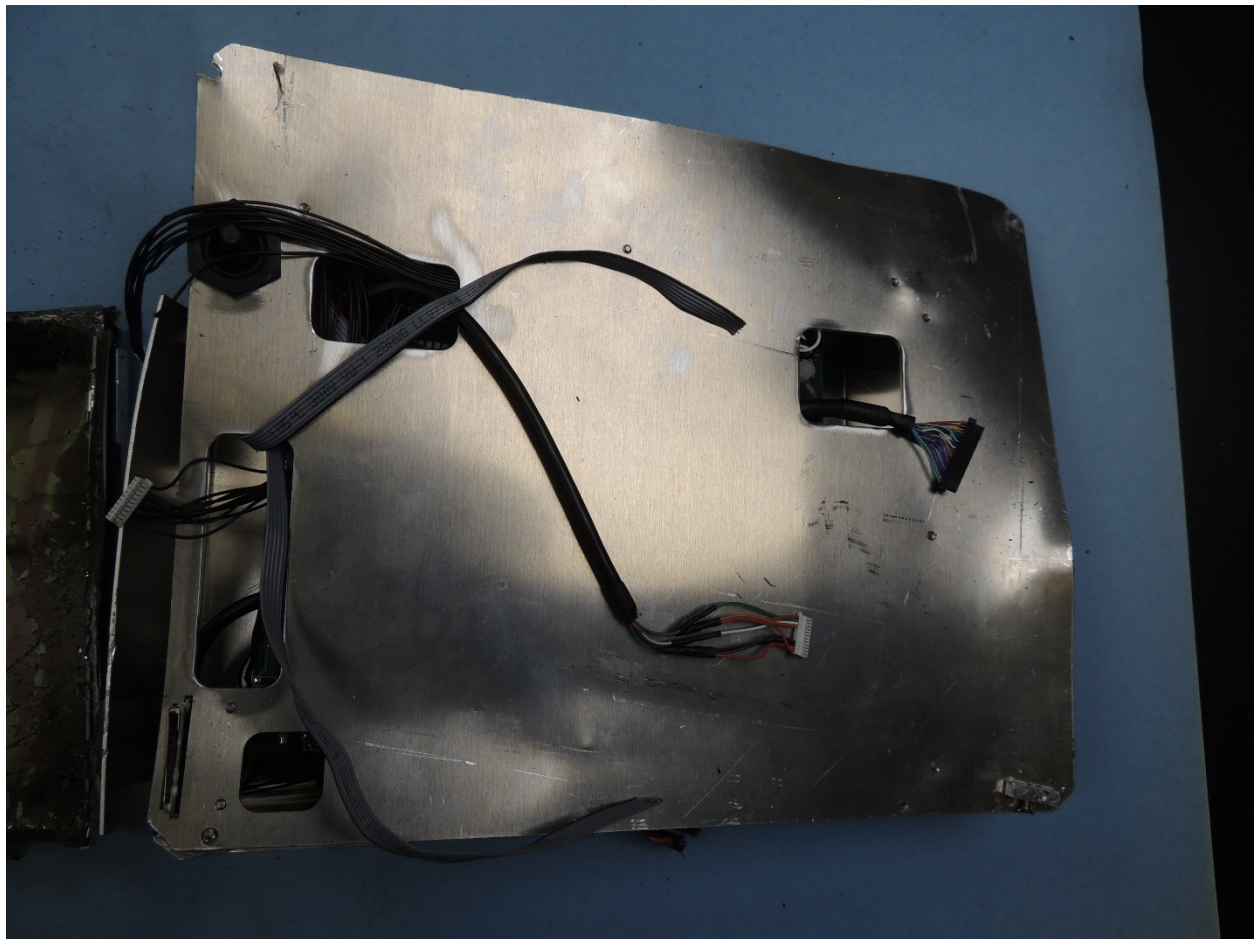
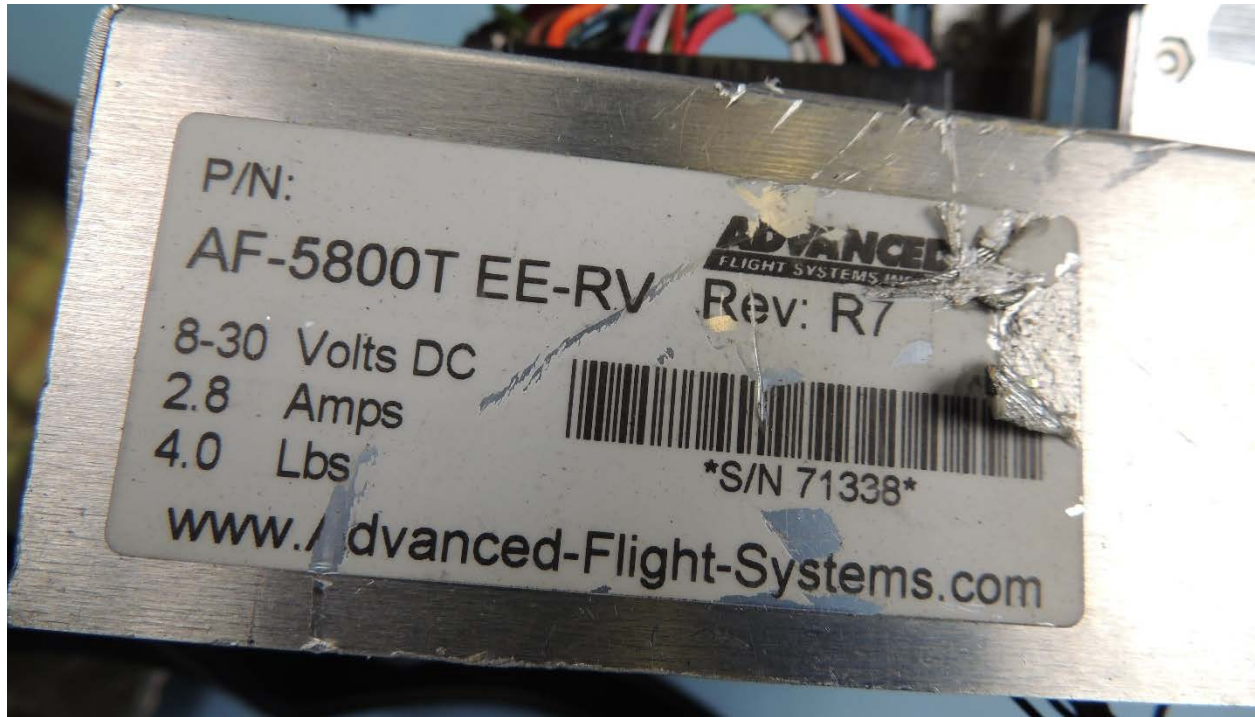
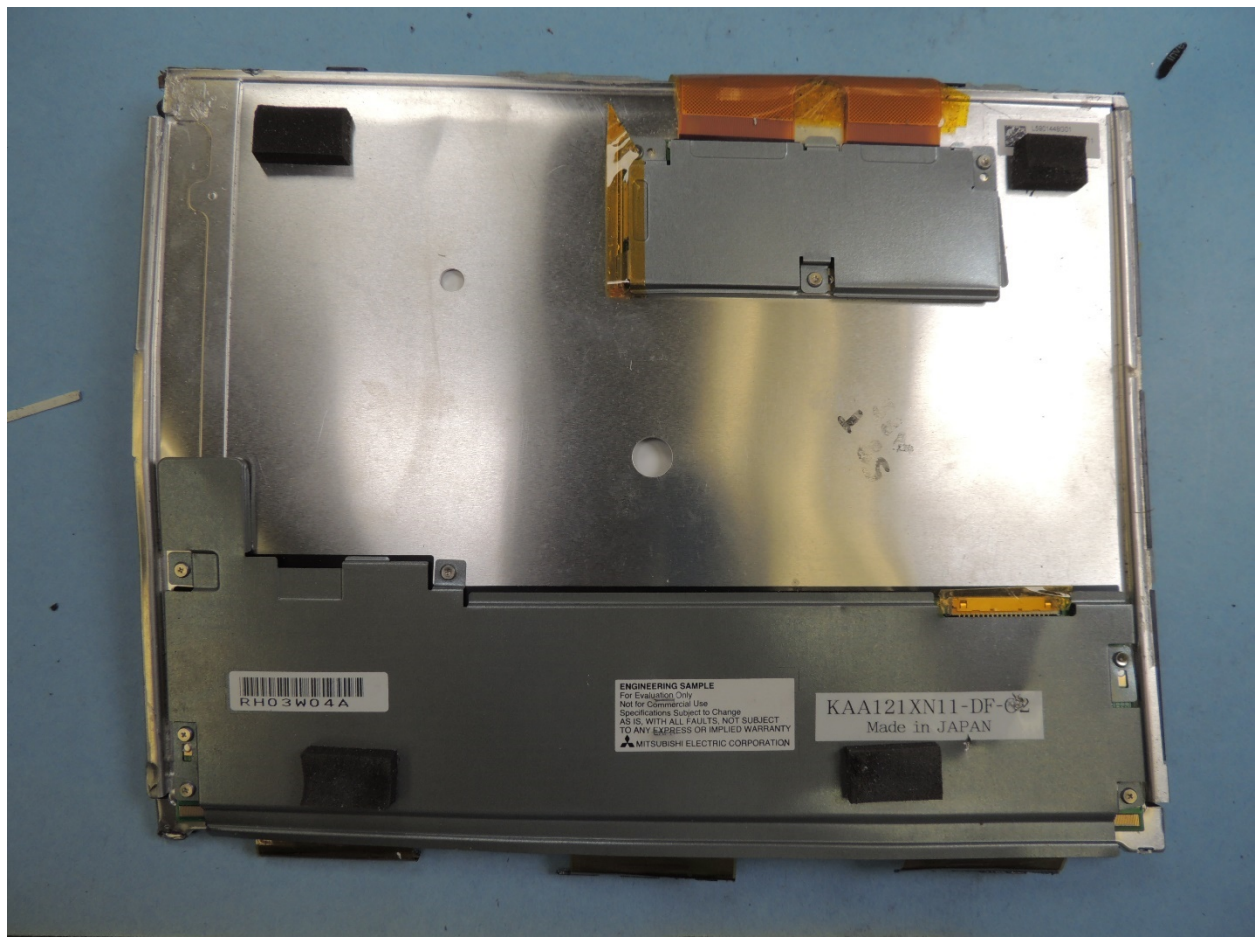
Upon arrival at the Vehicle Recorder Division, an exterior examination revealed the unit had sustained severe damage. Figures 1 through 5 show the extent of the damage. The Solid State Drive (SSD) was removed from the unit and read out with an eSATA adapter. The data was sent to the manufacturer to be converted to engineering units.

**Figure 1. Advanced Flight Systems 5800T EE-RV as received.**

**Figure 2. Advanced Flight Systems 5800T EE-RV as received.**

**Figure 3. Advanced Flight Systems 5800T EE-RV as received.**

Figure 4. Advanced Flight Systems 5800T EE-RV as received.

Figure 5. Advanced Flight Systems 5800T EE-RV as received.

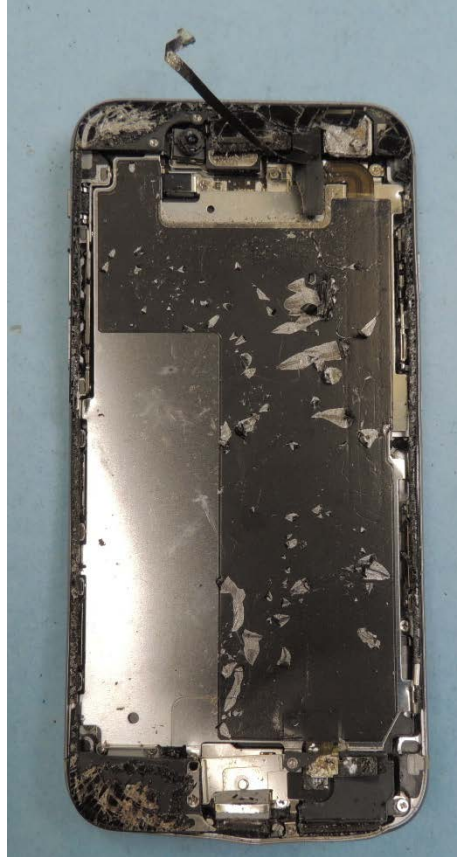
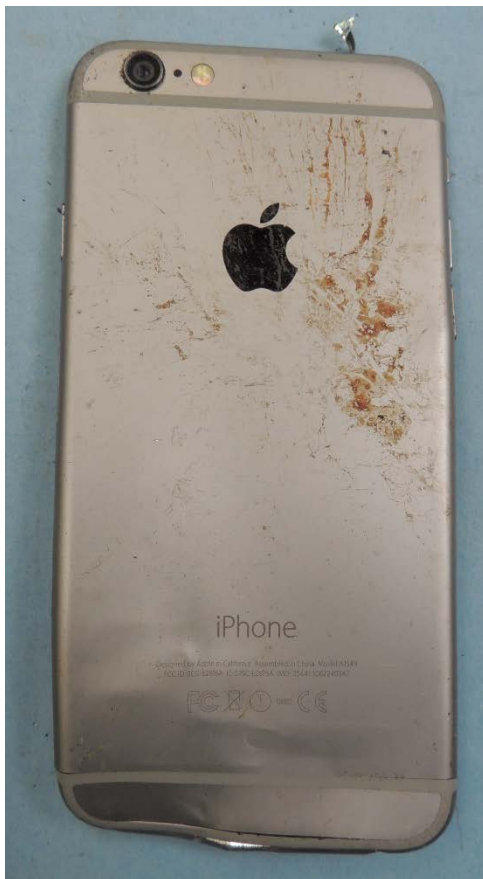
Upon arrival at the Vehicle Recorder Laboratory, an exterior examination revealed the unit had sustained severe damage. The extent of the damage is shown in figures 13 and 14.

**Figure 13. Front of Apple iPhone 6 as received.**

**Figure 14. Back of Apple iPhone 6 as received.**

The extent of the damage precluded normal recovery procedures and additional attempts were unsuccessful in yielding usable data. Therefore, no data pertinent to the event were recovered.

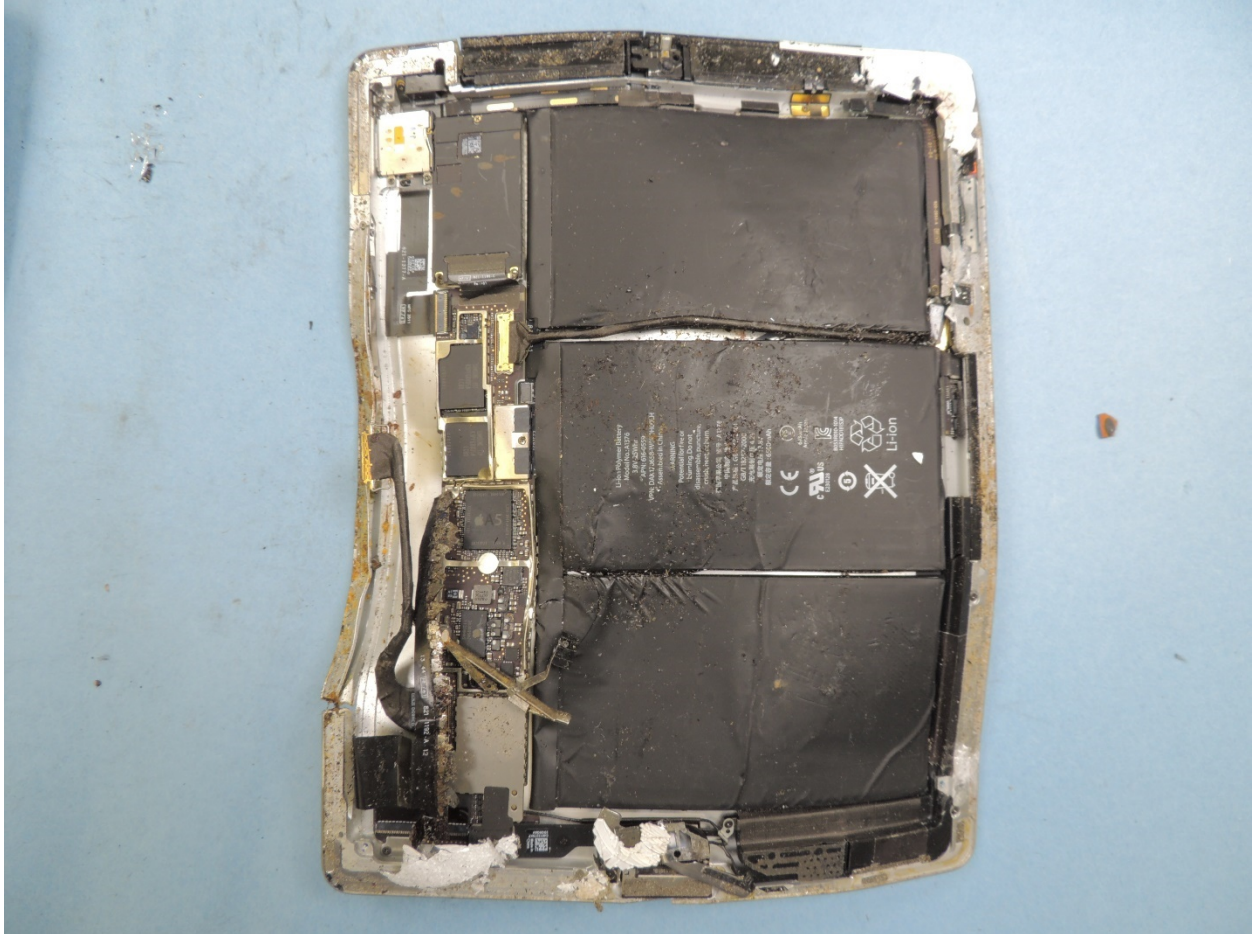
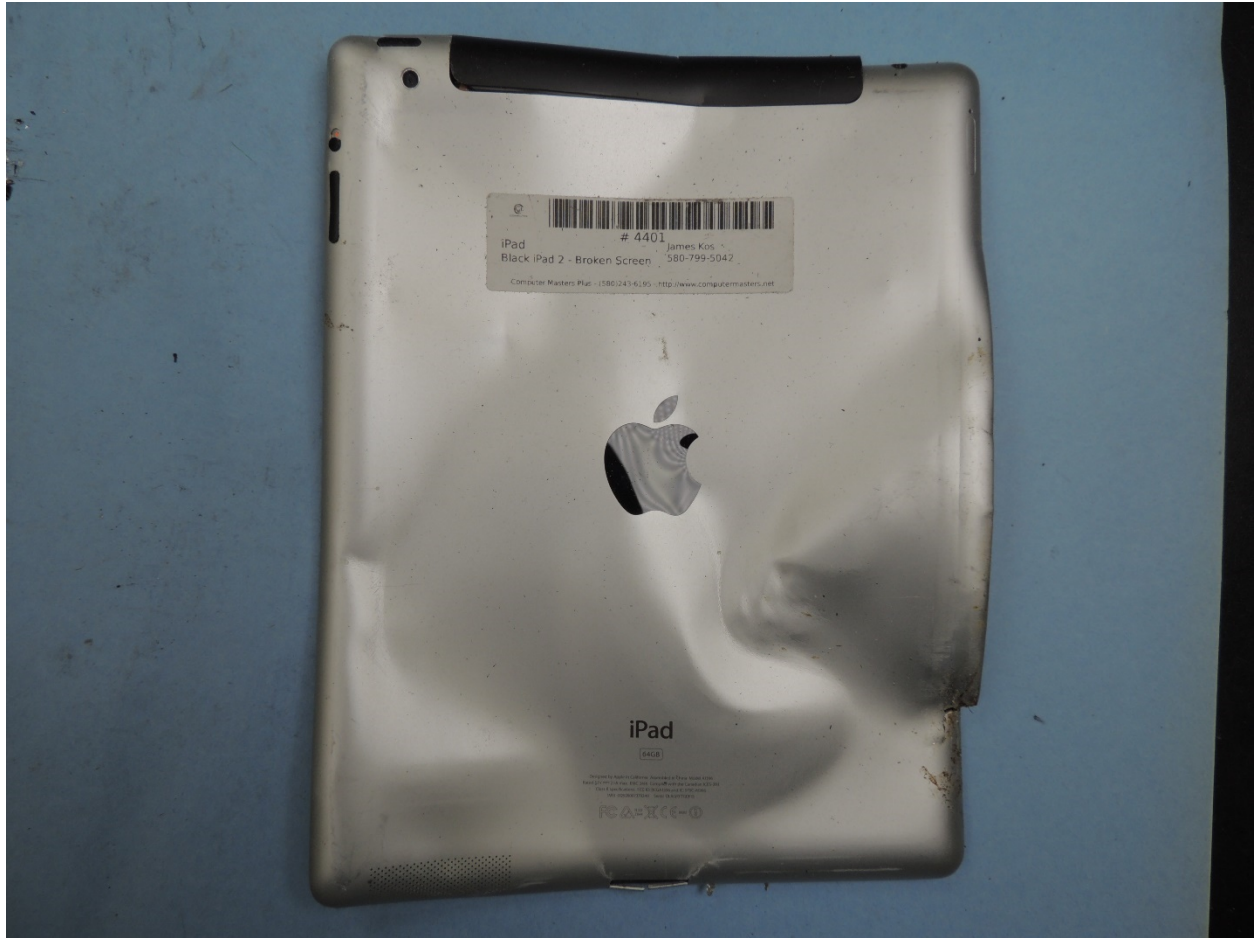
Upon arrival at the Vehicle Recorder Laboratory, an exterior examination revealed the unit had sustained severe damage. The extent of the damage is shown in figures 15 and 16.

Figure 15. Front of Apple iPad 2 as received.

**Figure 16. Back of Apple iPad 2 as received.**

The extent of the damage precluded normal recovery procedures and additional attempts were unsuccessful in yielding usable data. Therefore, no data pertinent to the event were recovered.
