**Photo 1 – NTSB Digital Photograph. View of the Cessna 340A Accident Site.**

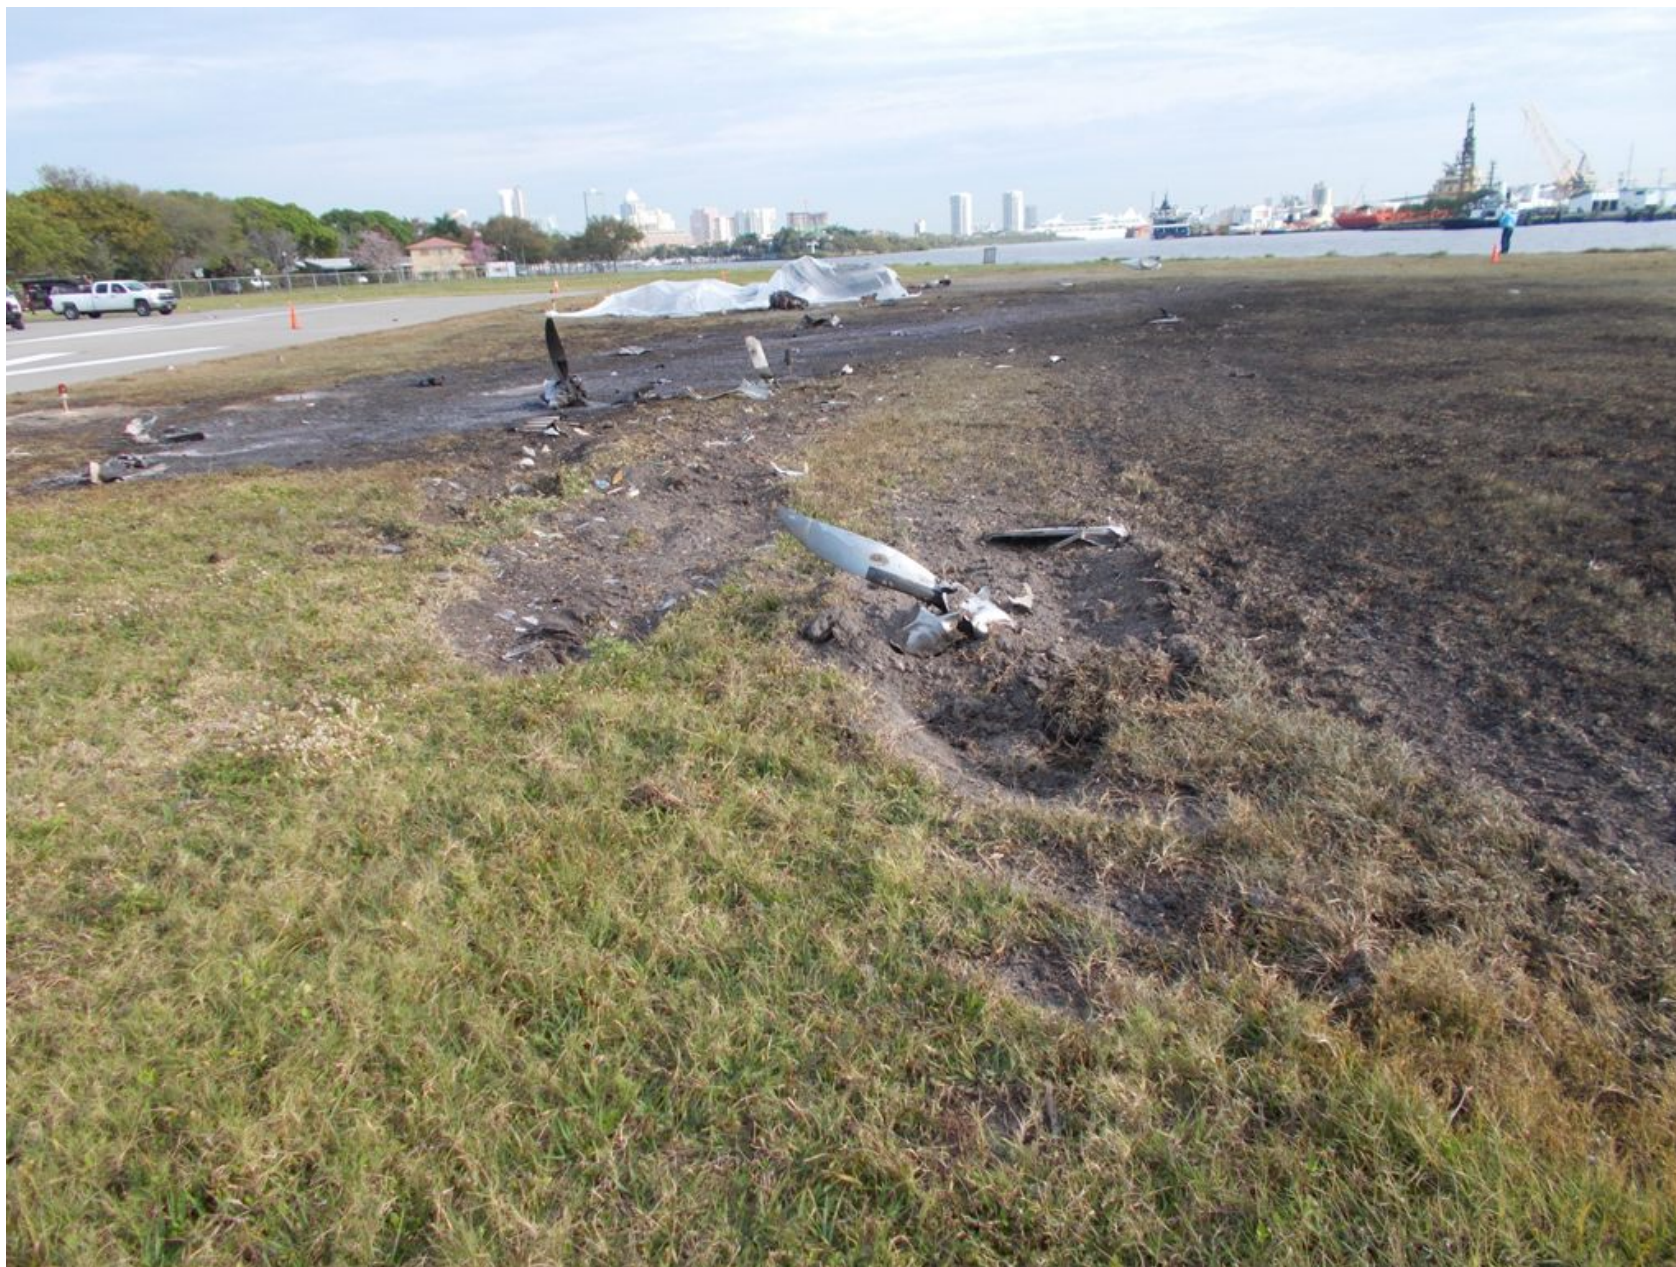
**Photo 2 - NTSB Digital Photograph. View of the Cessna 340A Initial Impact Site. Note the Separated Propellers and ground scars from the left propeller and upper portion of the forward fuselage.**

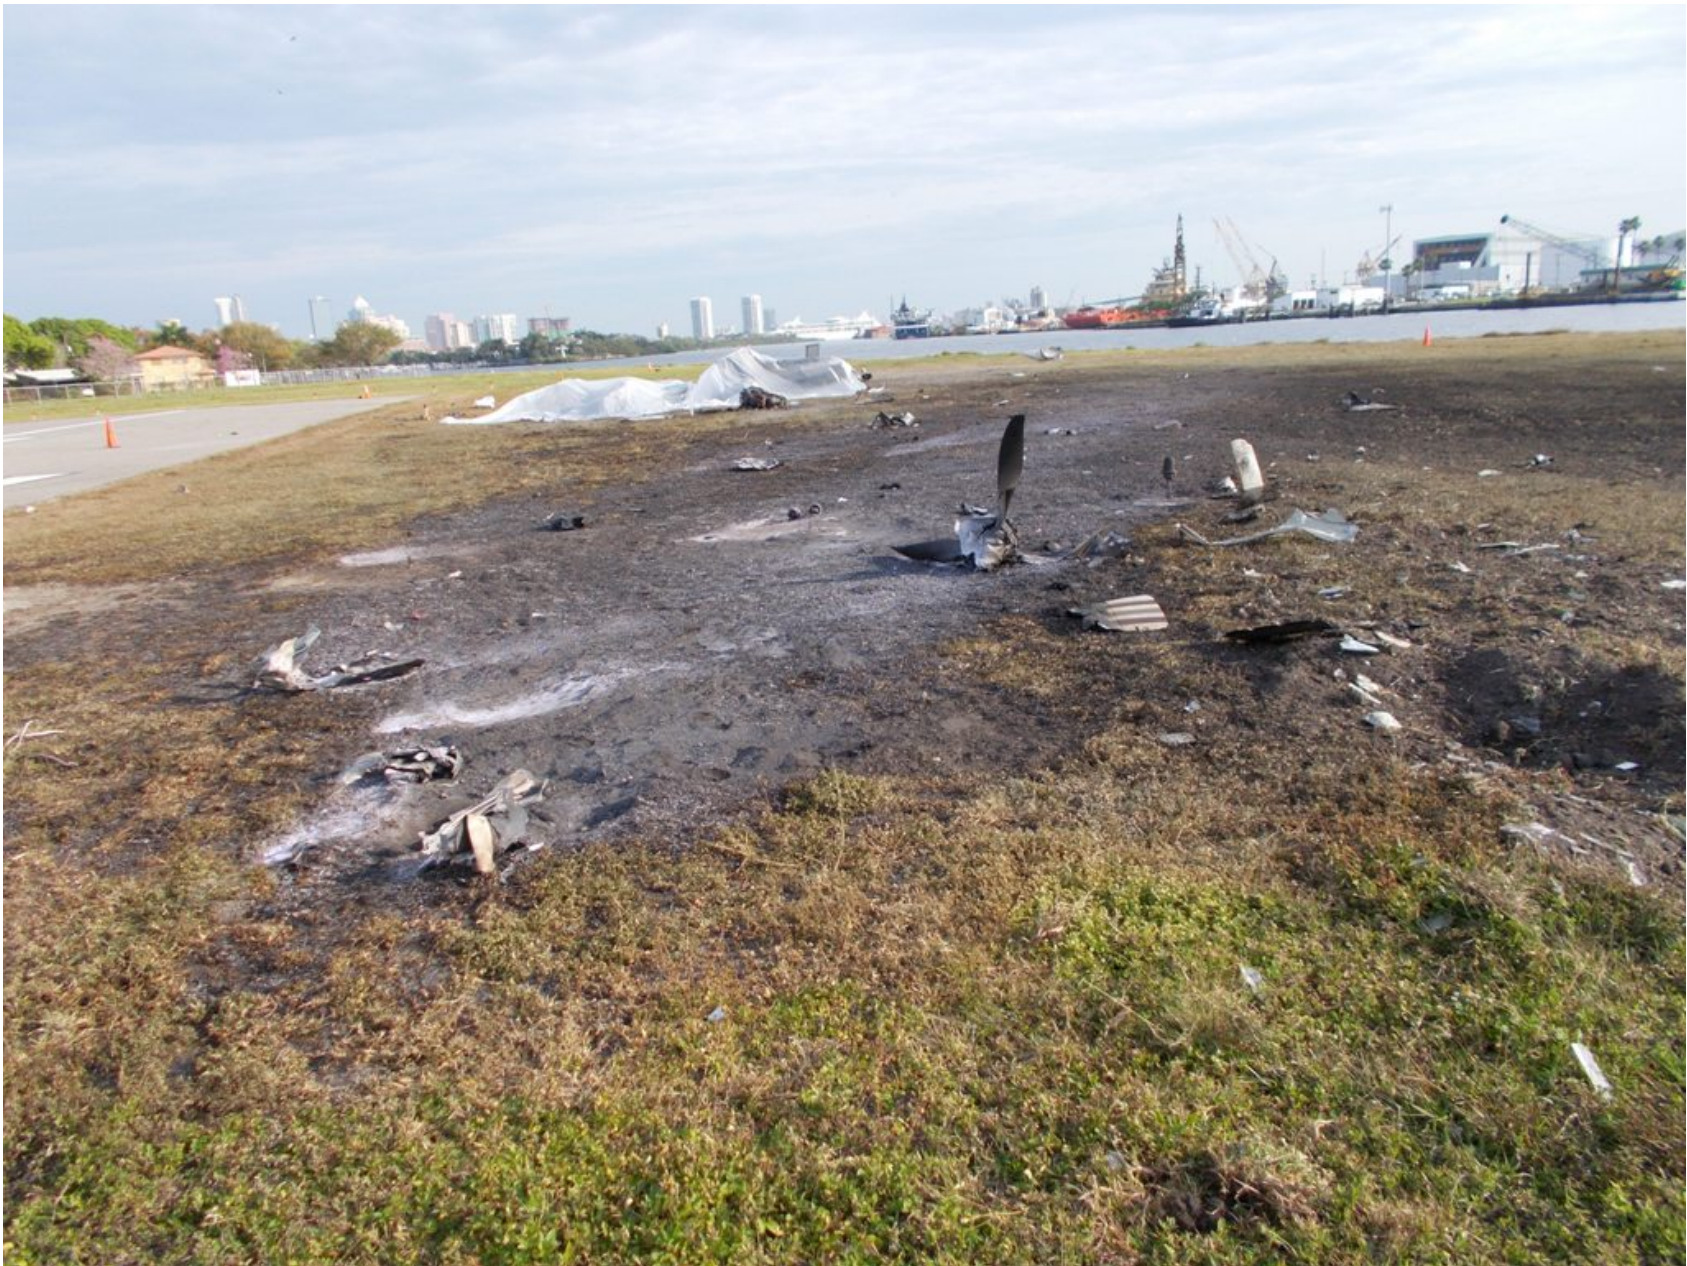
**Photo 3 - NTSB Digital Photograph. Another View of the Cessna 340A Initial Impact Site. Note the fire damage to the Grass.**

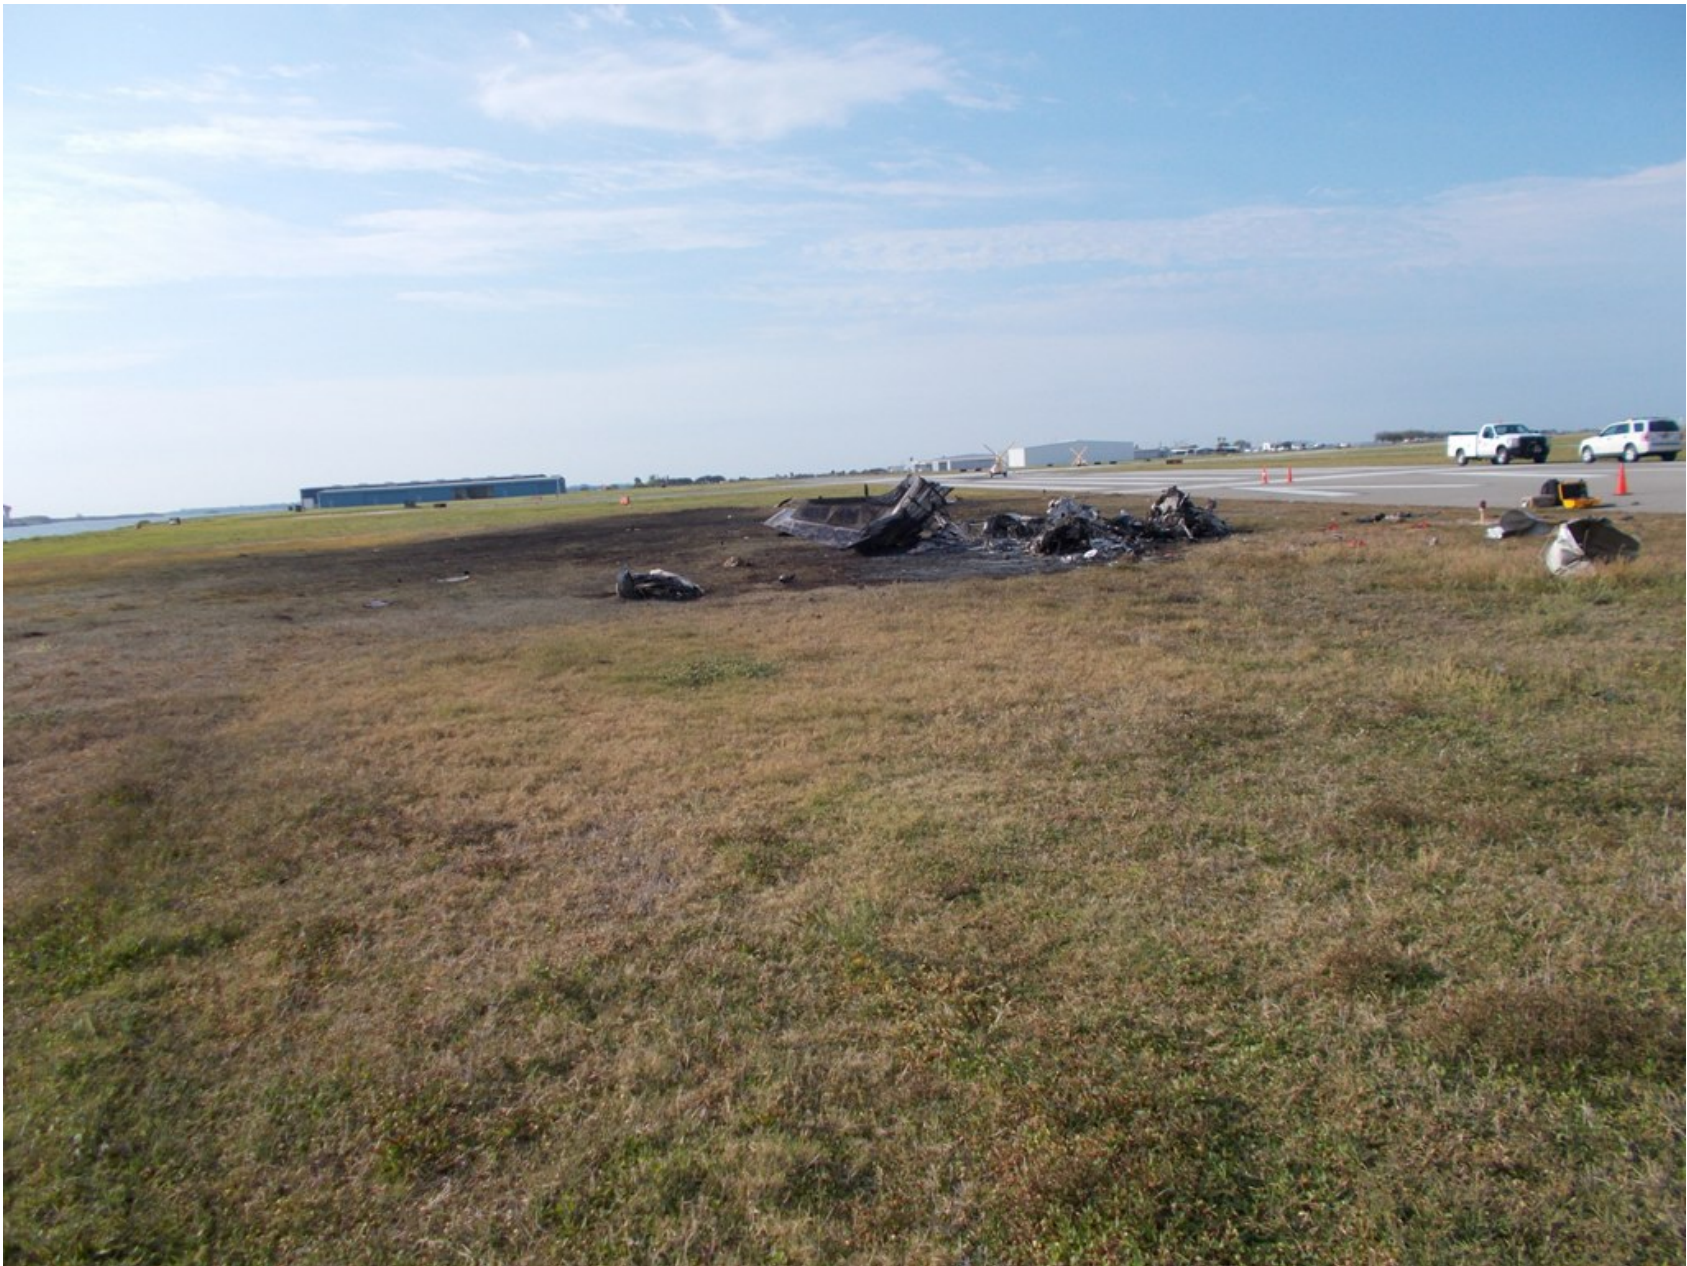
**Photo 4 - NTSB Digital Photograph. Another View of the Cessna 340A Main Wreckage.**

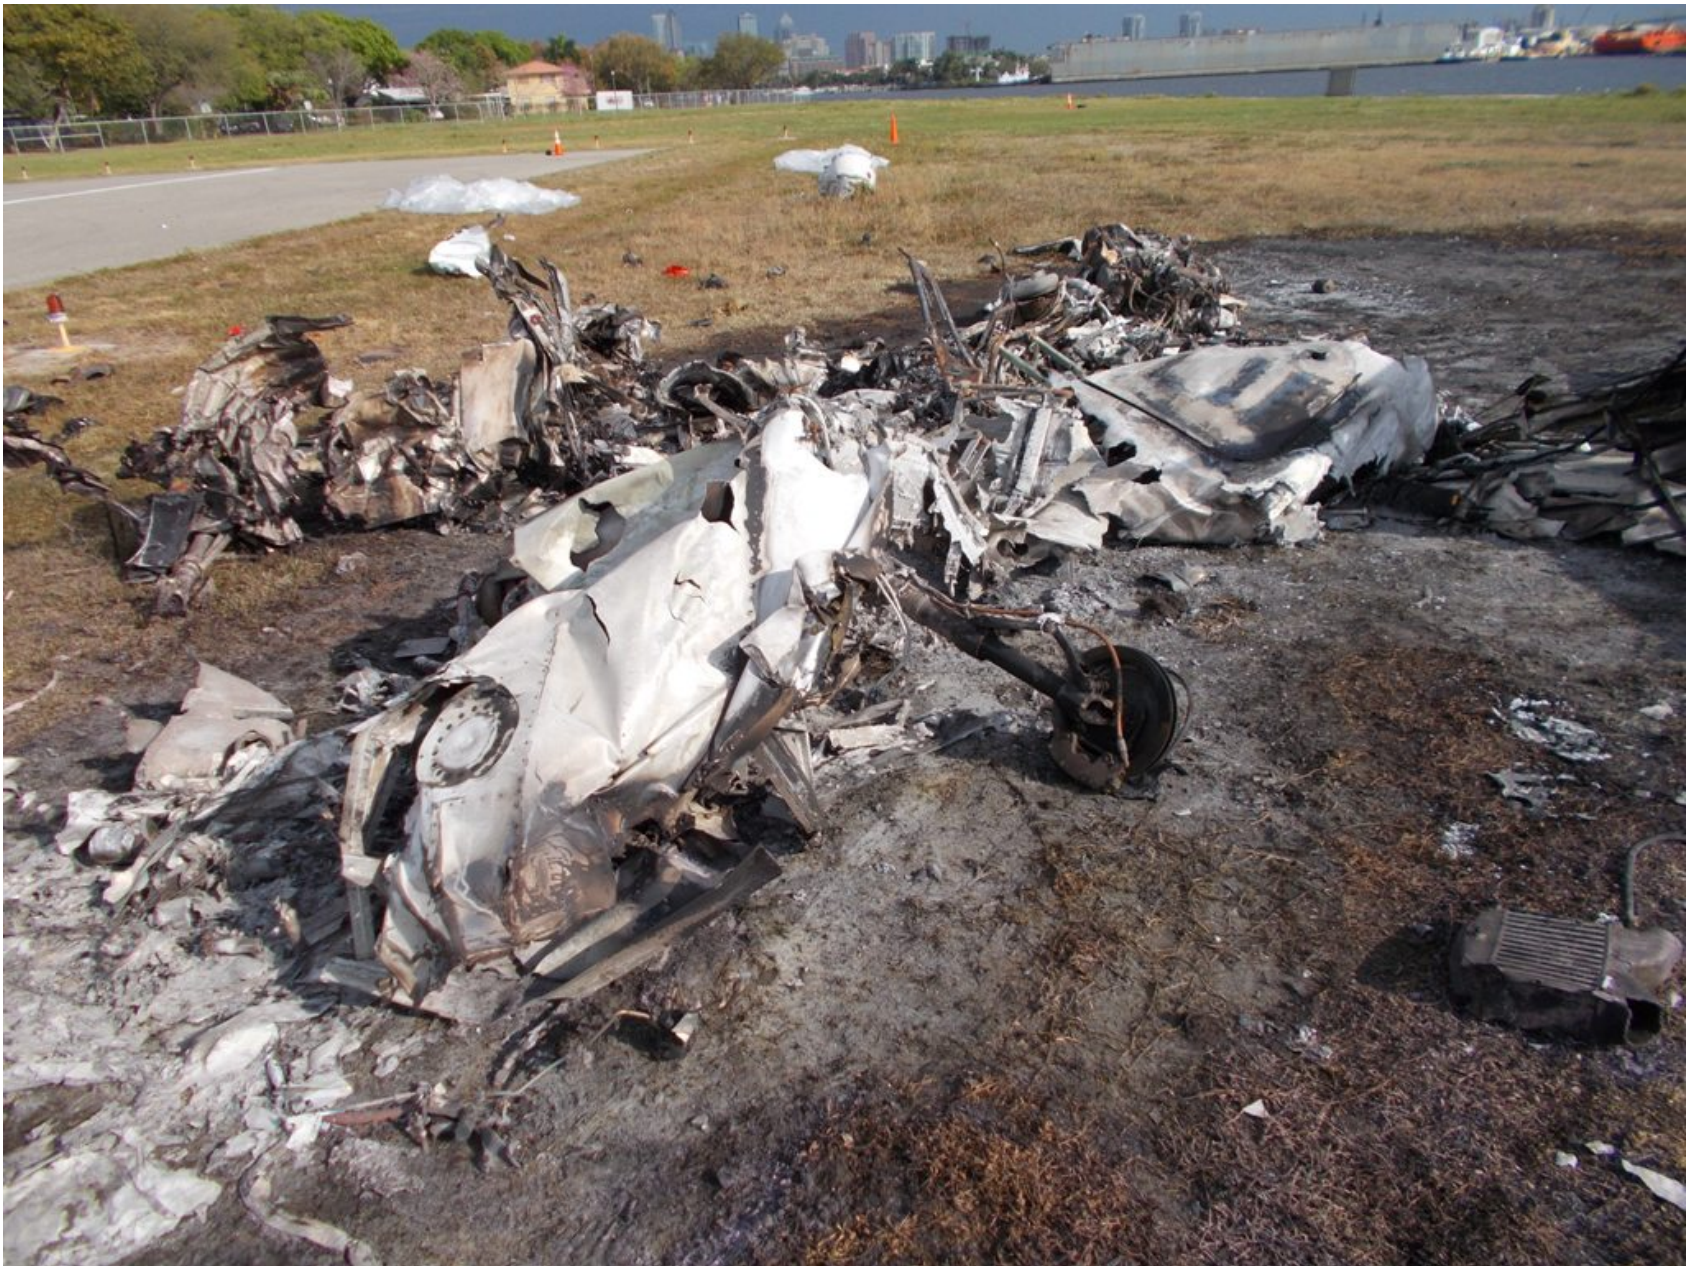
**Photo 5 - NTSB Digital Photograph. Close-Up View of the Cessna 340A Main Wreckage. Note the Extensive Fire Damage.**

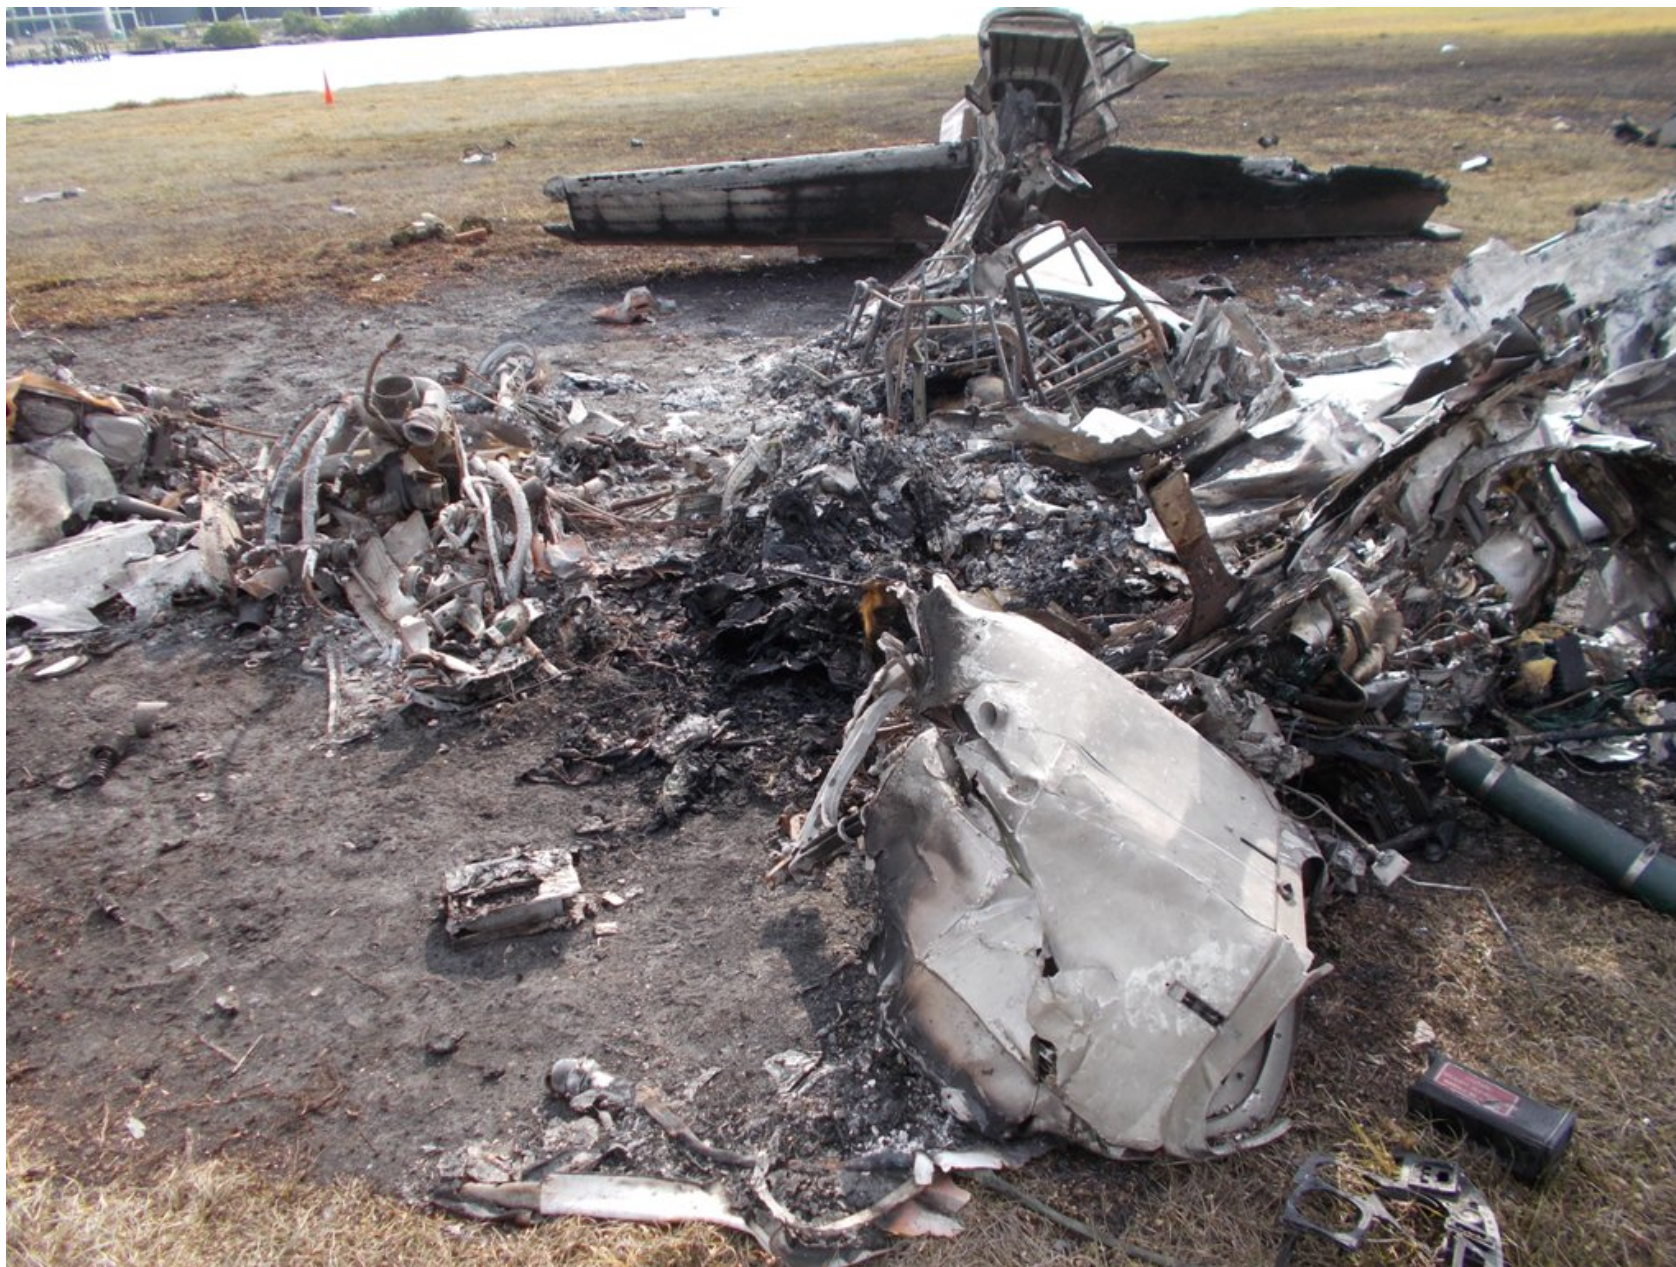
**Photo 6 - NTSB Digital Photograph. View of the Cessna 340A Aircraft Nose Section, Portion of Instrument Panel, Separated Instruments, and Cabin in Background. Note the Extensive Fire Damage.**

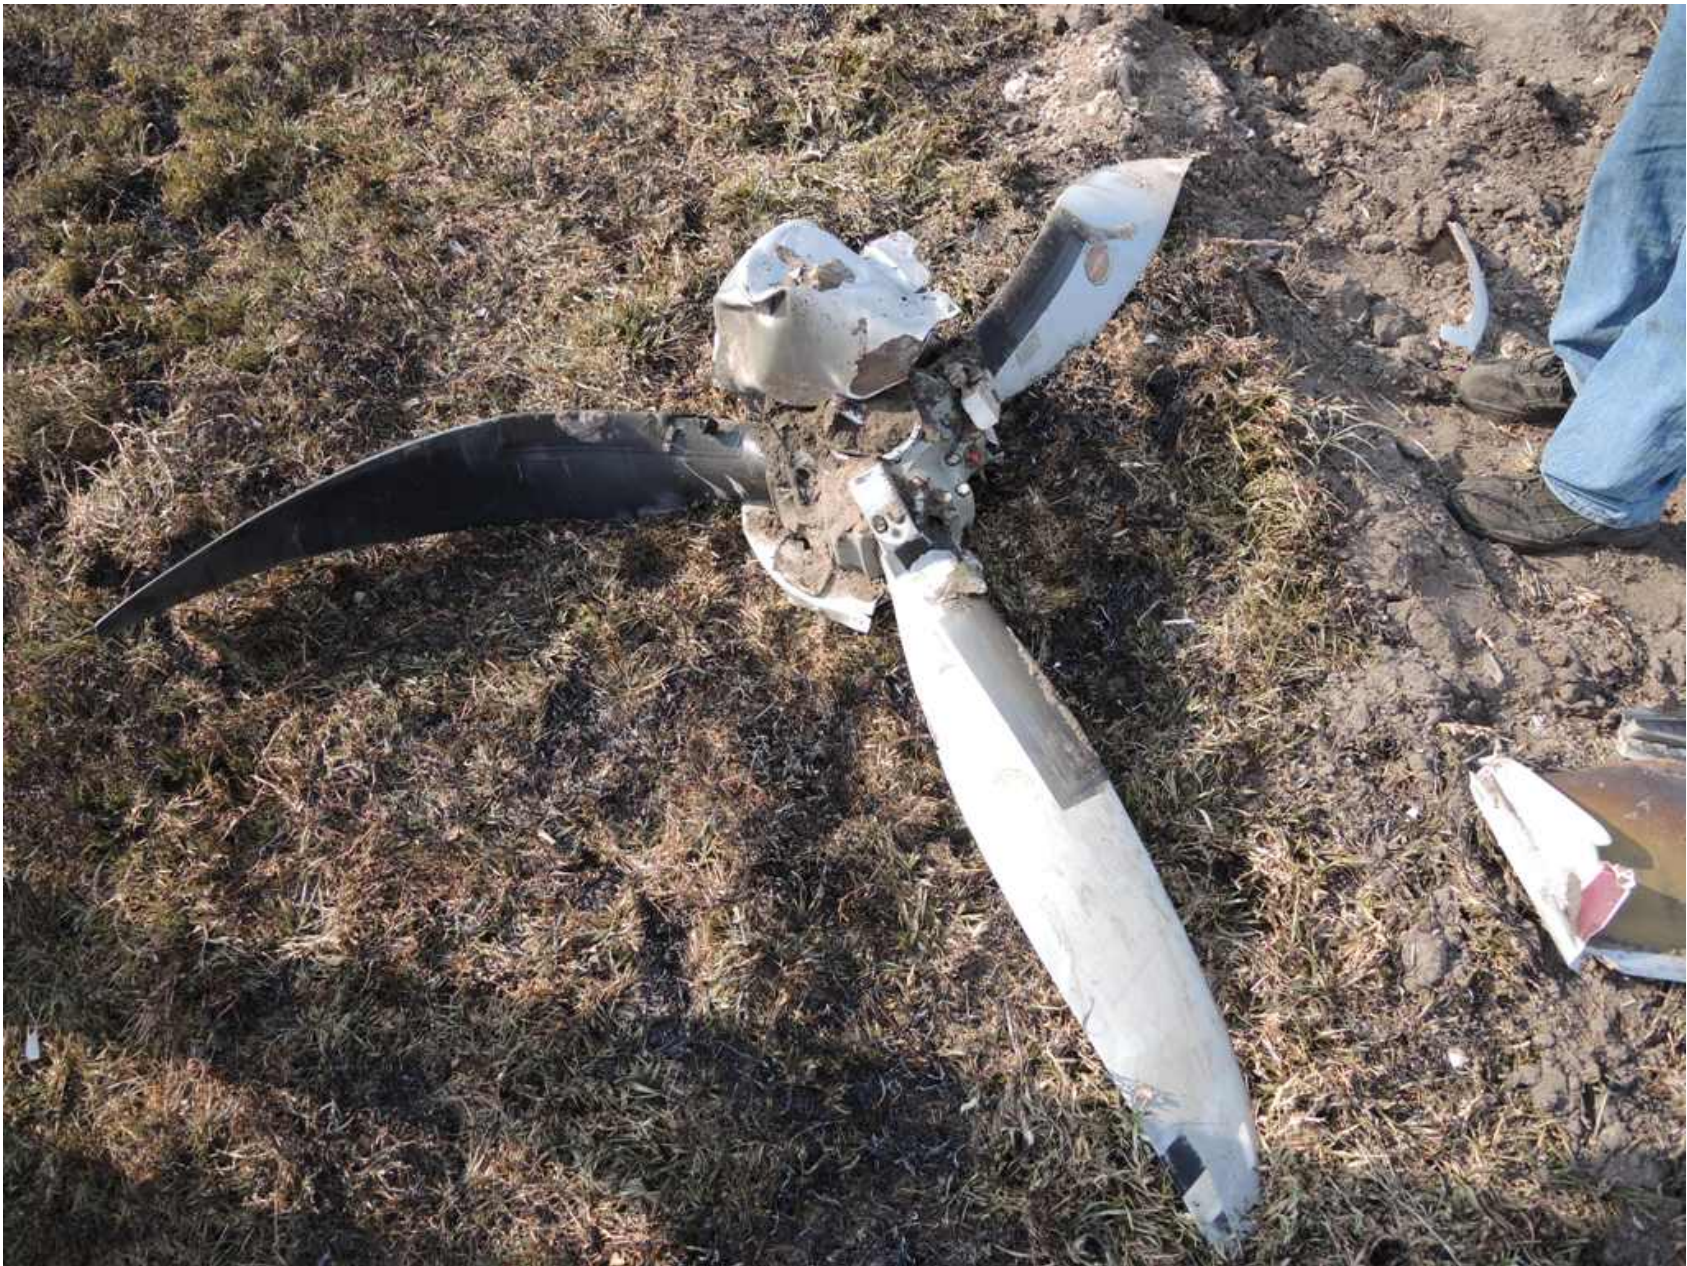
**Photo 7 – Textron Aviation Digital Photograph. View of the Left Propeller.**

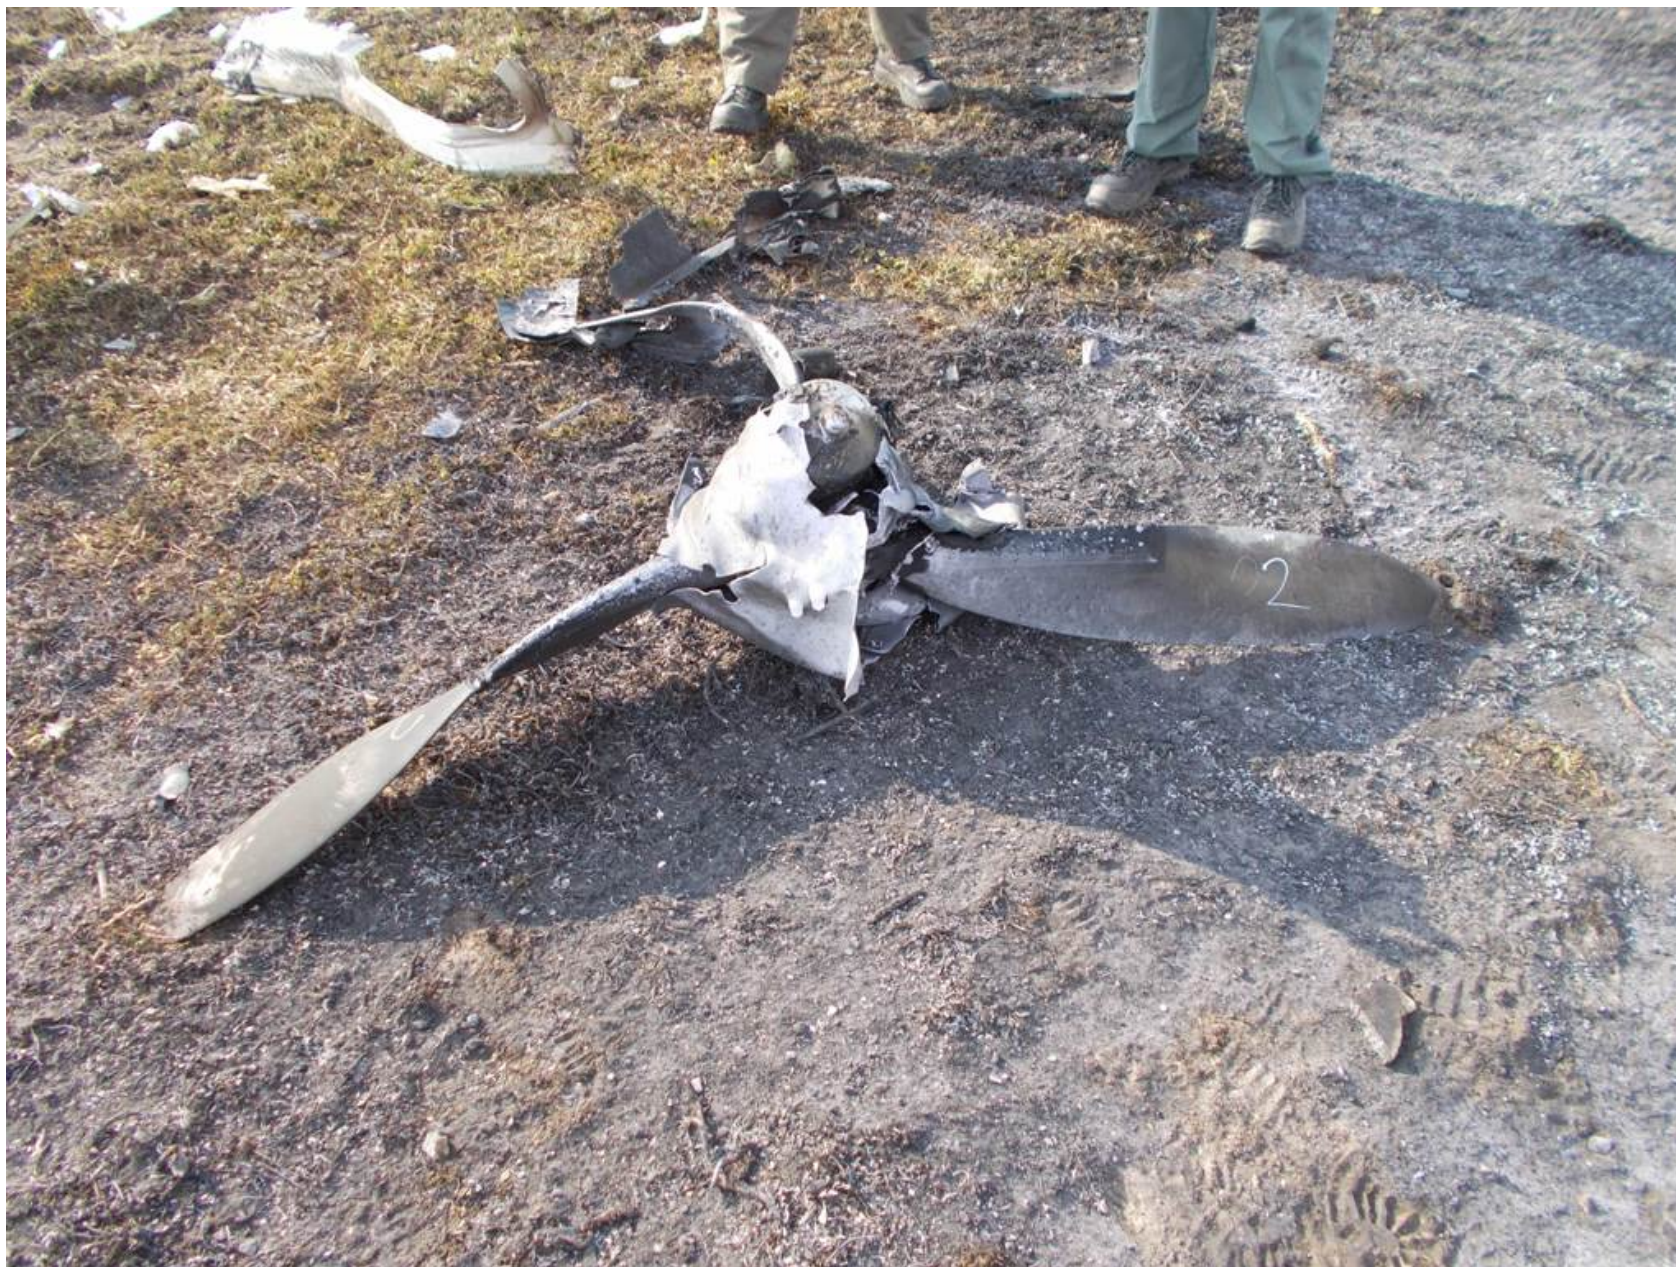
**Photo 8 – NTSB Digital Photograph. View of the Right Propeller.**

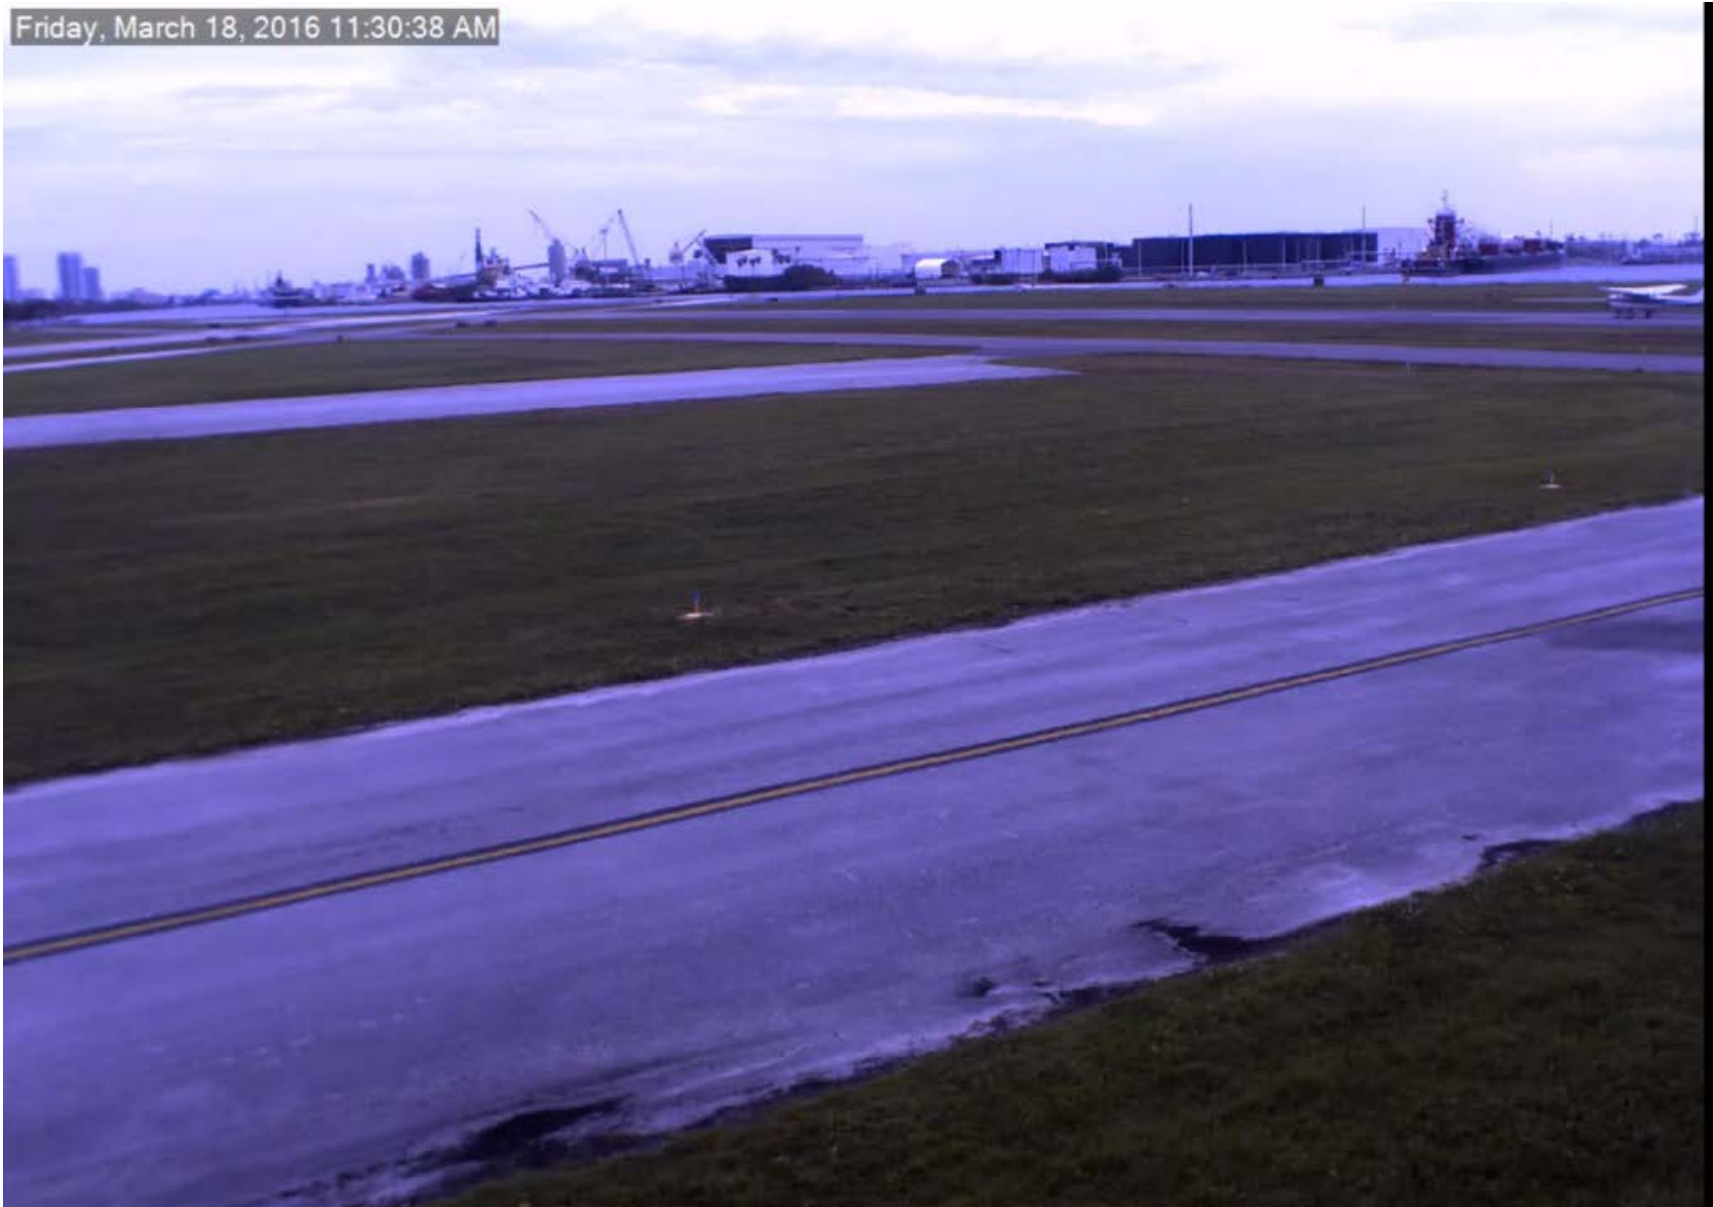
**Photo 9 - Video ScreenShot Capture as Cessna 172M First Came Into View on Runway 36.**

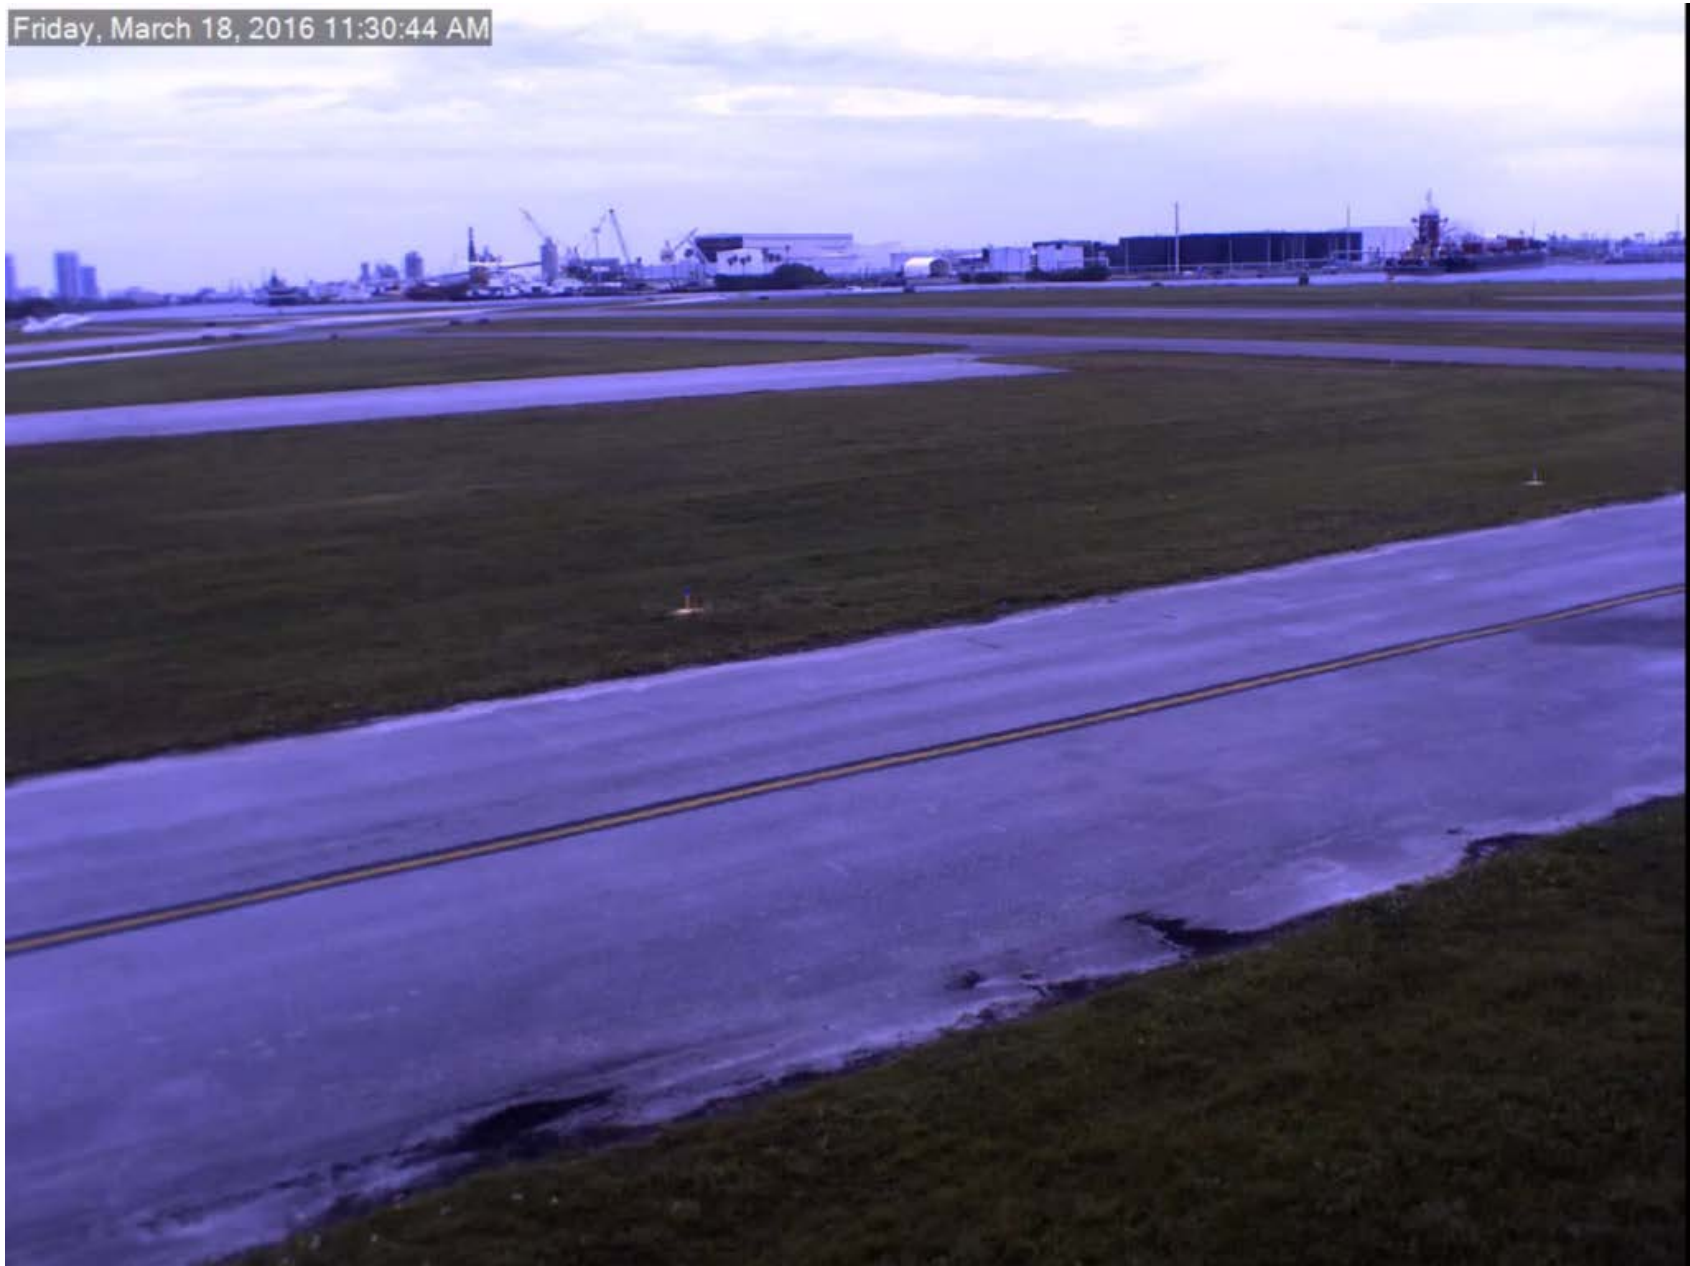
**Photo 10 - Video ScreenShot Capture as Cessna 340A First Came Into View Over Runway 4, and Location of Cessna 172M.**

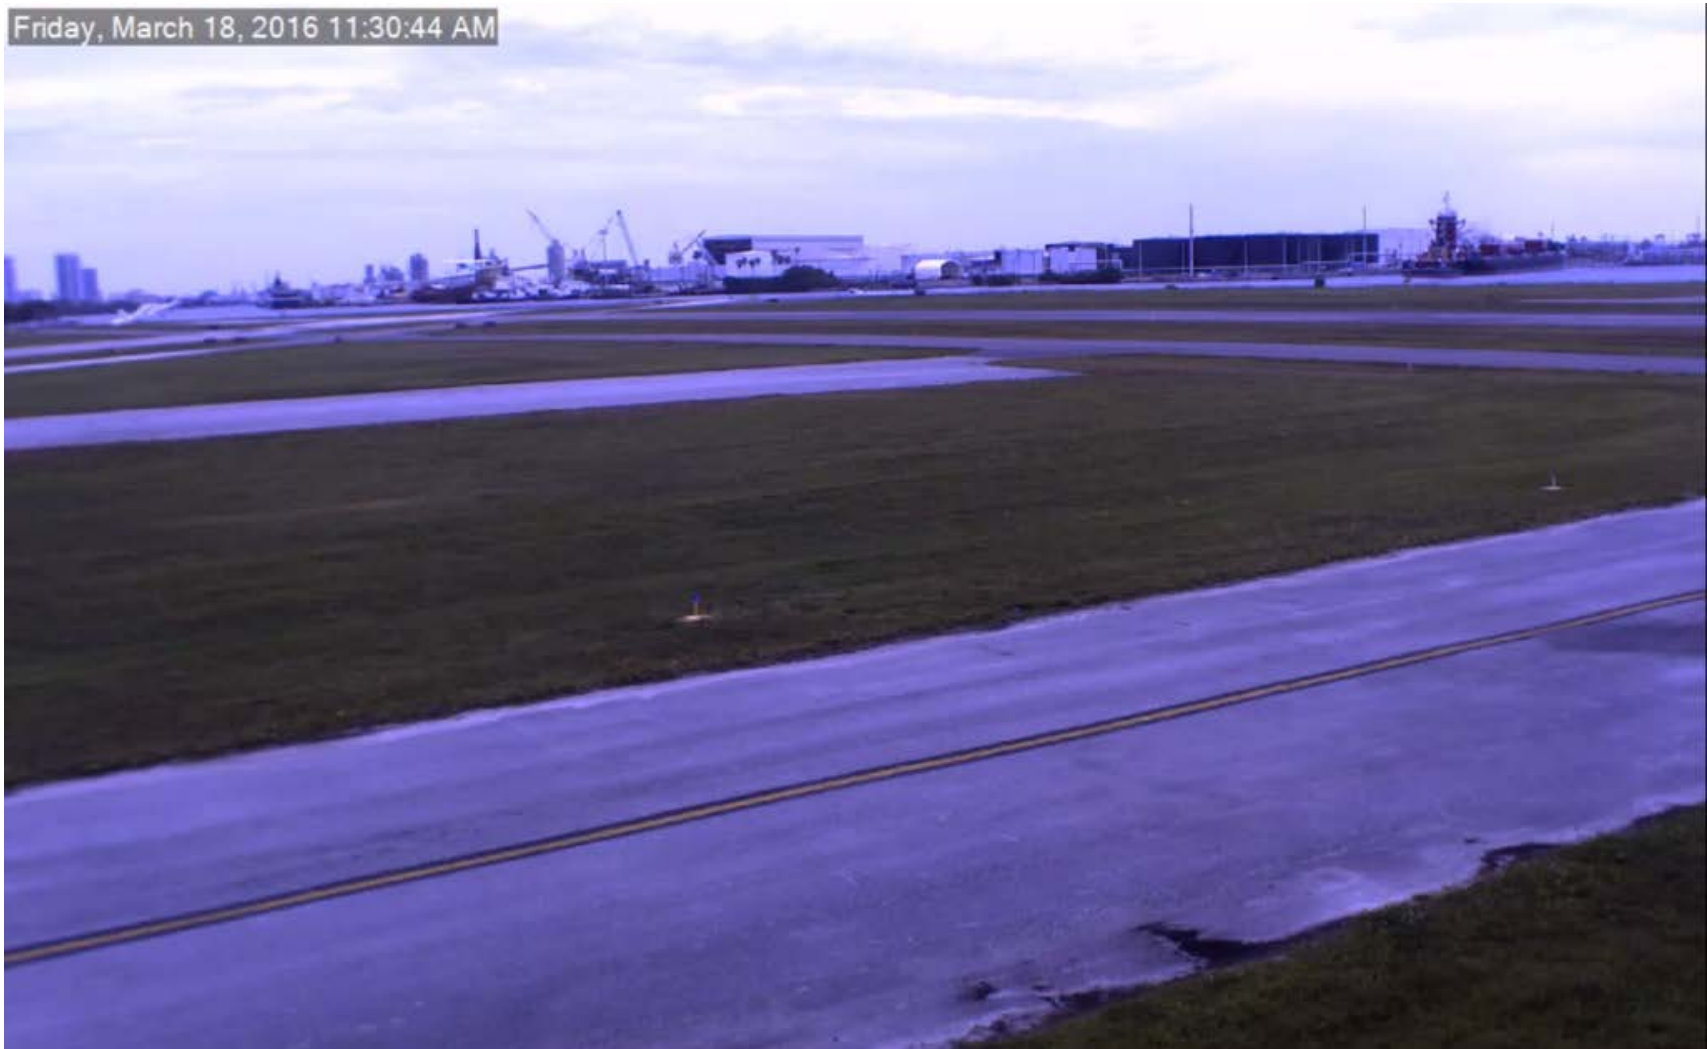
**Photo 11 - Video ScreenShot Capture as Cessna 340A Began Climbing Left Turn, and Location of Cessna 172M.**

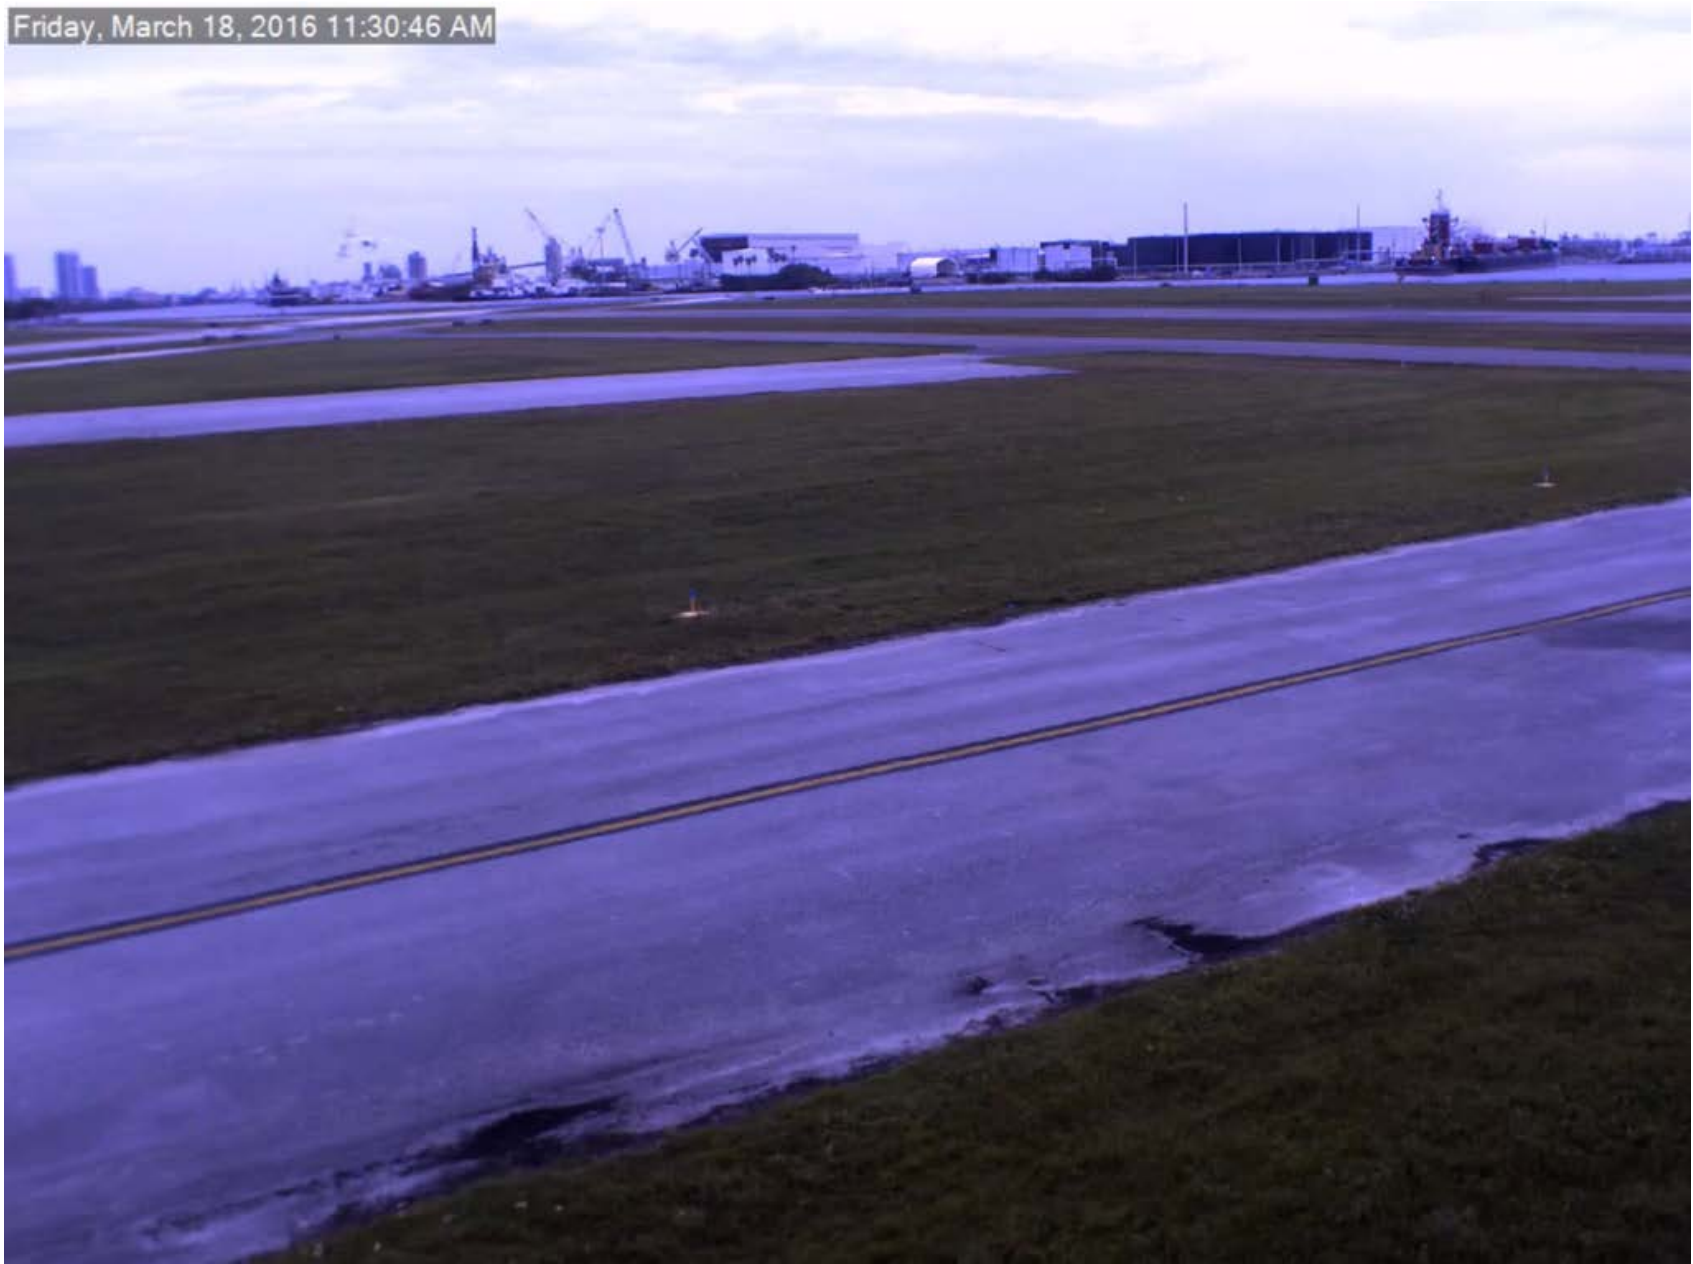
**Photo 12 - Video ScreenShot Capture As Cessna 340A Increased Left Bank Angle, and Location of Cessna 172M.**
