**Photo 1 – NTSB Digital Photograph. View of the Cessna 340A Accident Site.**

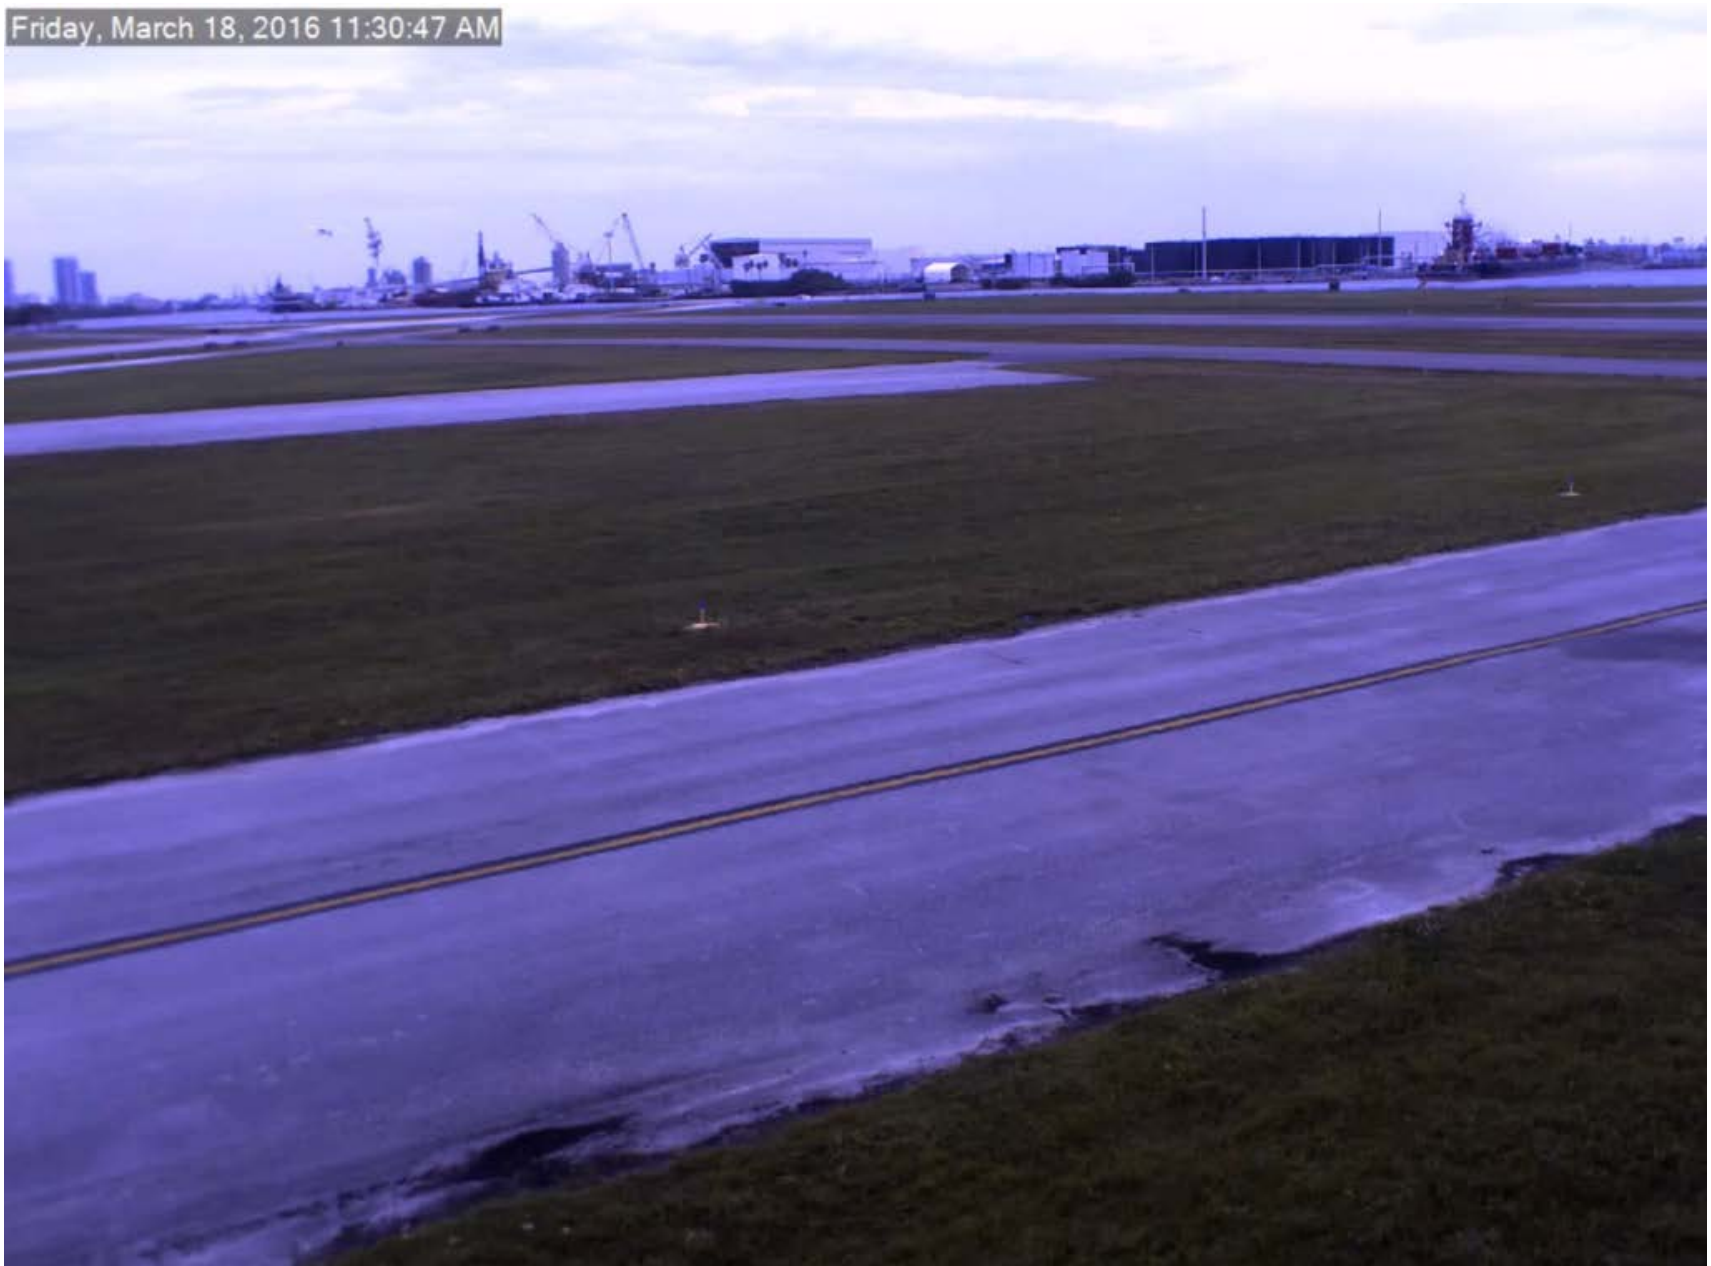
**Photo 13 - Video ScreenShot Capture As Cessna 340A Began Descending, and Location of Cessna 172M.**

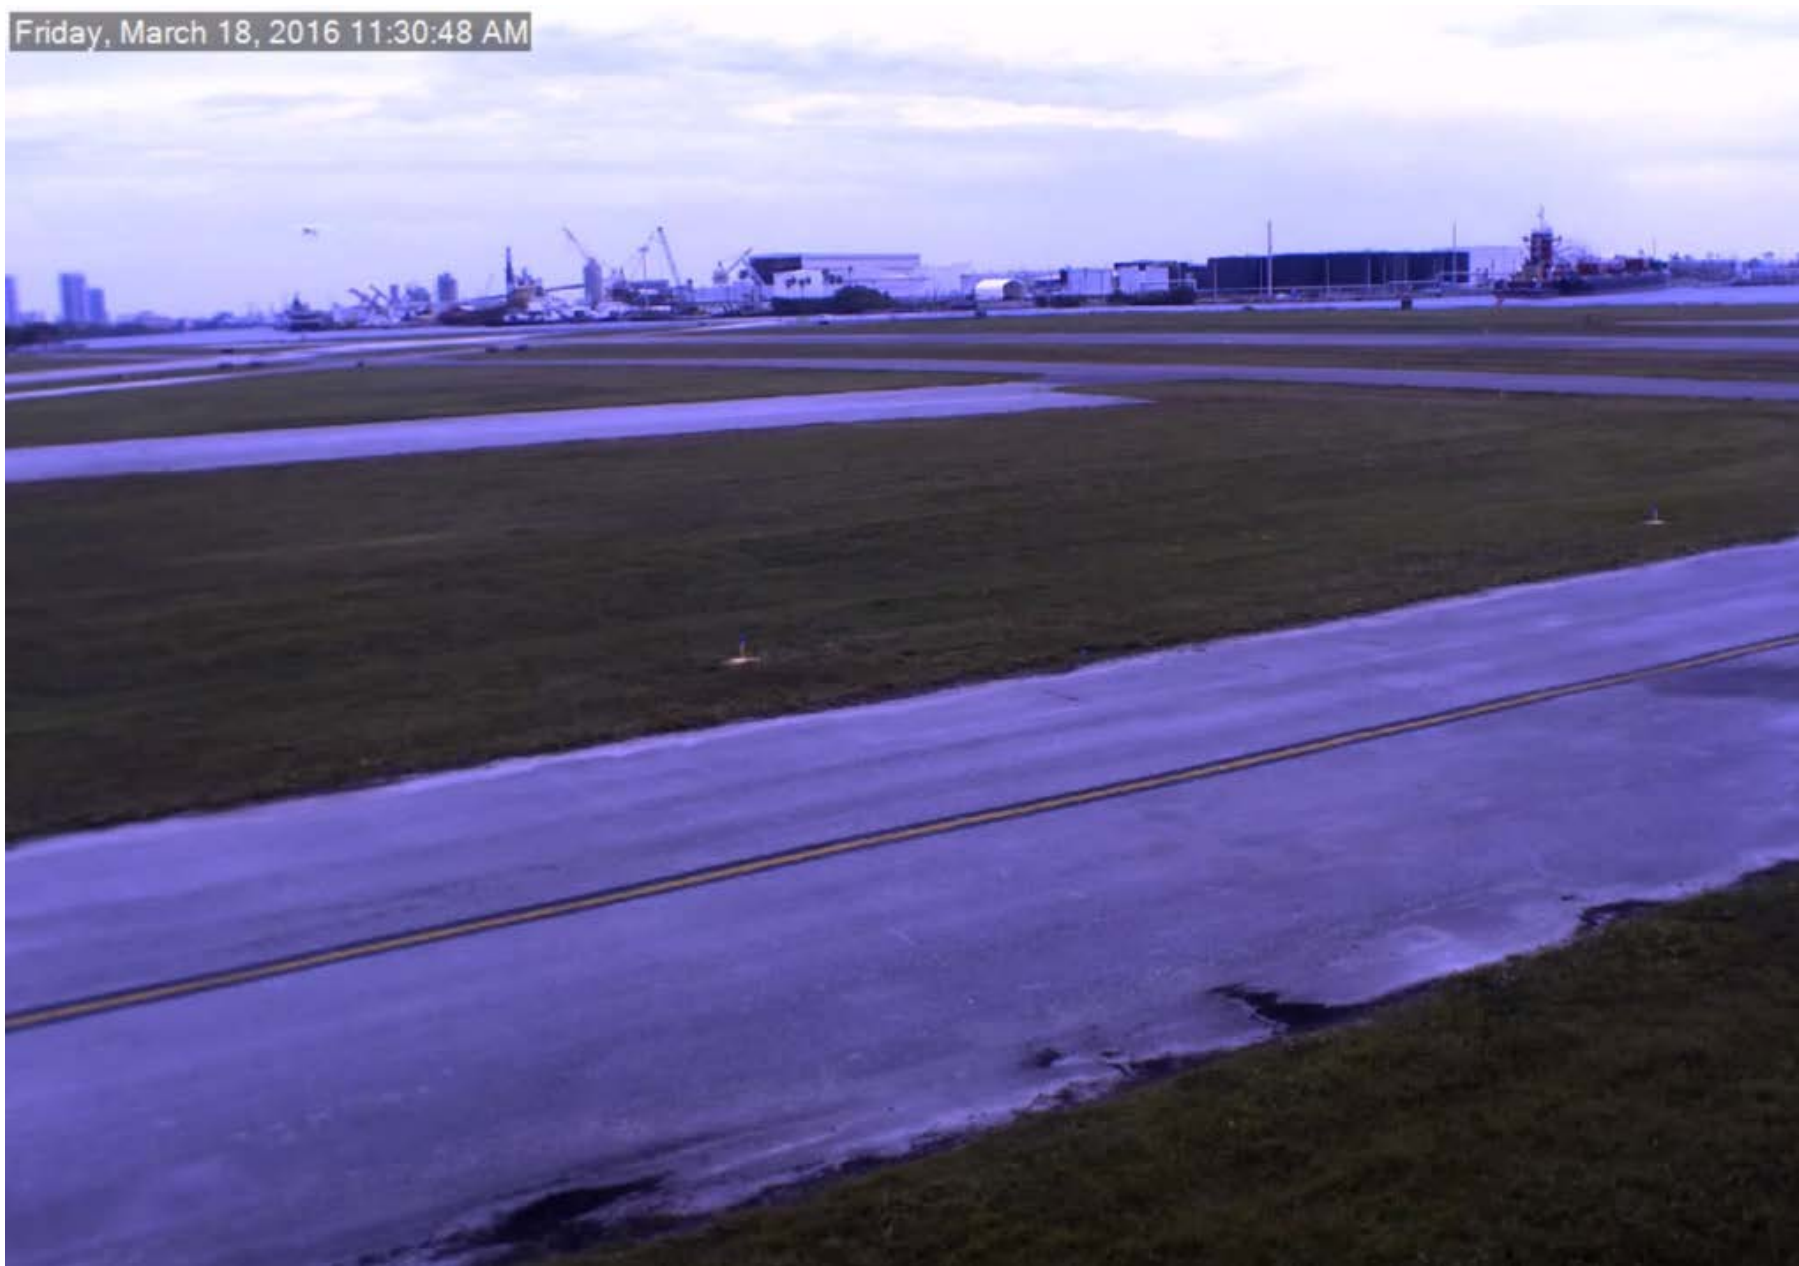
**Photo 14 - Video ScreenShot Capture Of Cessna 340A Just Before Impact, and Location of Cessna 172M.**

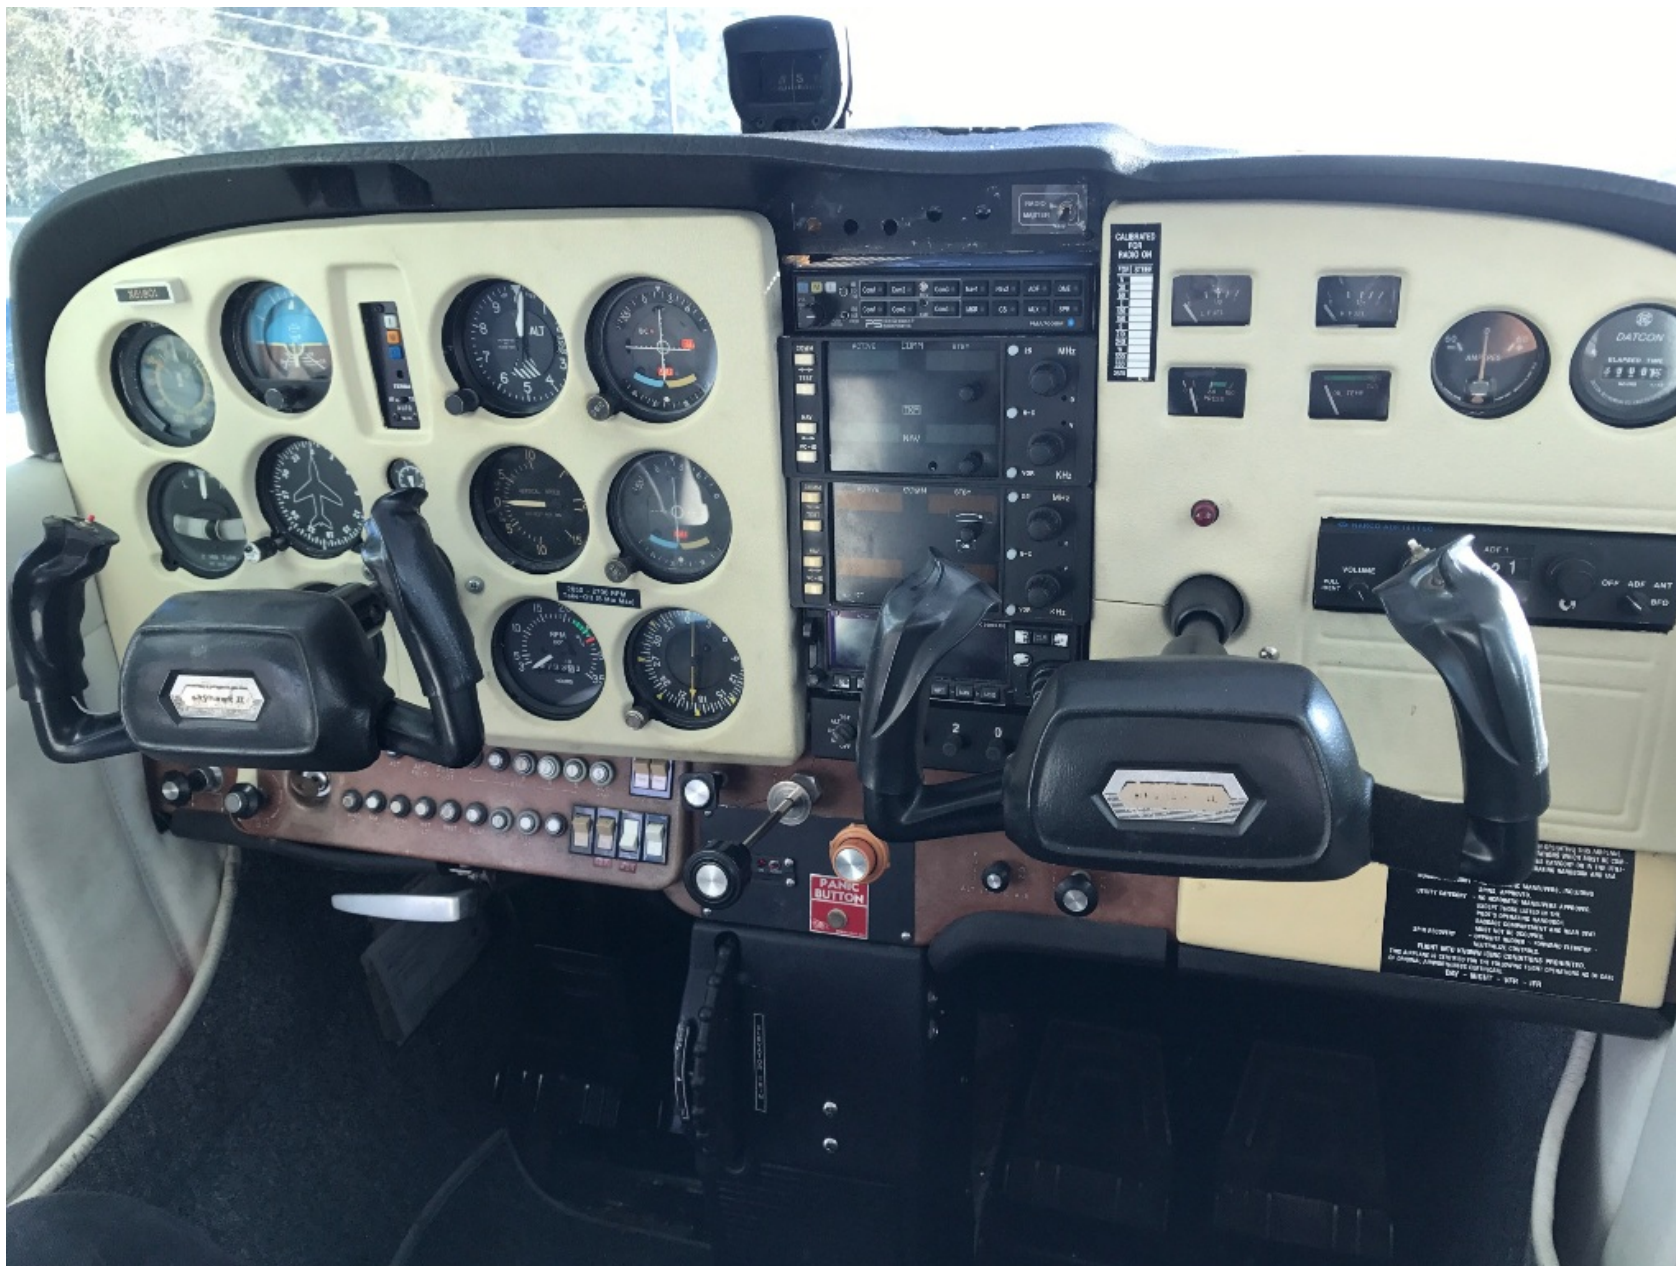
**Photo 15 – Digital Photograph Provided by Owner/Operator of Cessna 172M. View of the Instrument Panel of Cessna 172M.**
