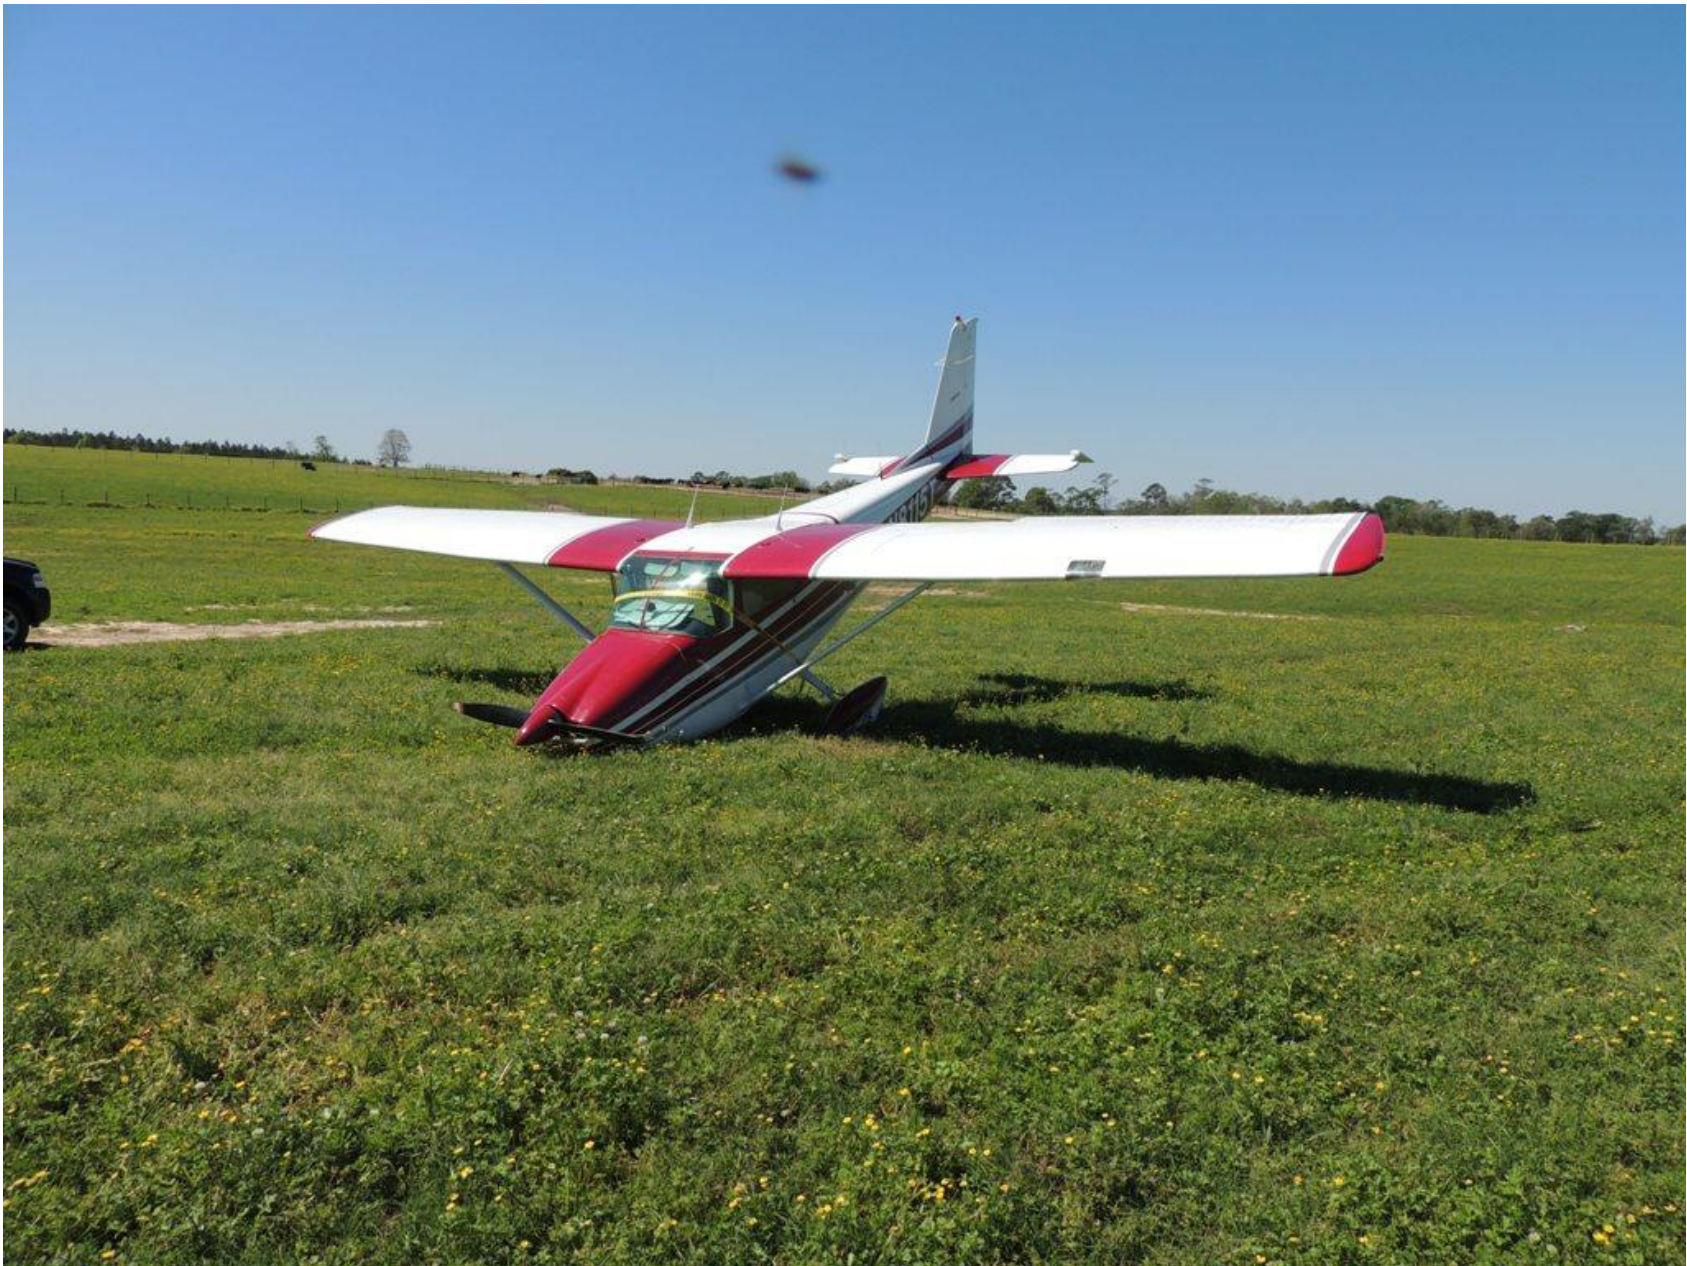
**Photo 1 – FAA Digital Photograph. View Depicting the Airplane at the Accident Site.**

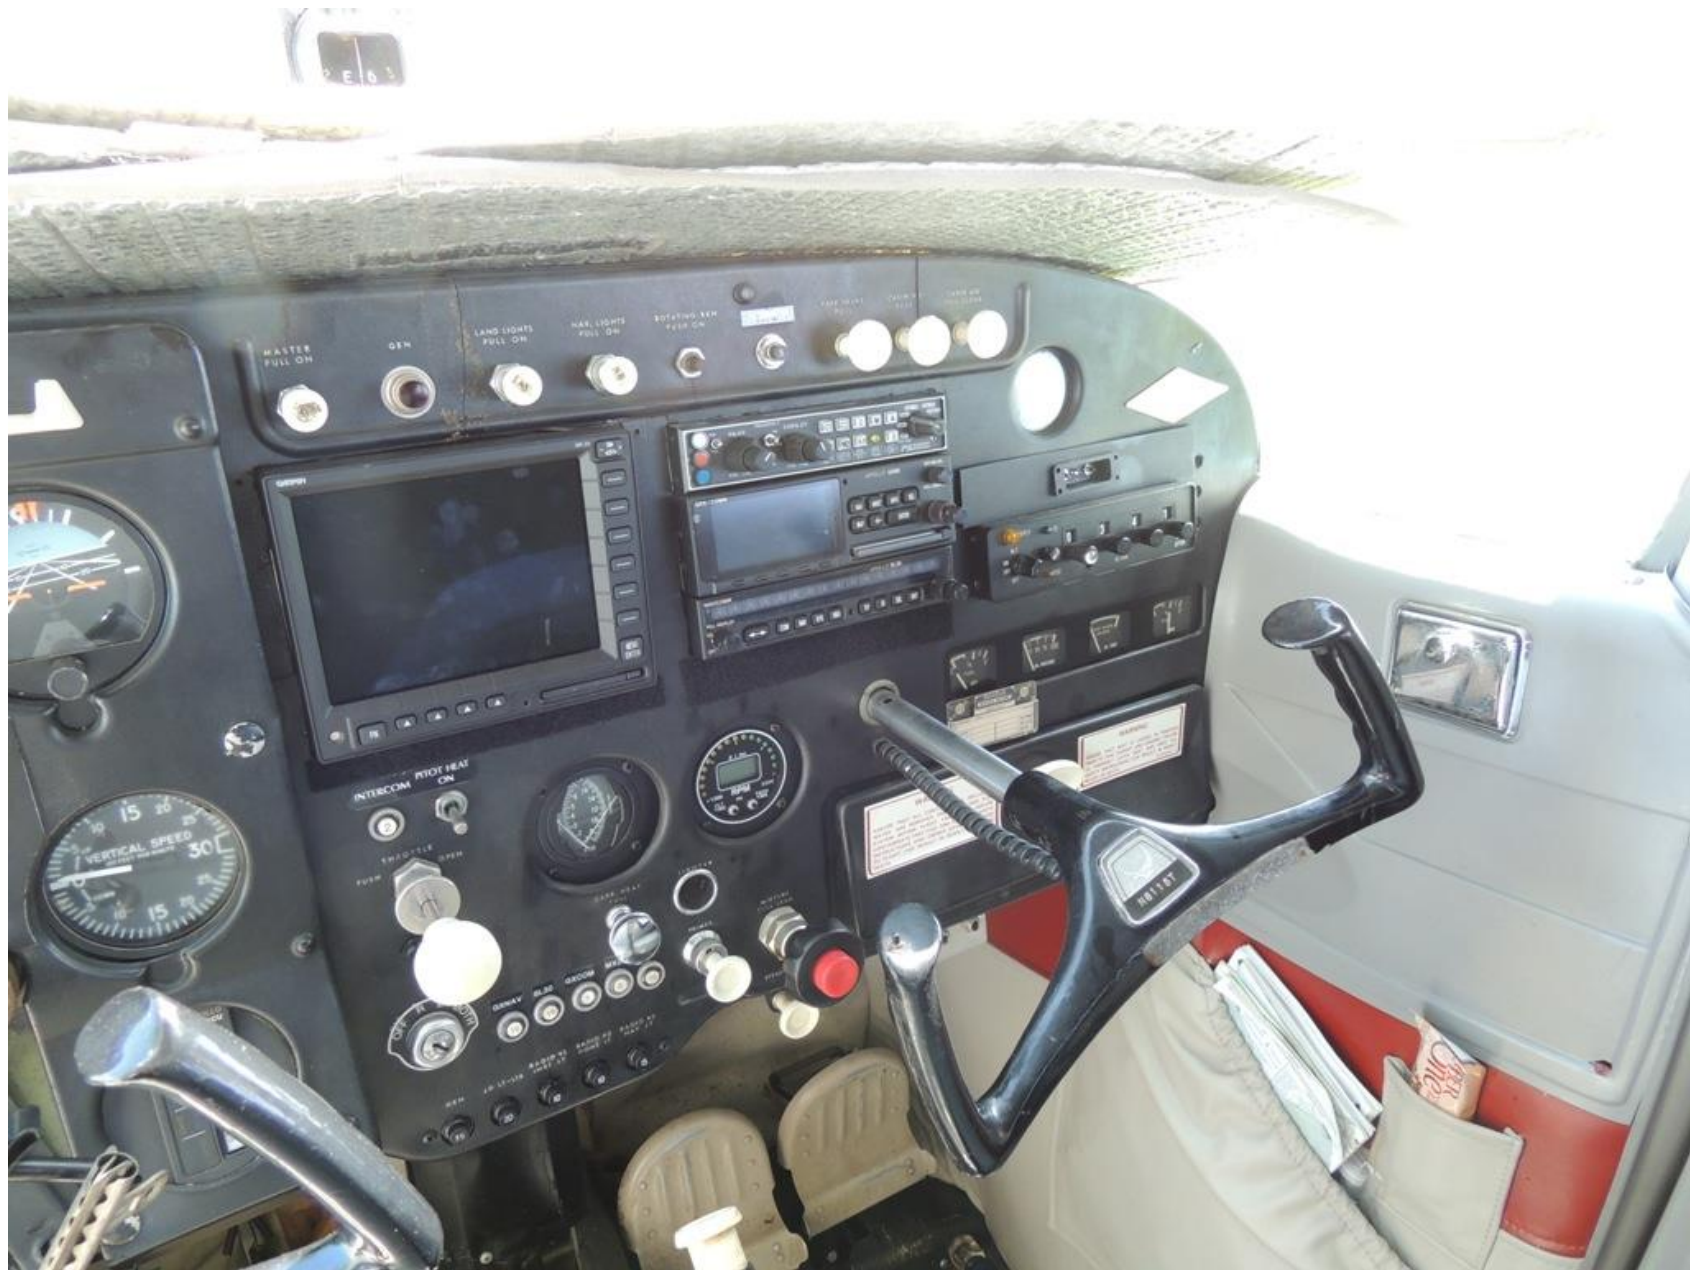
**Photo 2 - FAA Digital Photograph. View Depicting the As-Found Position of the Mixture Control**

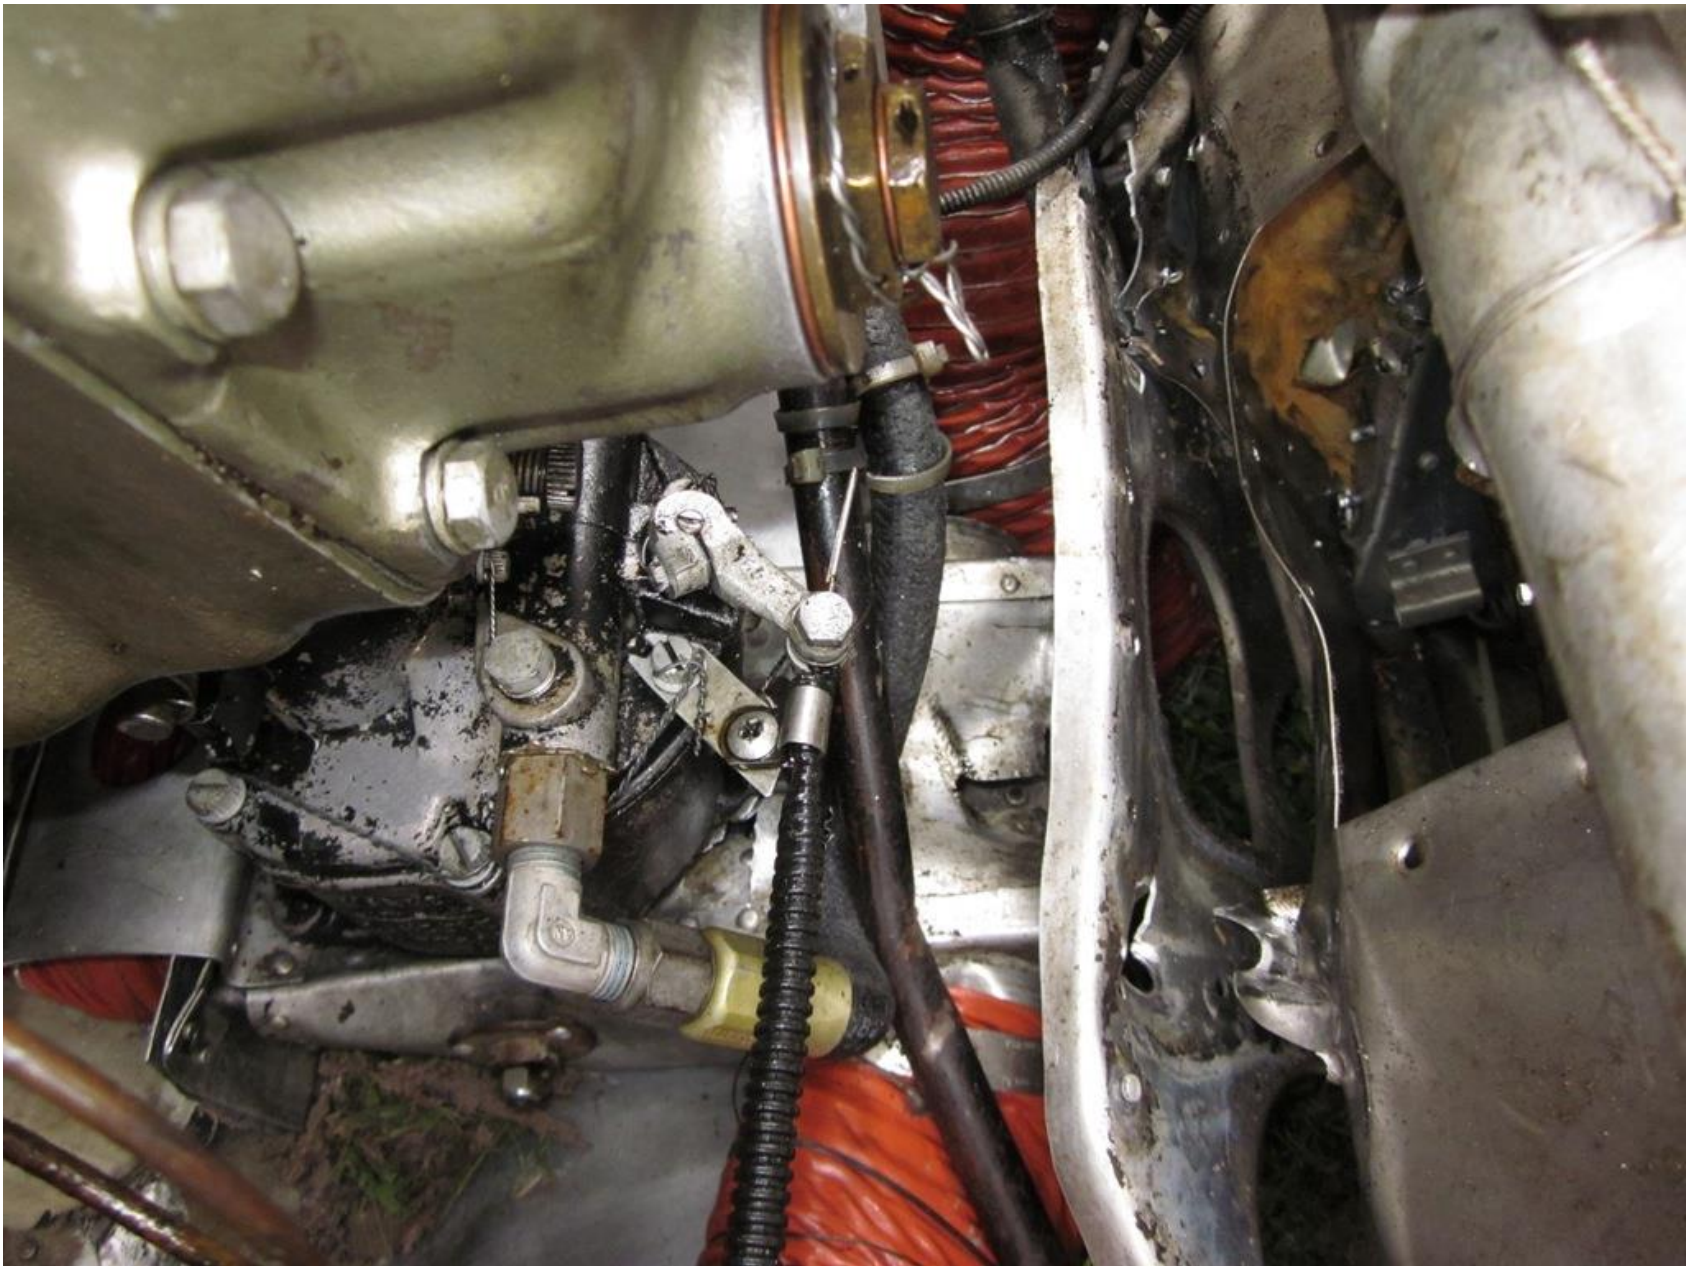
**Photo 3 - FAA Digital Photograph. View Depicting the As-Found Position of the Mixture Control at the Carburetor in the Idle-Cutoff Position**

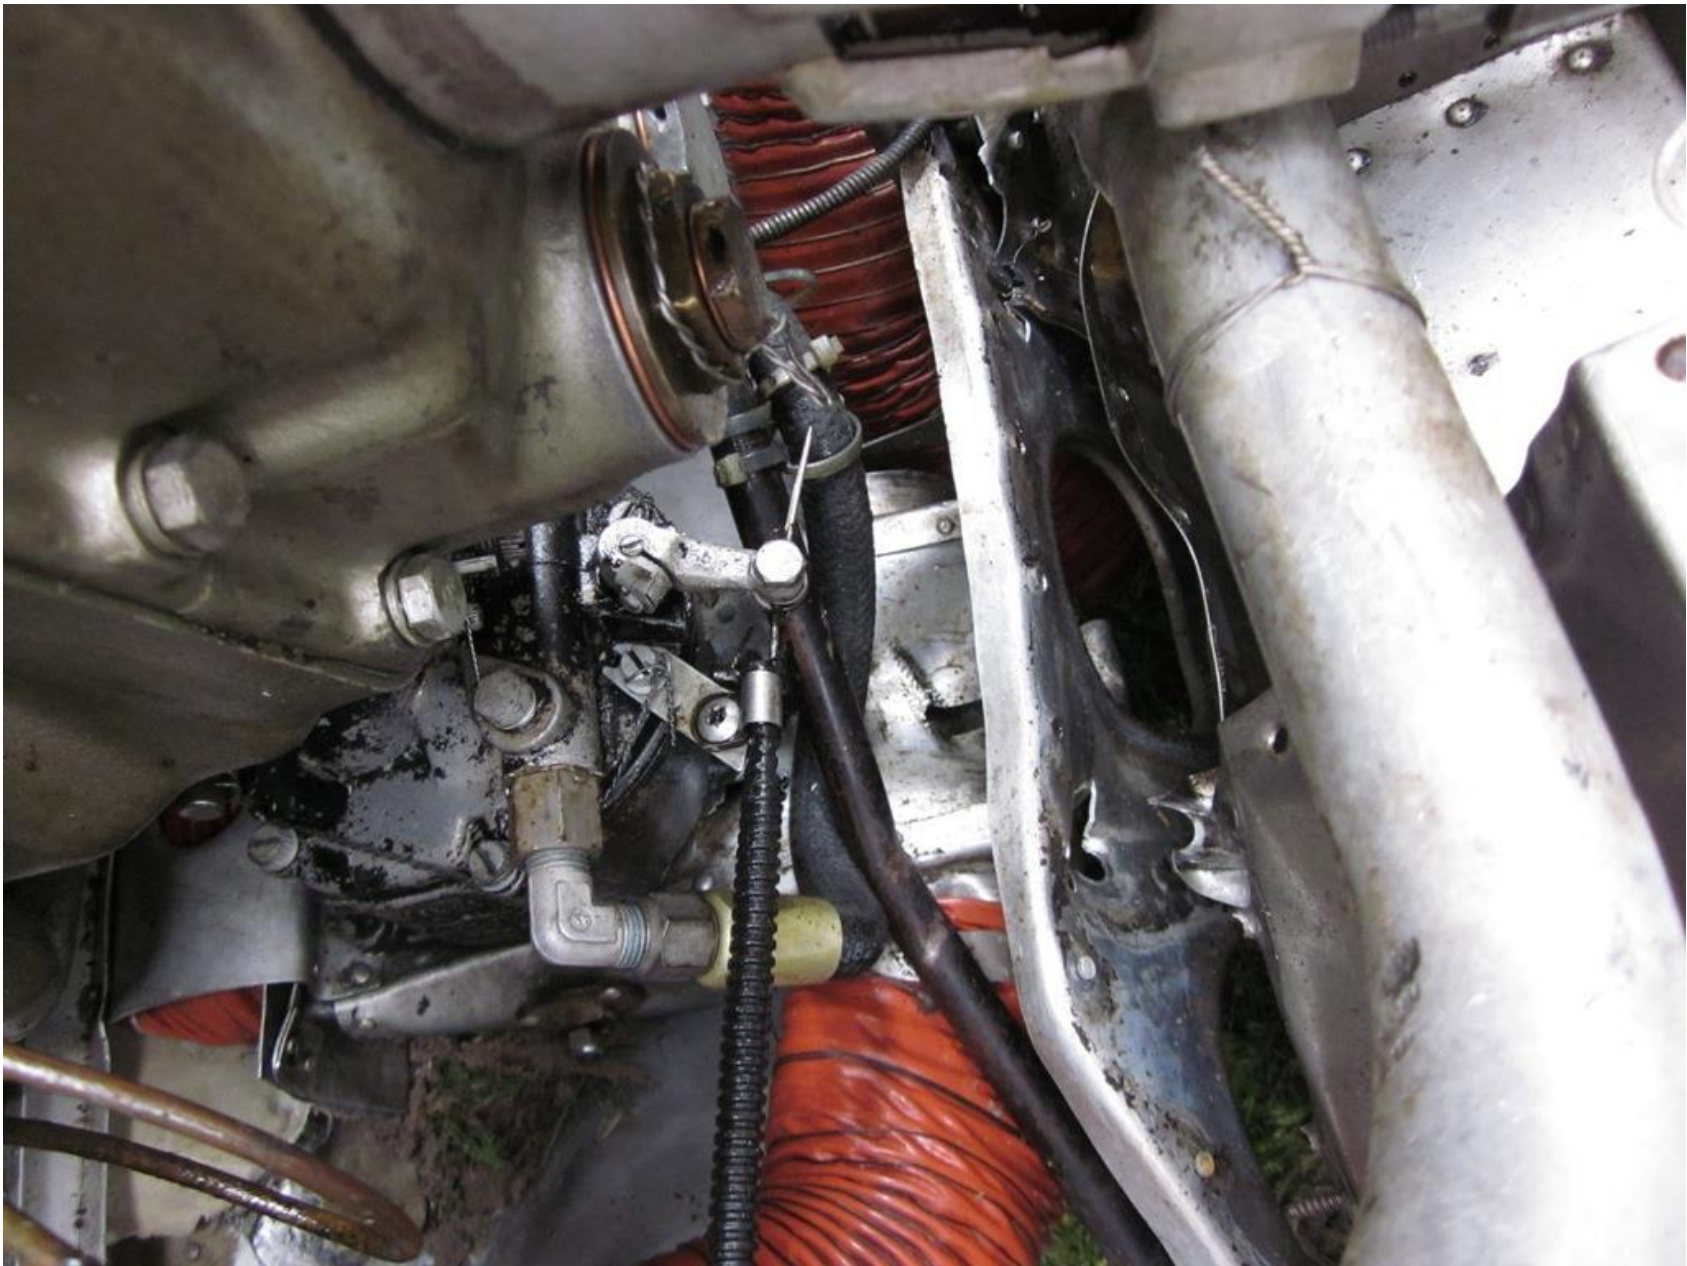
**Photo 4 - FAA Digital Photograph. View Depicting the Position of the Mixture Control at the Carburetor Following Pulling of the Mixture Control Full Aft and then Pushing of the Mixture Control to Full Rich.**
