# NATIONAL TRANSPORTATION SAFETY BOARD

### Specialist's Factual Report

Location: Critz, Virginia  
Date: May 7, 2016  
Aircraft: Taylorcraft BC12-D  
Registration: N43363  
Operator: Private  
NTSB Number: ERA16LA179

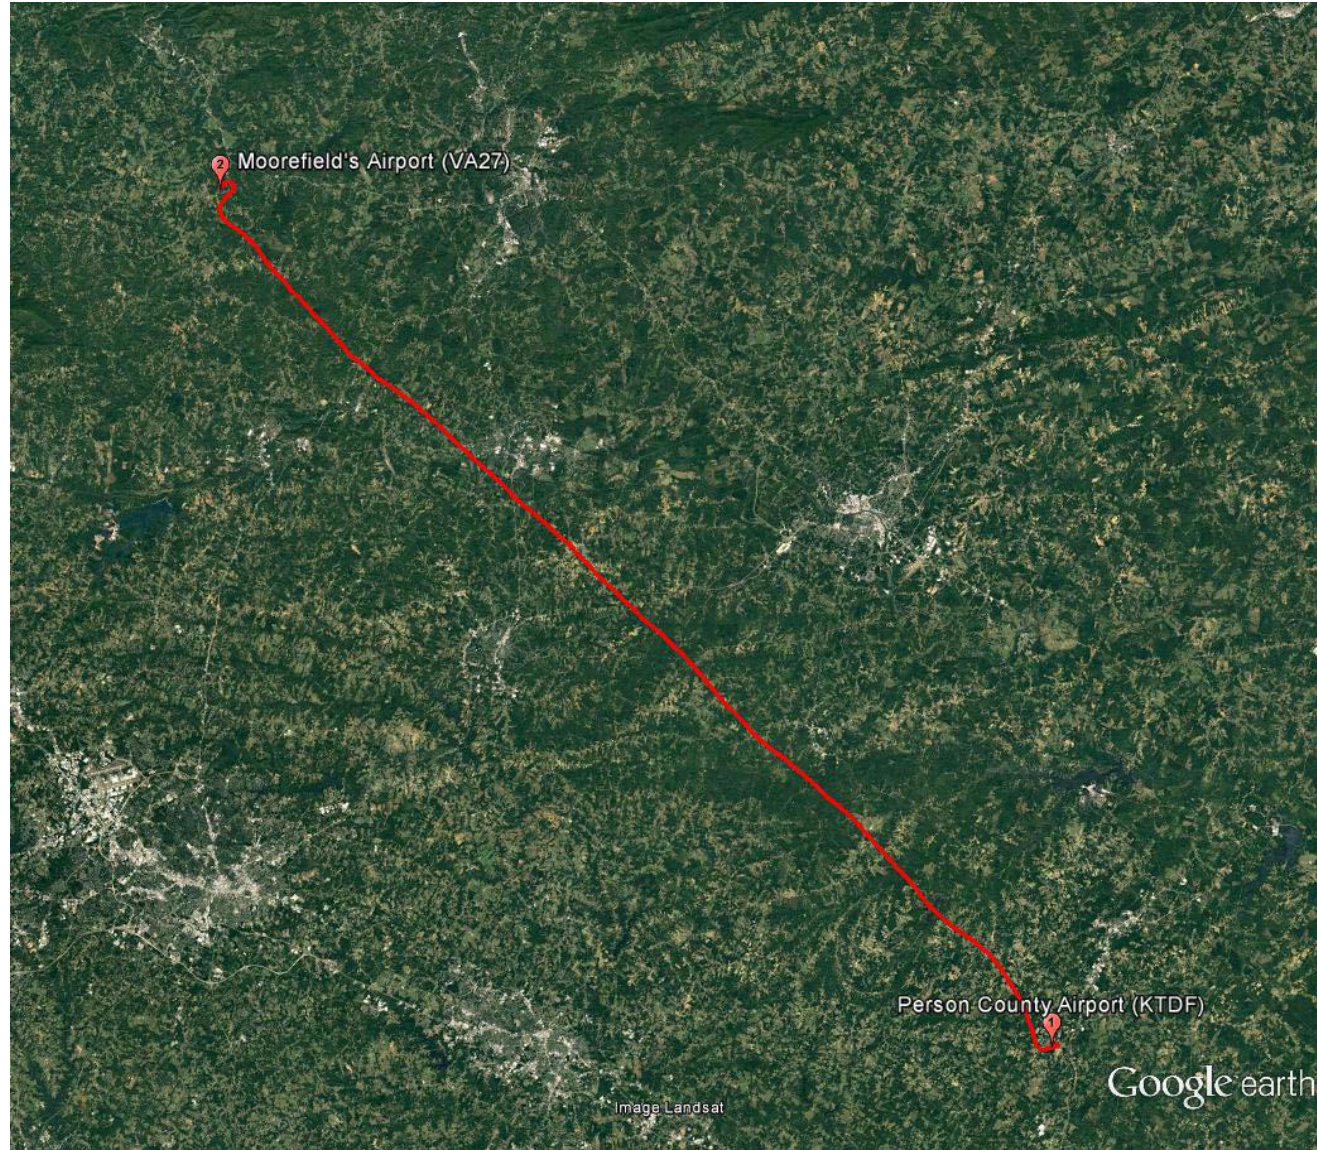
**Figure 1. Overview of accident flight session 24 from Person County Airport (KTDF) to Moorefield's Airport (VA27)**

The accident flight departed Person County Airport (KTDF) from Runway 24 at approximately 17:23:58 UTC on May 7, 2016. The last relevant recorded parameter for the accident flight was as at 18:29:49 UTC on May 7, 2016, with a GPS altitude of 1096 feet above Mean Sea Level (MSL) and a ground speed of 38 knots. Figure 1 depicts the entire flight path recorded by the GPS unit for the accident flight recorded during flight session 24.

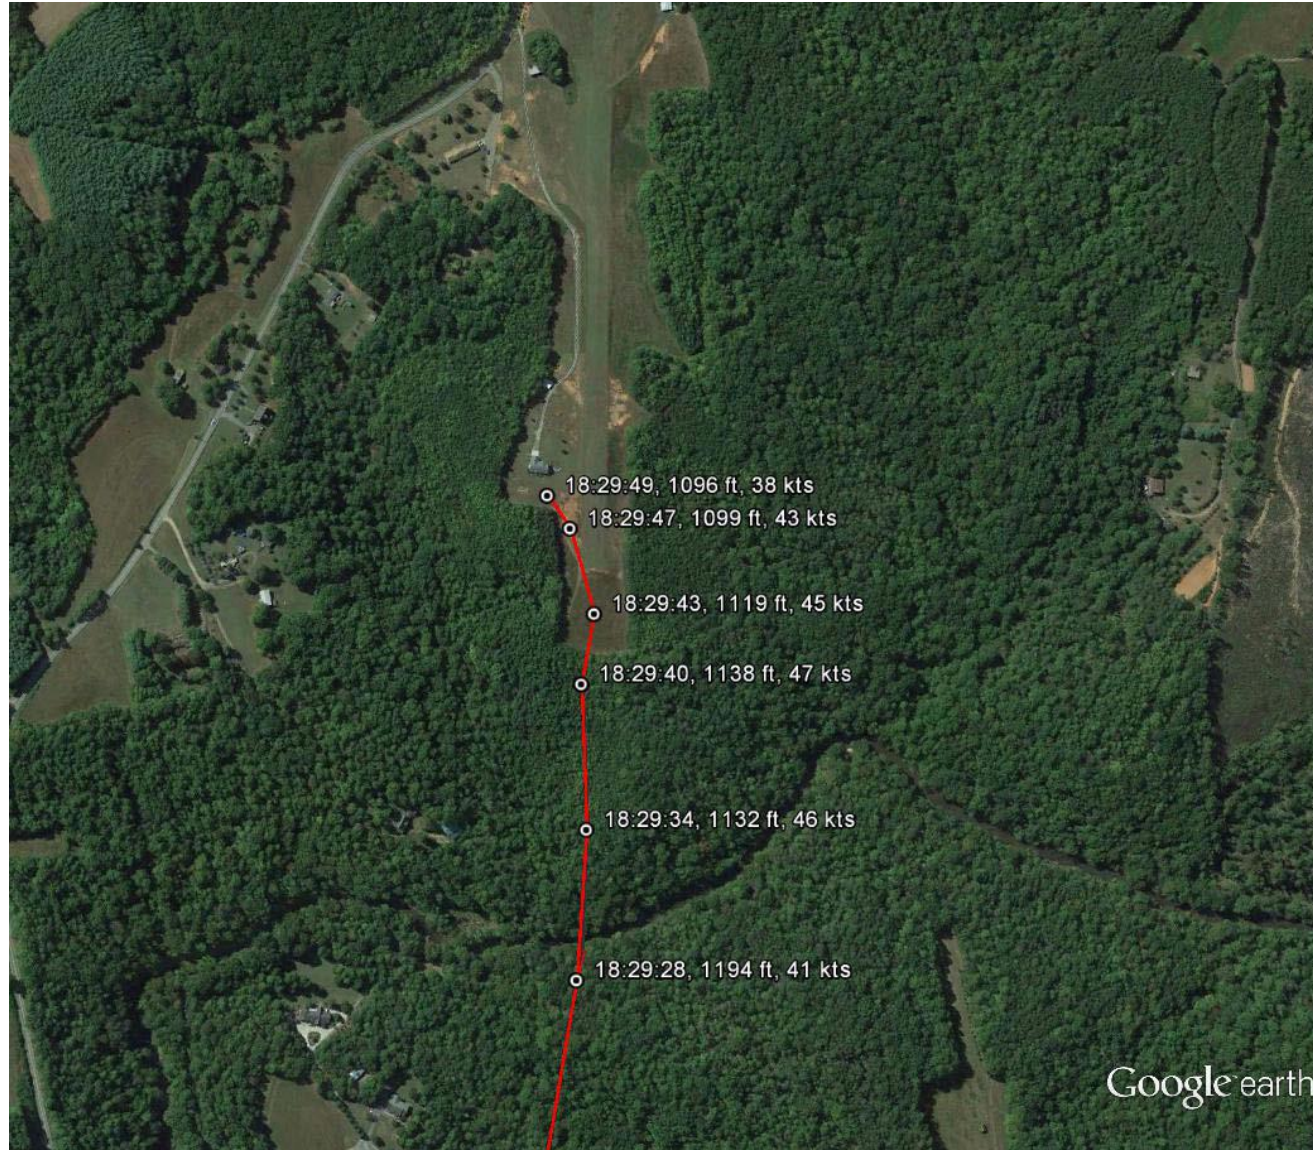
**Figure 4. Ground path of aircraft's final approach to Moorefield's Airport (VA27) displaying area of impact**

Figures 2 through 4 use the data of flight session 24 data to provide a close view of the aircraft's final approach to Runway 19 of Moorefield's Airport (VA27). Scattered data samples recorded for this session after 18:29:49 UTC were considered erroneous and likely a result of post-impact effects and search efforts. Figure 5 is included to demonstrate some of the erroneous data samples believed to have occurred after impact.

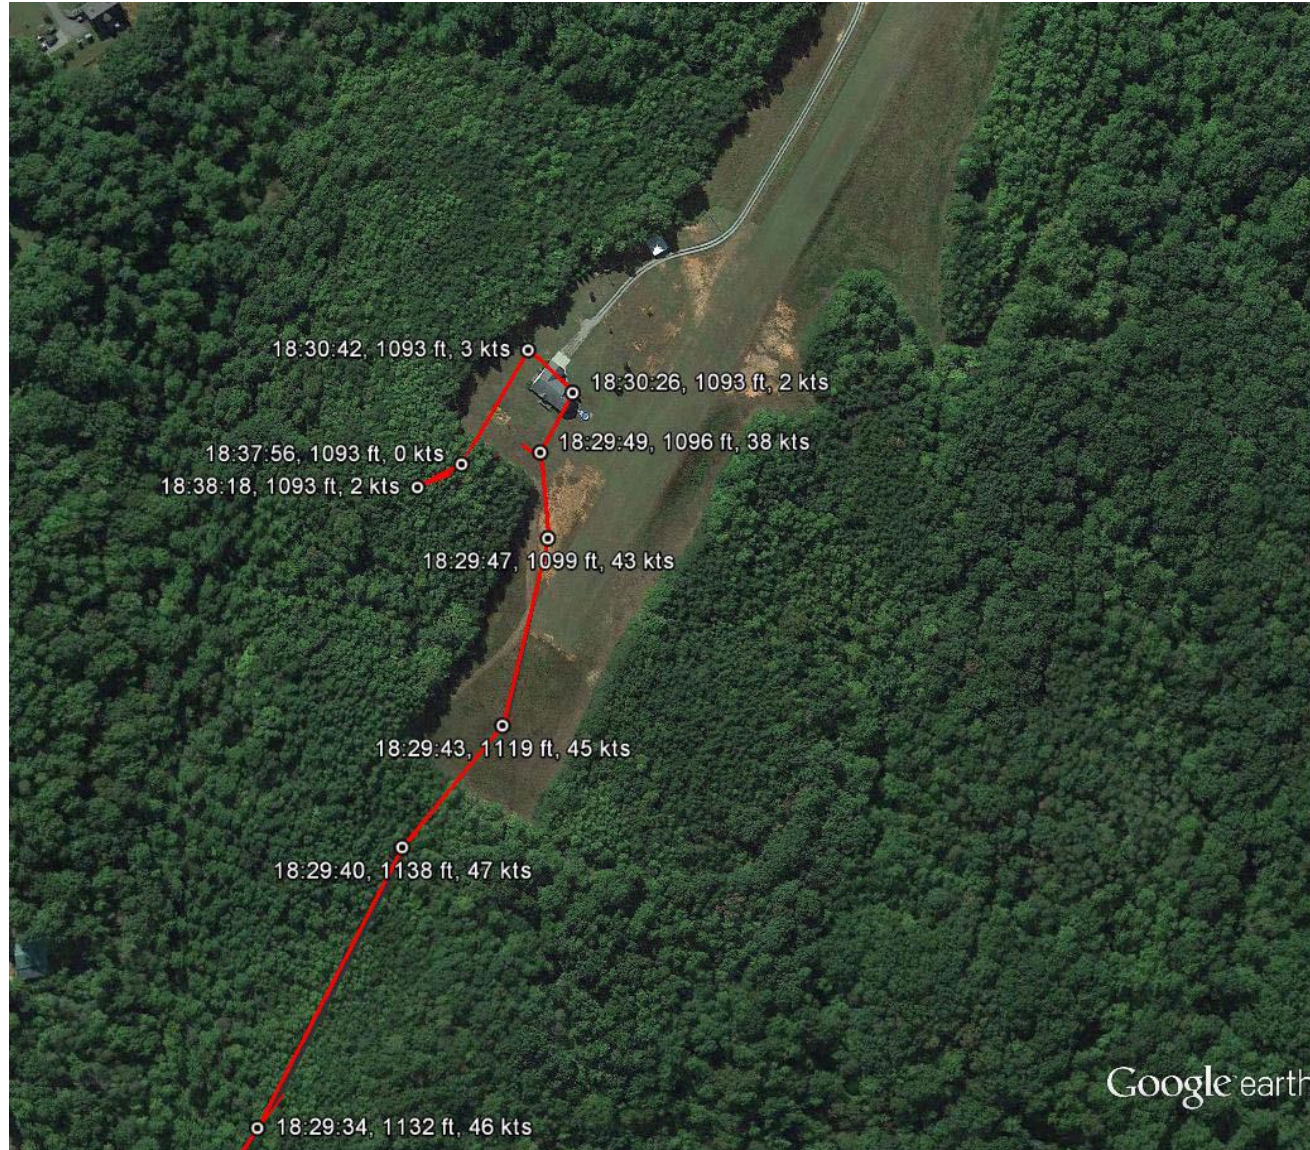
Figure 5. Aircraft's final approach and impact including some samples of post-crash data
