# NATIONAL TRANSPORTATION SAFETY BOARD

## Global Positioning System Device

### Specialist's Factual Report

Location: Chatham, Massachusetts  
Date: June 17, 2016  
Aircraft: Robinson R44  
Registration: N141TM  
Operator: Ryan Rotors Inc.  
NTSB Number: ERA16LA216

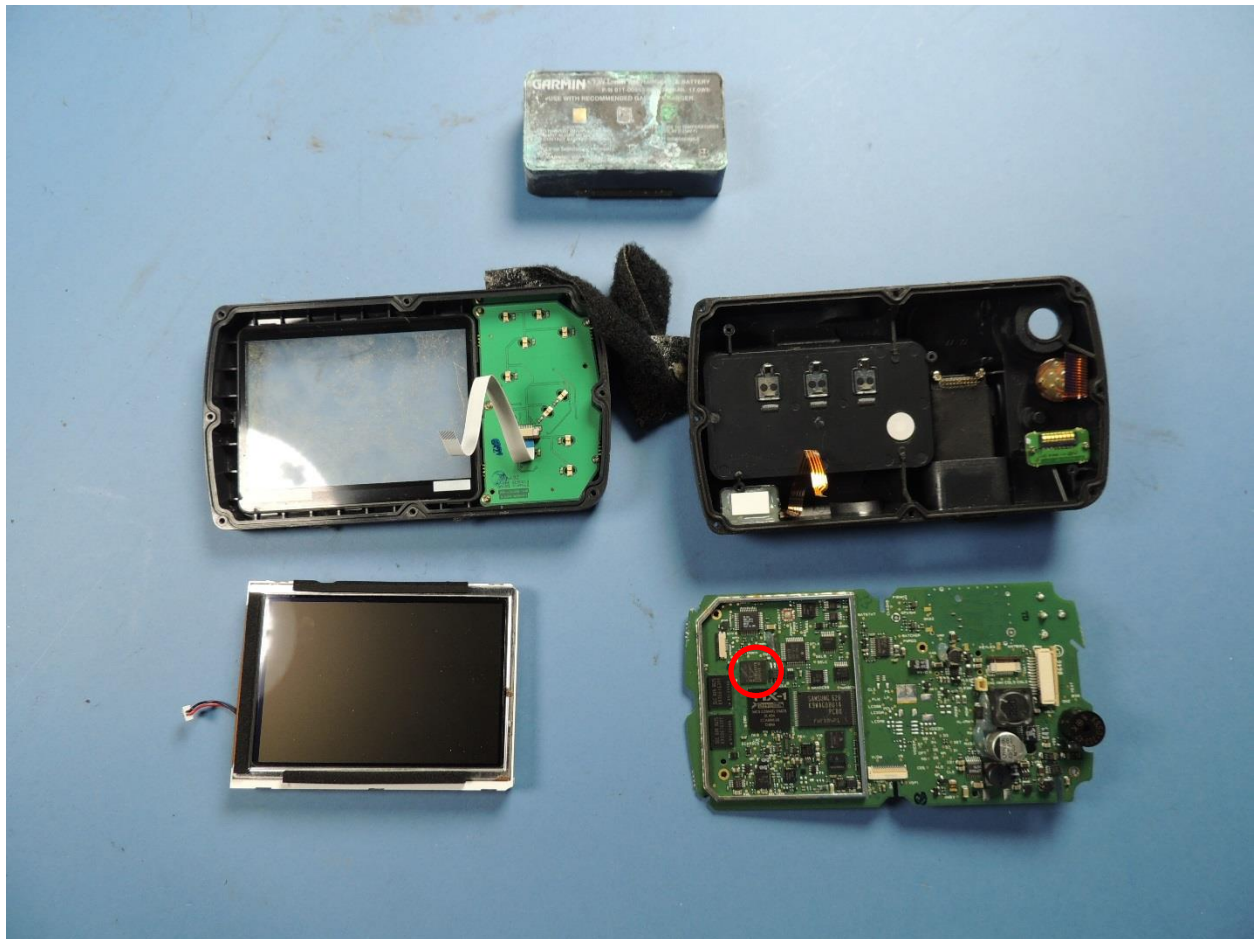
The Garmin GPSMAP 496 sustained water damage during the accident, and would not power on. It was disassembled and, using a universal chip programmer, data was recovered directly from the NVM chip that contained the recorded information. Figure 1 shows the damaged device, after disassembly and cleaning; the NVM chip that was removed from the circuit board assembly is identified with a red circle.

**Figure 1.** Photo of disassembled Garmin GPSMAP 496.

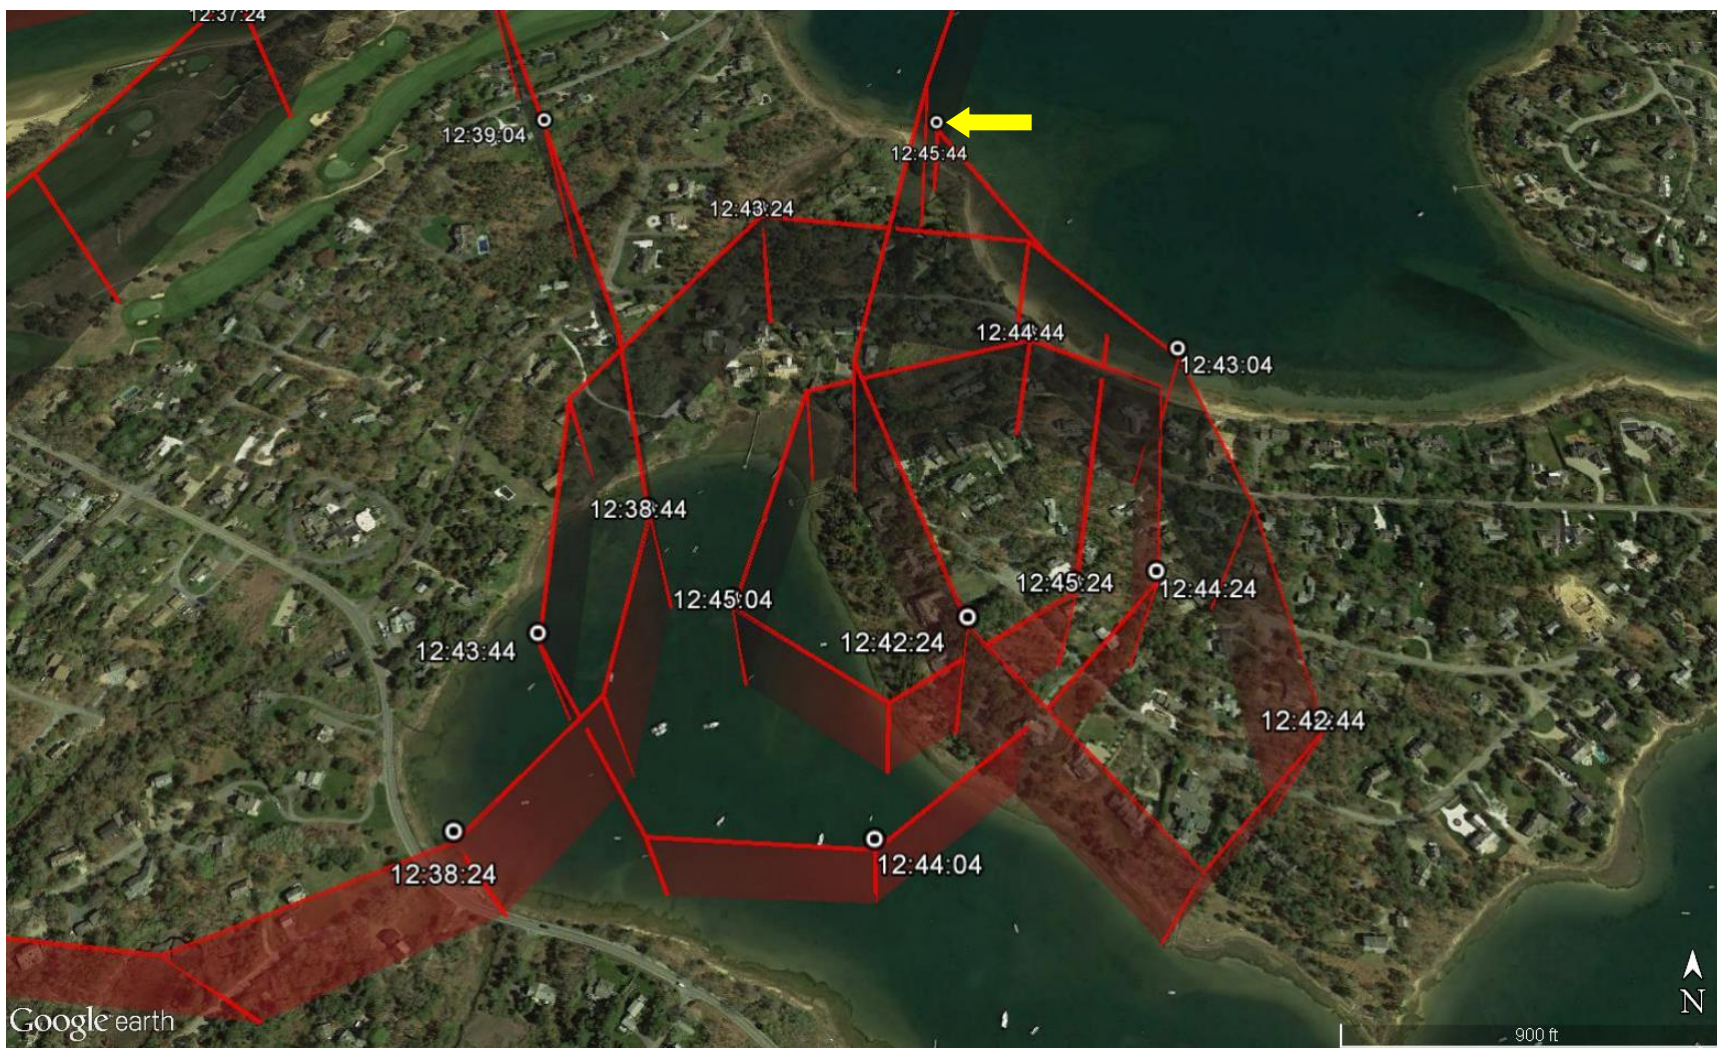
Figure 2 shows an overhead view of the entire flight. Figure 3 shows an oblique overhead view of the final minutes of the flight.

**Figure 3.** Google Earth overlay of accident flight, immediately prior to accident. The final position was recorded at 12:45:44 EDT, highlighted with a yellow arrow.

Figures 2 and 3 are graphical overlays, generated using Google Earth, for the accident flight. The weather and lighting conditions in Google Earth are not necessarily the weather and lighting conditions present at the time of the recording.

Tabular data used to generate Figures 2 and 3 are included as Attachment 1, provided in electronic comma-delimited (CSV) format.
