Inspector Statement  
ASI William A. Anderson  
NTSB Case # ERA16LA274

On December 23, 2016, at approximately 1215 CST, Inspector Anderson met with Mr. Leo Bennetti-Longhini at the Tullahoma, TN. Airport (THA) to inspect and evaluate the canopy attachment mechanism of N602SL, S/N 2024, 2006 Alisport SRL powered glider.

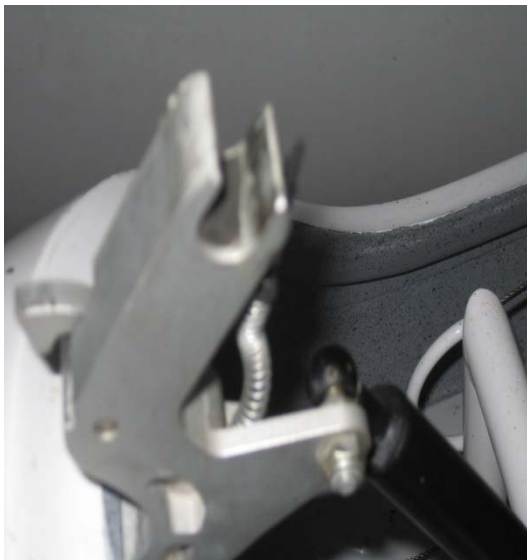
Above photo is the forward canopy attachment point emergency jettison mechanism functioned properly and as designed.

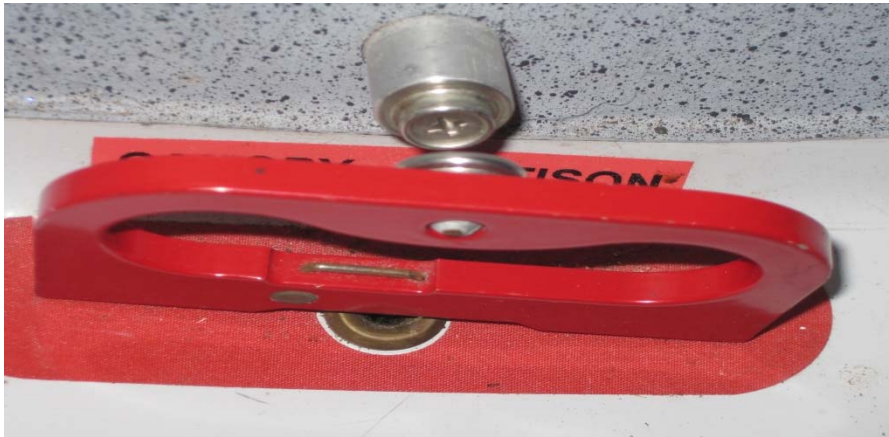
Inside the cockpit R/H side, Canopy emergency jettison mechanism functioned properly and as designed.

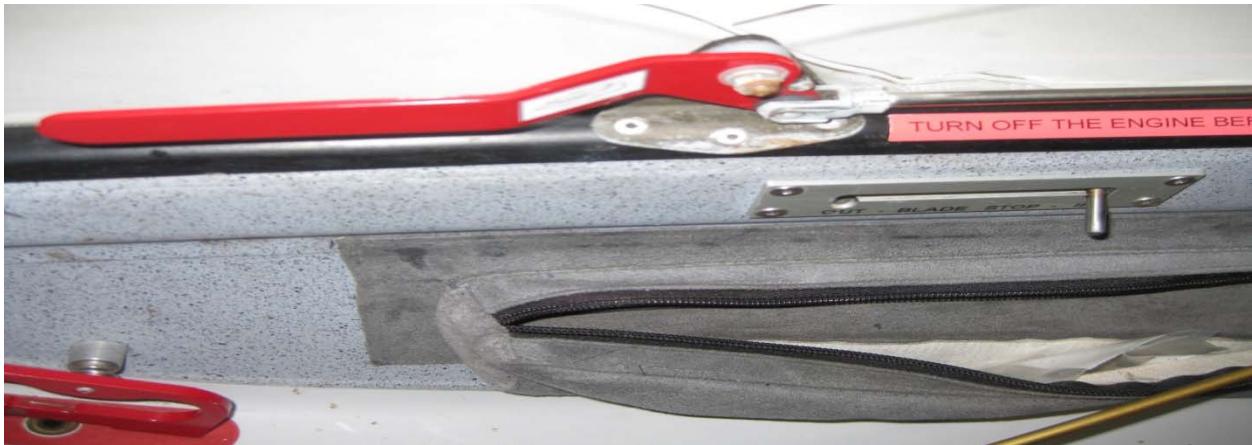
Inside Cockpit R/H canopy latch mechanism, in the latched position, handle forward. Latch mechanism functioned properly and as designed. This was also the case for the left hand side. Note surface corrosion at the latch hardware. Aircraft sat outside and exposed to weather for 2 months following the accident.

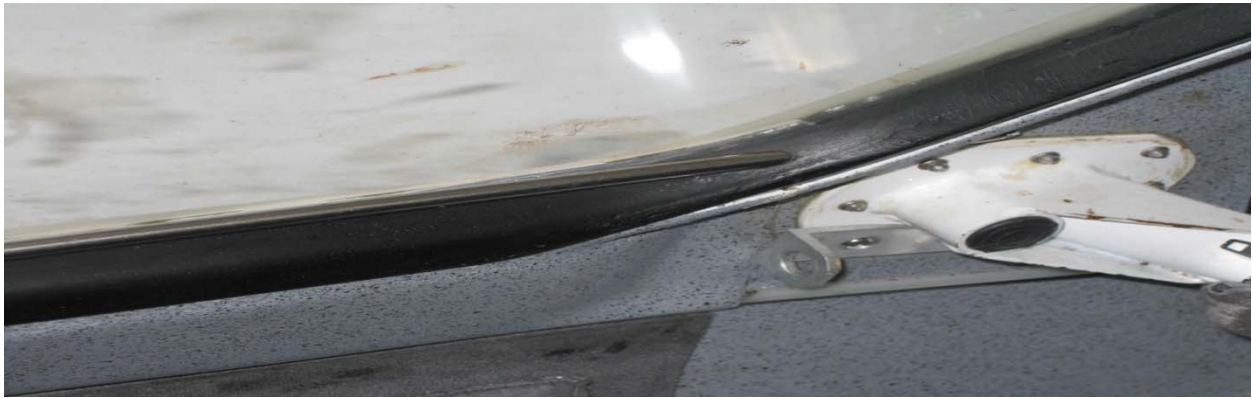
Canopy closed right hand inside view, note the closing rod penetration thru the canopy frame as well as the airframe receiver hole when the canopy is seated properly. This was also the case for the left hand side.

During my inspection I found the canopy system operated perfectly. It was possible to offset the canopy during the closing process to the point that one side or the other of the canopy closure pins could be offset enough that the pin could actually pass buy the outside of the airframe side receiver hole, thus not allowing the canopy to seat properly. With that being said, if that occurs there is really no visible indication in the cockpit that the canopy was closed improperly. If the canopy latches were left open the canopy could lift from the rear initially, but once the air pressures equal over the airframe with a forward airspeed the canopy would stabilize in forward flight.
