CESSNA AIRCRAFT COMPANY  
**MODEL 150 SERIES (1969 - 1976)**  
SERVICE MANUAL

**SUPPLEMENTAL INSPECTION NUMBER: 55-10-01**

**1. TITLE:**  
Horizontal Stabilizer, Elevators and Attachments Inspection

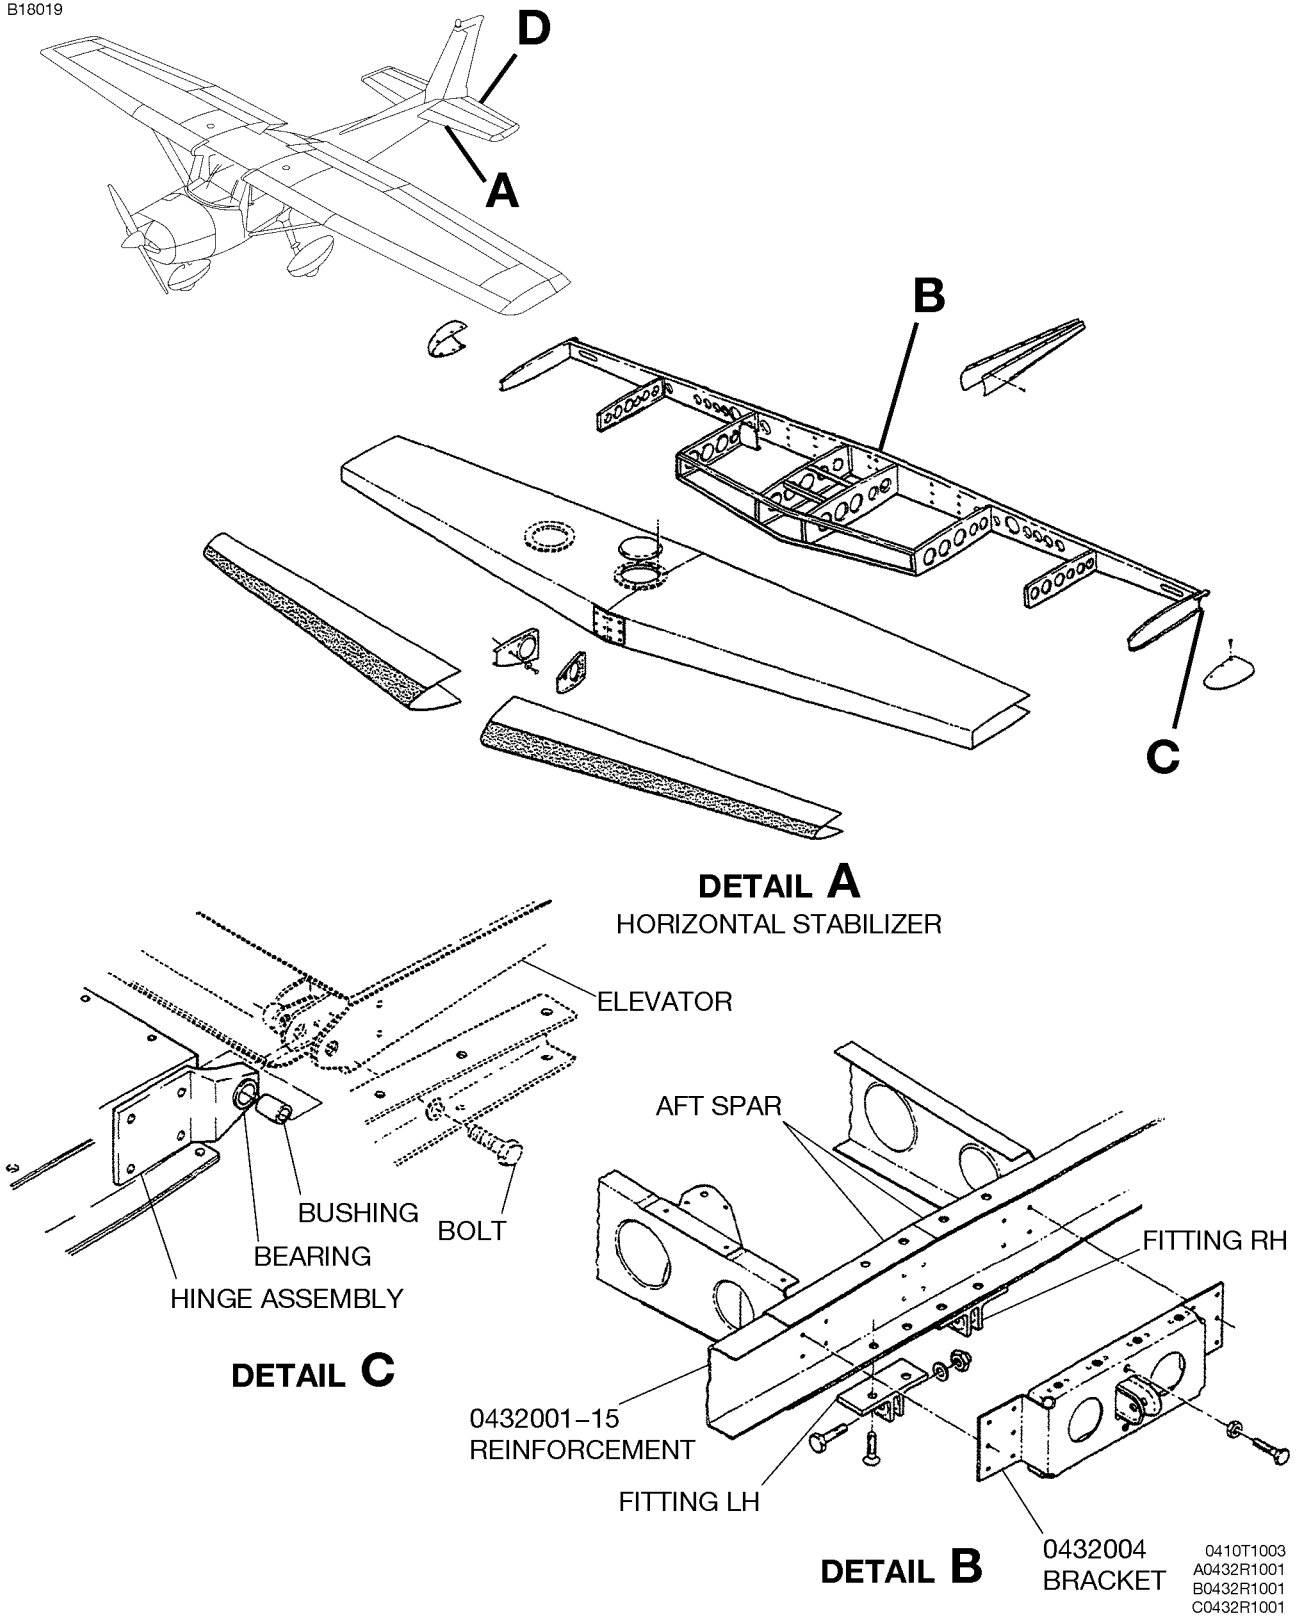
HORIZONTAL STABILIZER, ELEVATORS AND ATTACHMENTS INSPECTION  
 Figure 1 (Sheet 1)

- B. Visually inspect stabilizer and elevator for condition, cracks and security; hinge bolts, hinge bearings for condition and security; bearings for freedom of rotation; attach fittings for evidence of damage, wear, failed fasteners and security. Refer to Figure 1.

- (3) With the inspection plate on top of the horizontal stabilizer removed, pay particular attention to the forward side of the aft spar where the 0432001-15 reinforcement and 0432004 bracket are installed. Refer to Figure 1, Detail B.

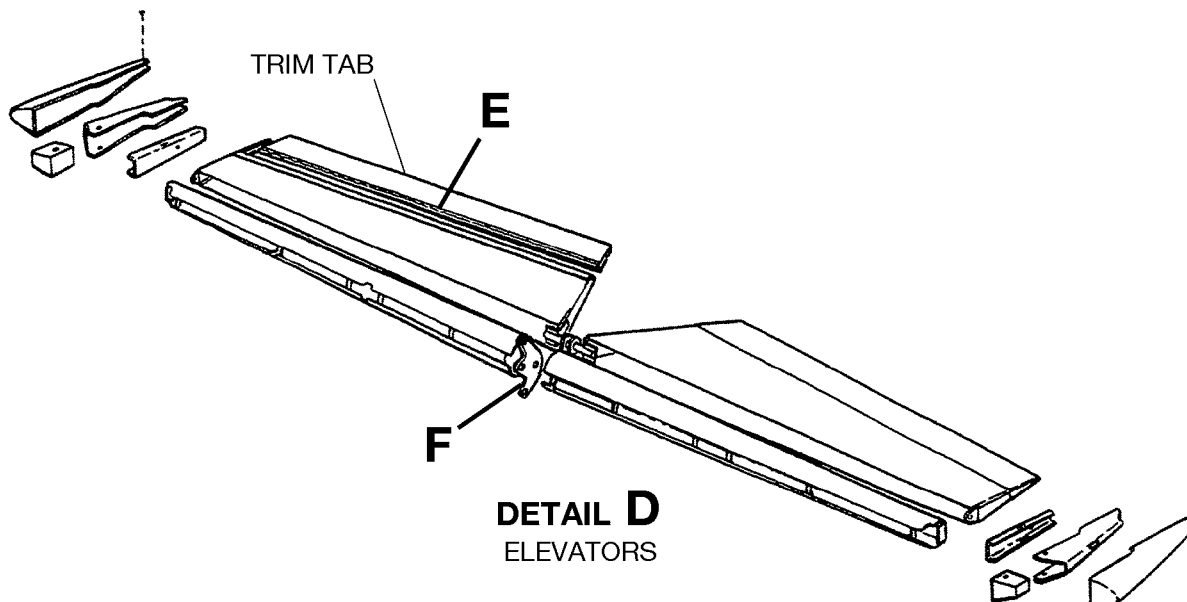
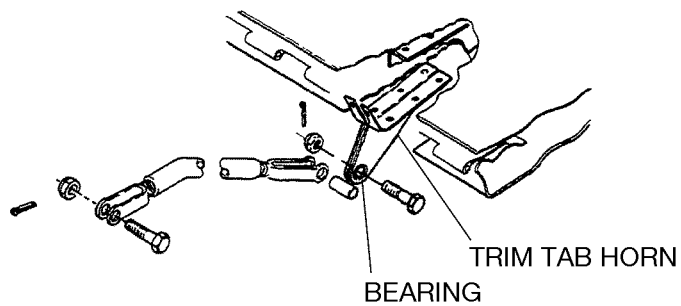
**DETAIL E**

- F. Visually inspect the trailing edge portion of the elevator for indications of cracks, corrosion and deterioration. Visually inspect the attachment of the trim tab horn to the trim tab. Refer to Figure 1, Detail E.
- G. Install all previously removed access panels according to the applicable Model 150 Service Manual.

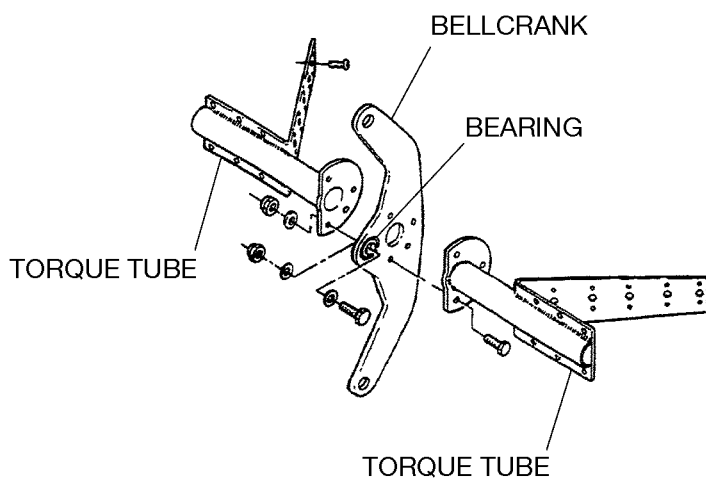
**DETAIL F**

- C. Visually inspect the elevator torque tube for corrosion and rivet security. Pay particular attention to the flange riveted onto the torque tube near the airplane centerline for corrosion. Refer to Figure 1, Detail F.
