## SERVICE LETTER #47

SUBJECT: Rudder Pedal Torque Tube Cracking

APPLICABILITY: Kitfox Models 1 through 4, Classic 4

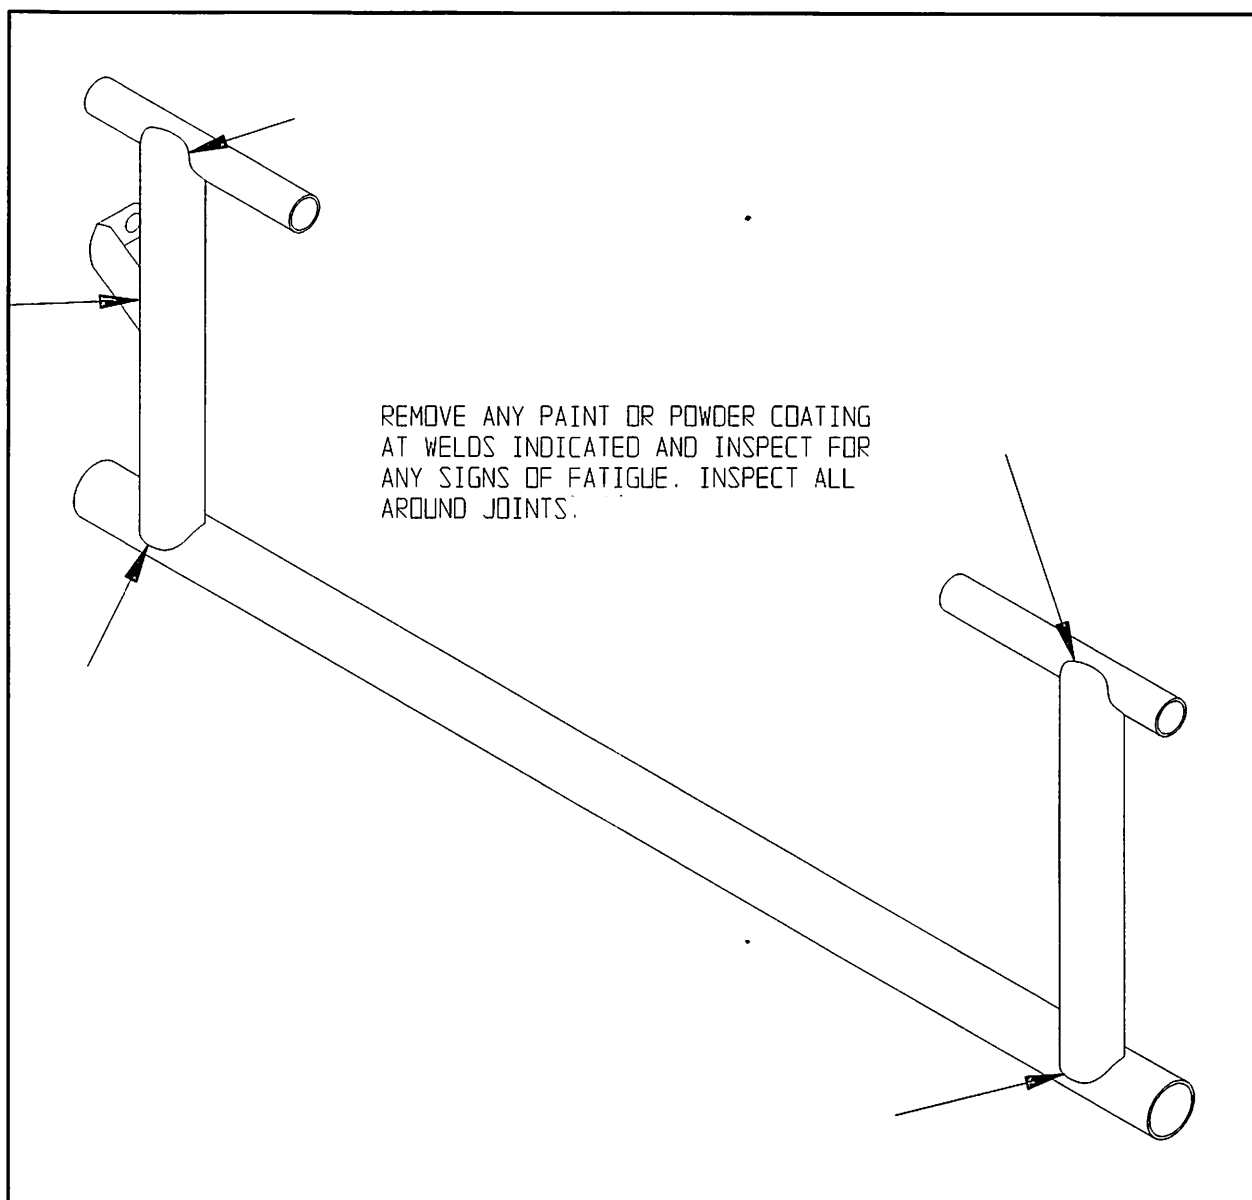
**Figure 3 - Torque Tube Inspection**

We have recently noticed that some of the rudder pedal torque tubes in our older factory aircraft have started showing signs of fatigue at the positions shown in Figure 1. Because of this we recommend that each owner/builder inspect his torque tubes carefully for any signs of fatigue or cracking prior to the next flight of the aircraft. You should remove the assembly from the aircraft so it may be inspected under more optimal conditions. Prior to inspecting the areas indicated, remove any paint or powder coating around the welded joints with a piece of emery paper. If no cracks are seen, repaint the areas around the joint with a coat of paint just thick enough to protect the assembly from corrosion and add the tube to your list of items to be inspected on both preflight inspections and annual condition inspections.

If cracks are seen, replace the assembly before flying the aircraft. Even if no cracks are seen, we advise that you install a reinforcement kit on the tubes prior to continuing operation of the aircraft. This kit is part number 35015.000 and may be purchased from SkyStar for \$59.95.
