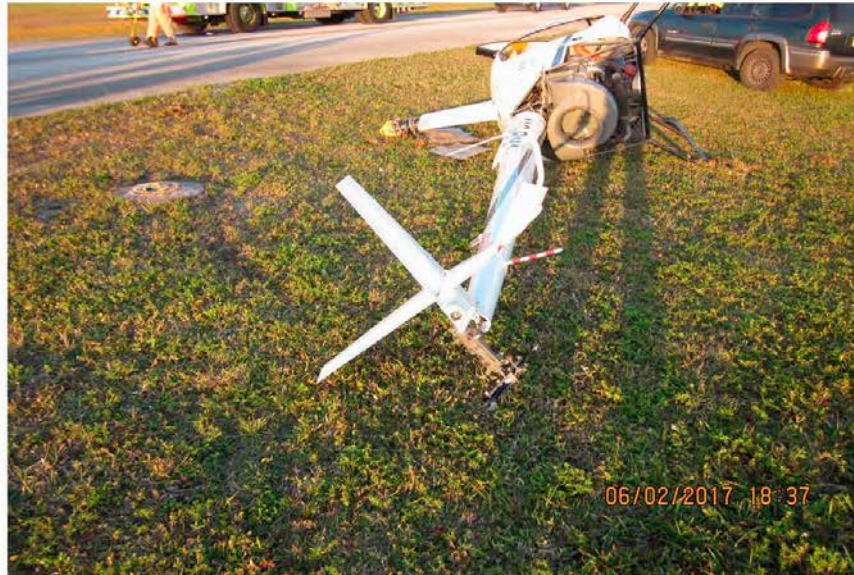
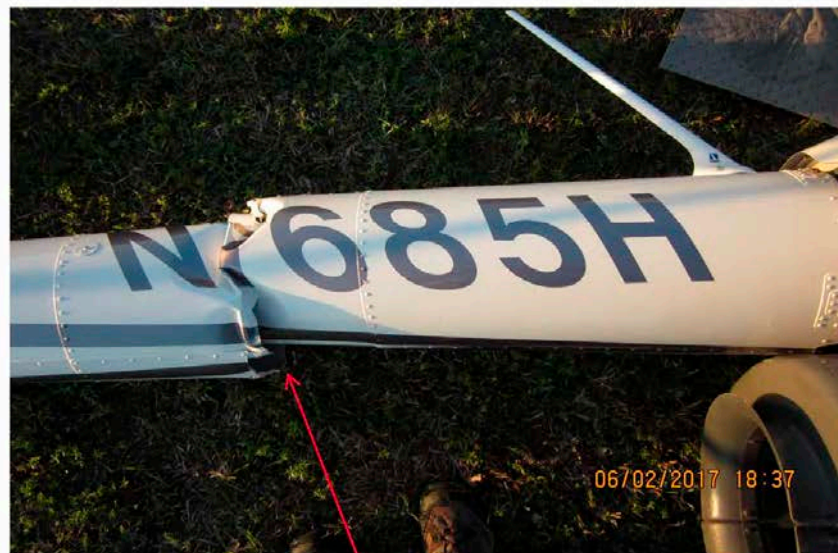
No evidence of main rotor contact with tail boom

Photo 1 – FAA photo-View of tail boom buckled

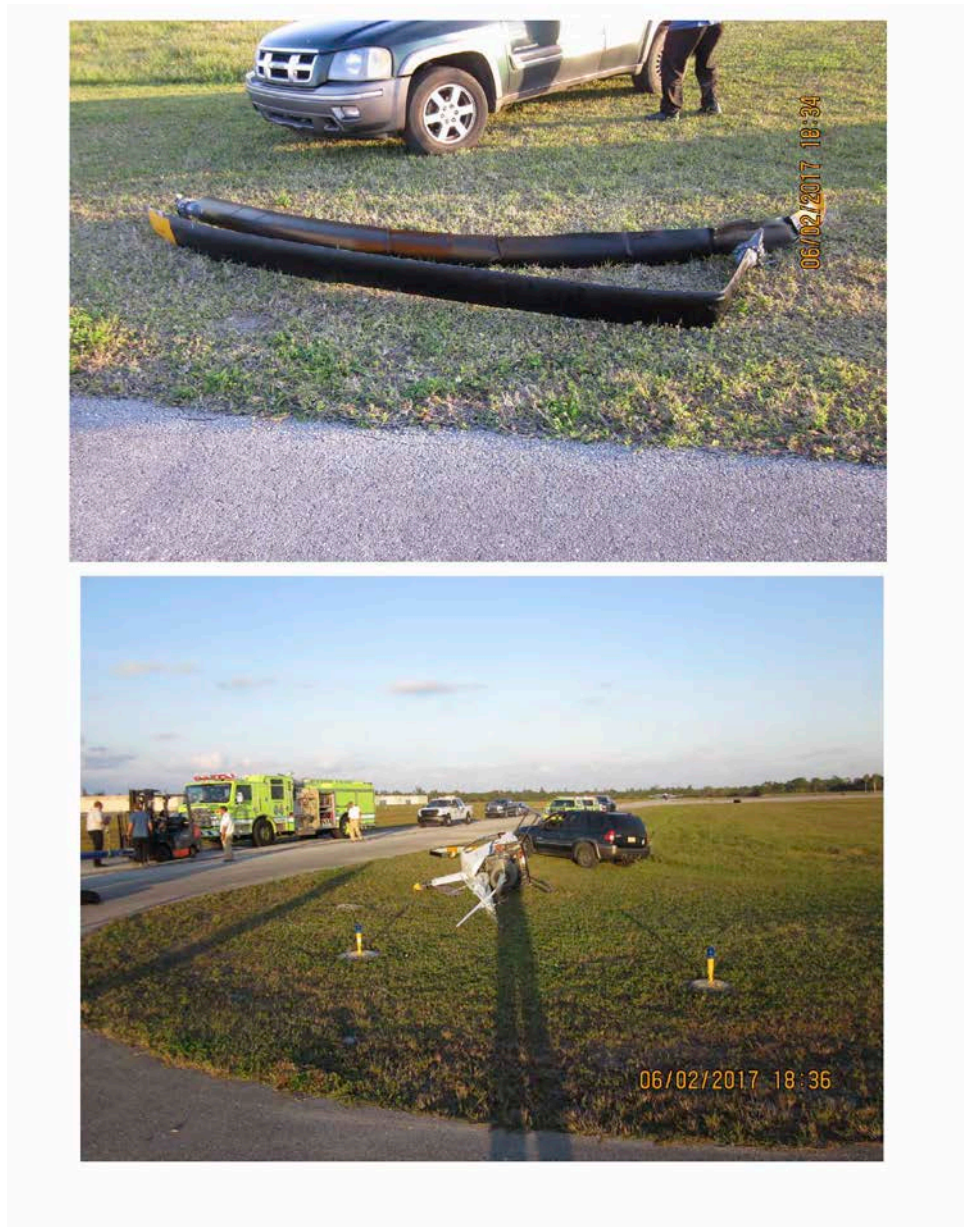
**Photo 2 – FAA photo-View of bent main rotor blades and helicopter laying on its left side**
