## **NATIONAL TRANSPORTATION SAFETY BOARD**

### **Weather Study**

# **METEOROLOGY**

ERA17FA017

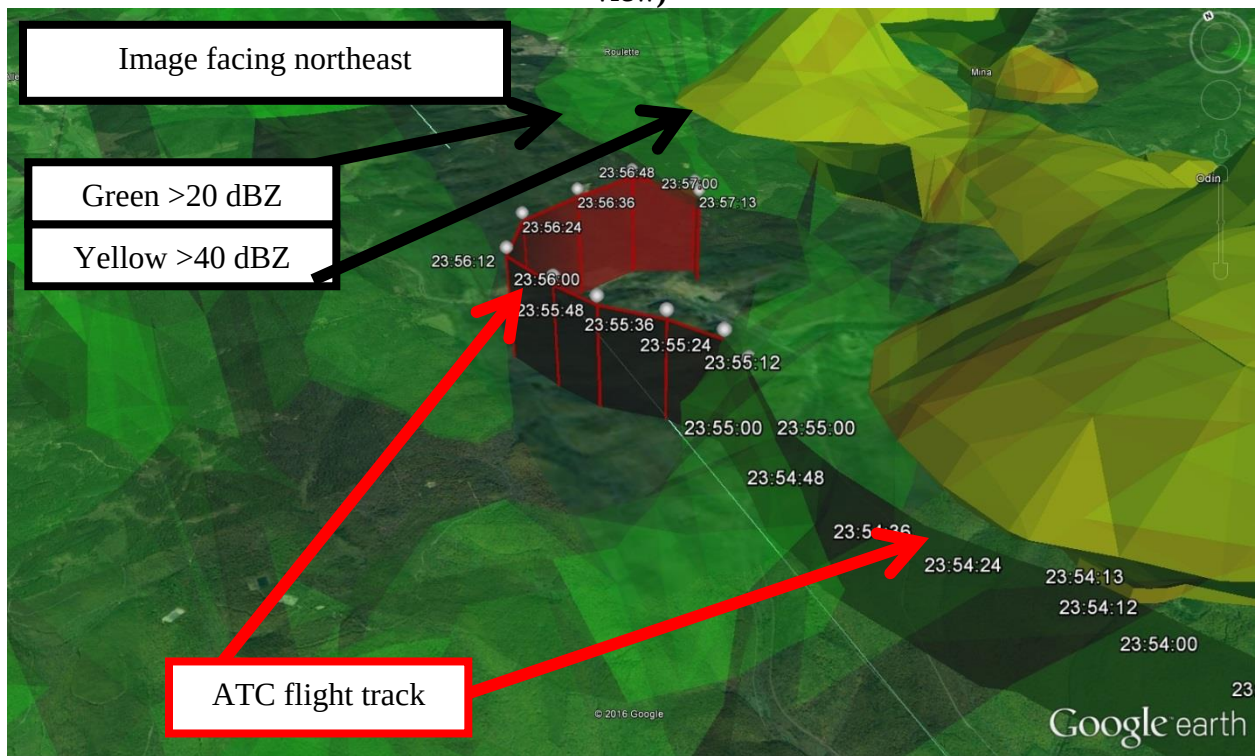
**Figure 28 – 3-dimensional KCCX WSR-88D base reflectivity from the scan initiated at 1957 EDT and the ATC Flight Track (gray dots) with the image facing northeast**

Figures 25, 26, 27, 28, and 29 present a 3-dimensional view of the KCCX WSR-88D base reflectivity for the elevation scans initiated at 1947, 1952, and 1957 EDT. The accident aircraft's flight track obtained from ATC<sup>25</sup> was also plotted on the Google Earth image for a time comparison with the base reflectivity images. Figure 25 indicated that the accident flight flew into an area of greater than 10 to 20 dBZ reflectivity values around 1947 EDT (figure 25), with the accident flight likely in instrument meteorological conditions (IMC) and precipitation. By 1952 to 1957 EDT the accident flight flew through greater than 40 dBZ values (figures 26 and 27). After 1957 EDT the accident flight was still located in greater than 20 dBZ values (figures 28 and 29), with IMC likely along with turbulence, wind shear, and updrafts and downdrafts associated with the rain shower activity.
