**NATIONAL TRANSPORTATION SAFETY BOARD**

## **Multiple Electronic Devices**

### **Specialist's Factual Report**

Location: Austin, Pennsylvania  
Date: October 16, 2016  
Aircraft: Piper PA-28-161  
Registration: C-GYSN  
Operator: Private  
NTSB Number: ERA17FA017

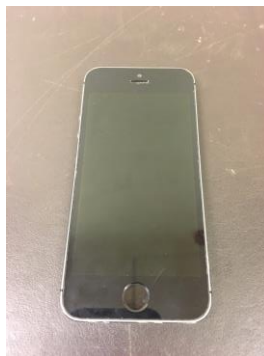
**Figure 1.** Photo of PED.

Upon arrival at the Vehicle Recorder Laboratory, an examination revealed the unit had not sustained any damage. The PED is shown below in figure 1.

The iPhone was functional but was passcode locked. A number of passcodes were provided by a family member, none of which unlocked the phone. No data was recovered from the iPhone.
